Date of Inspection:	Time:	Zone / Area:	Weather:	Person Contacted During Visit:
30.07.20	09:45		Overcast	Shawn McLean

Copies of Inspection Sent to:	Inspected By:
shawn.mclean@gleesonquarries.co.nz kate@pauaplanning.co.nz biance@pauaplanning.co.nz	Michael Parsonson (SouthernSkies Environmental)

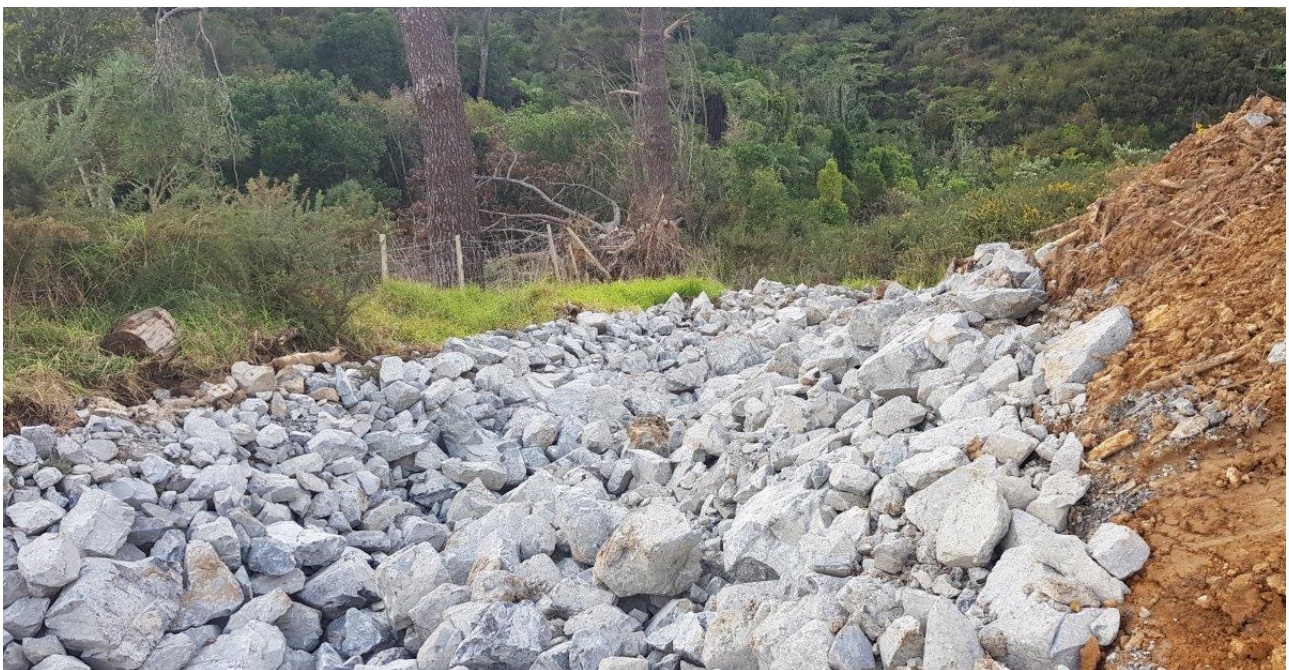
Figure 1: Outlet spill way. Slope to right to be seeded and mulched.

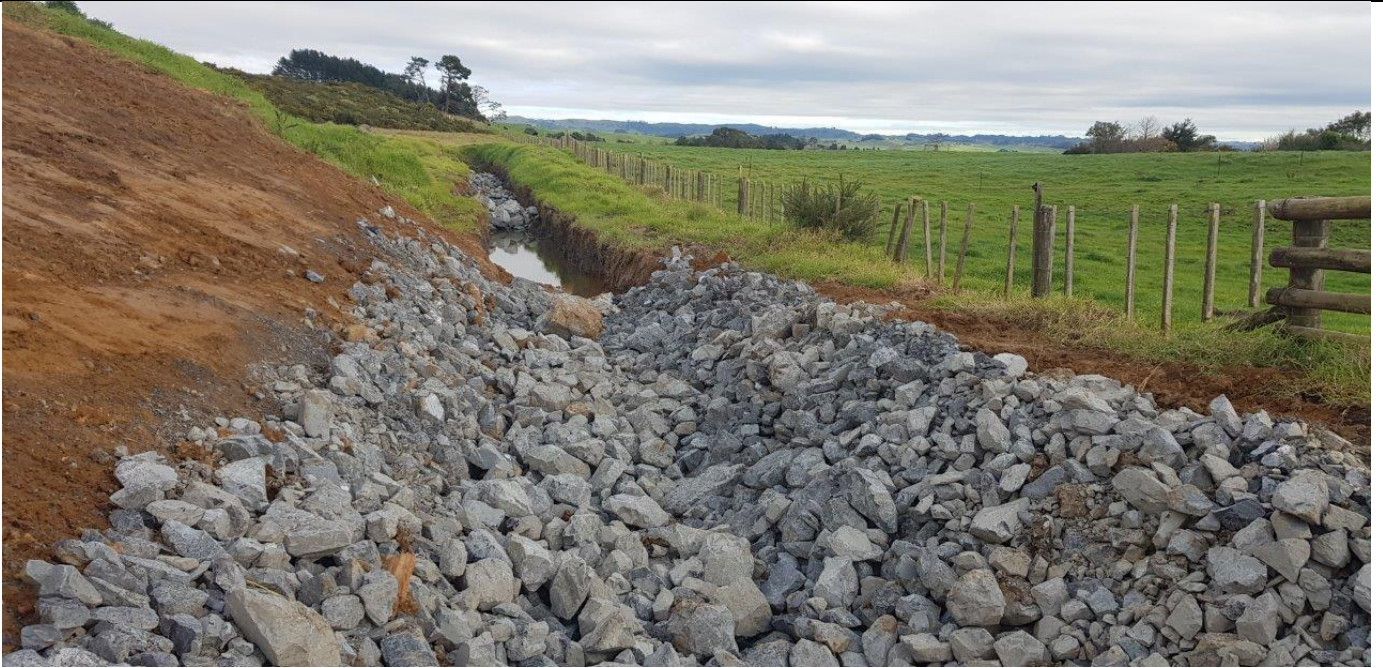
Figure 2: Upstream extent of outlet spillway and check dams in background. Channel sides to be hydroseeded and slope to left to be seeded and mulched.

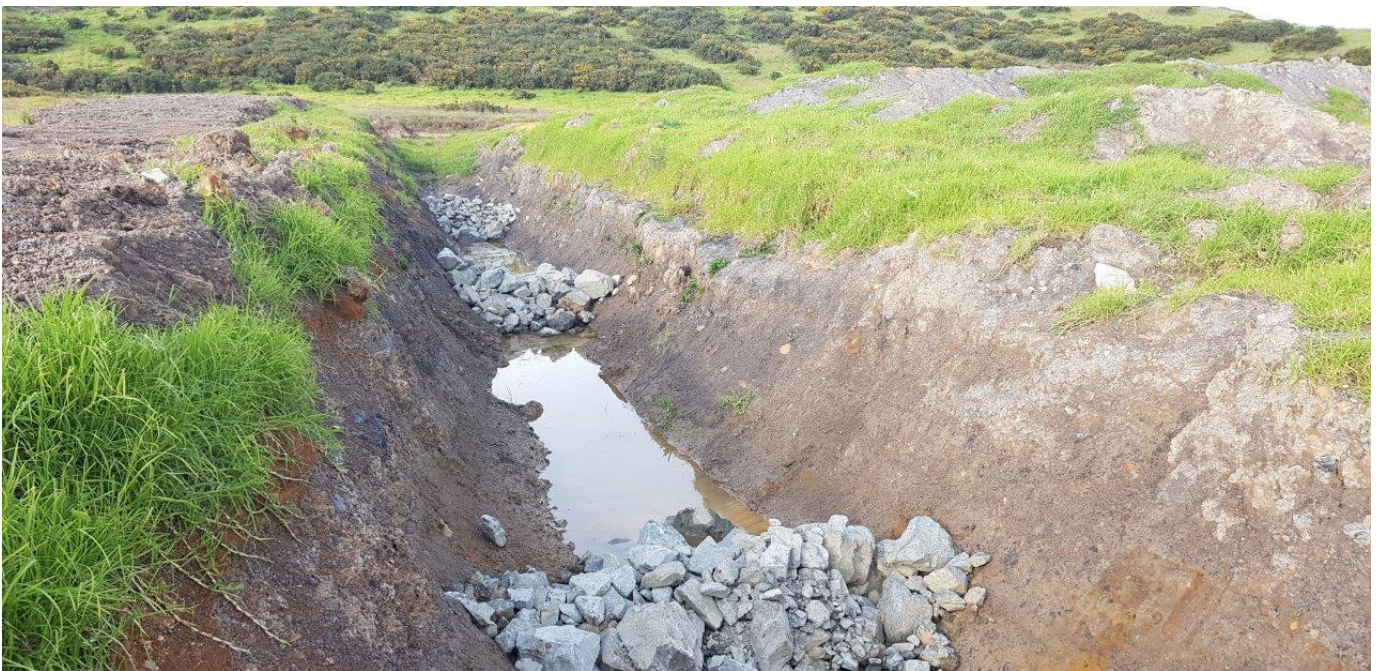
Figure 3: Check dams in southern branch of channel. Channel sides to be hydroseeded.

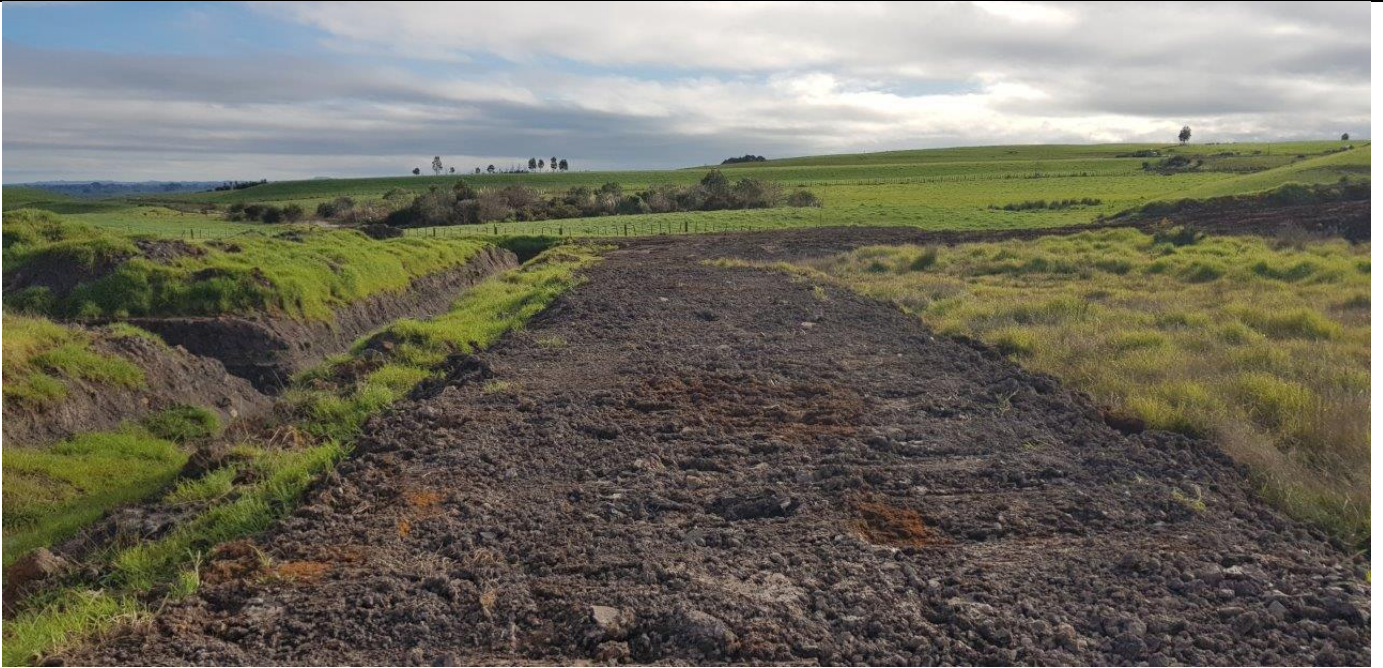
Figure 4: Flattened stockpiles to be seeded and mulched.

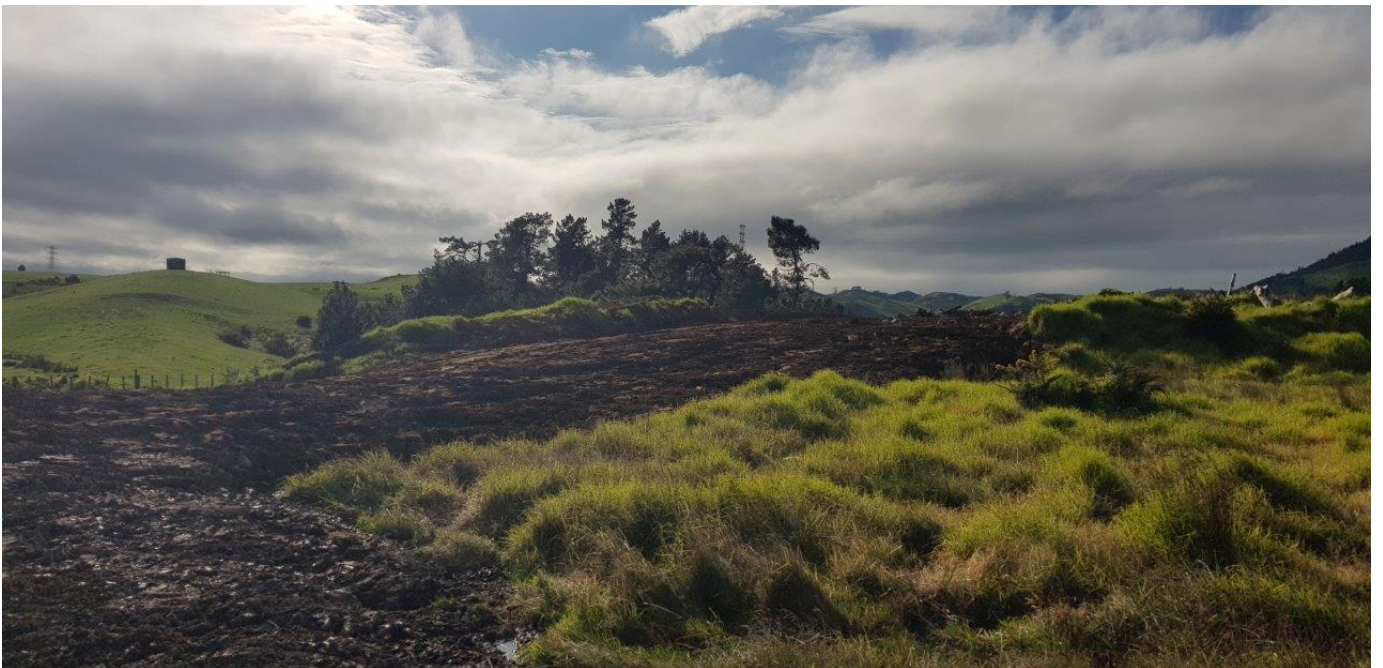
Figure 5: Flattened stockpiles to be seeded and mulched.

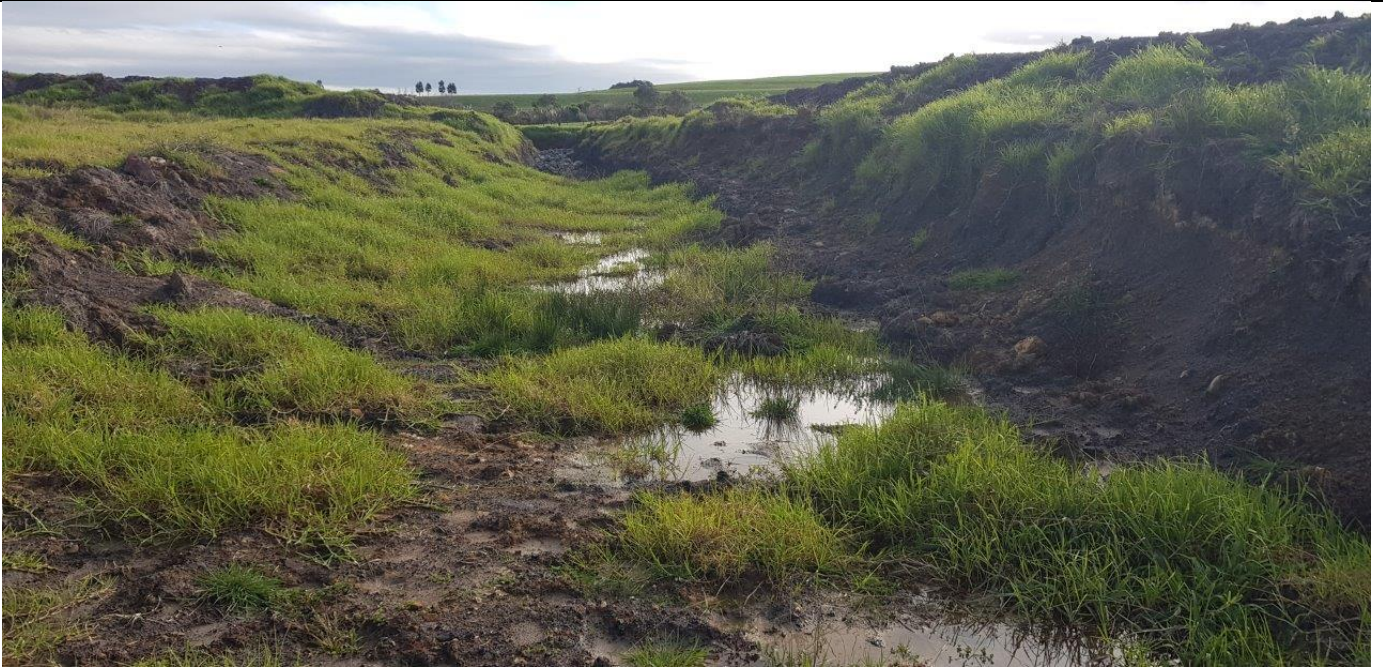
It was also observed that the recent works have caused limited little change in the depth of the ponded area at the upstream end of the of channels. Cracked margins of the ponded area are evident, which appear to have formed during summer and autumn, and are at a similar level to the outlet side of the pond.

Figure 6: Outlet of pond area which appears to be at similar level to previous standing water level. Exposed areas to be seeded and mulched, or hydroseeded.

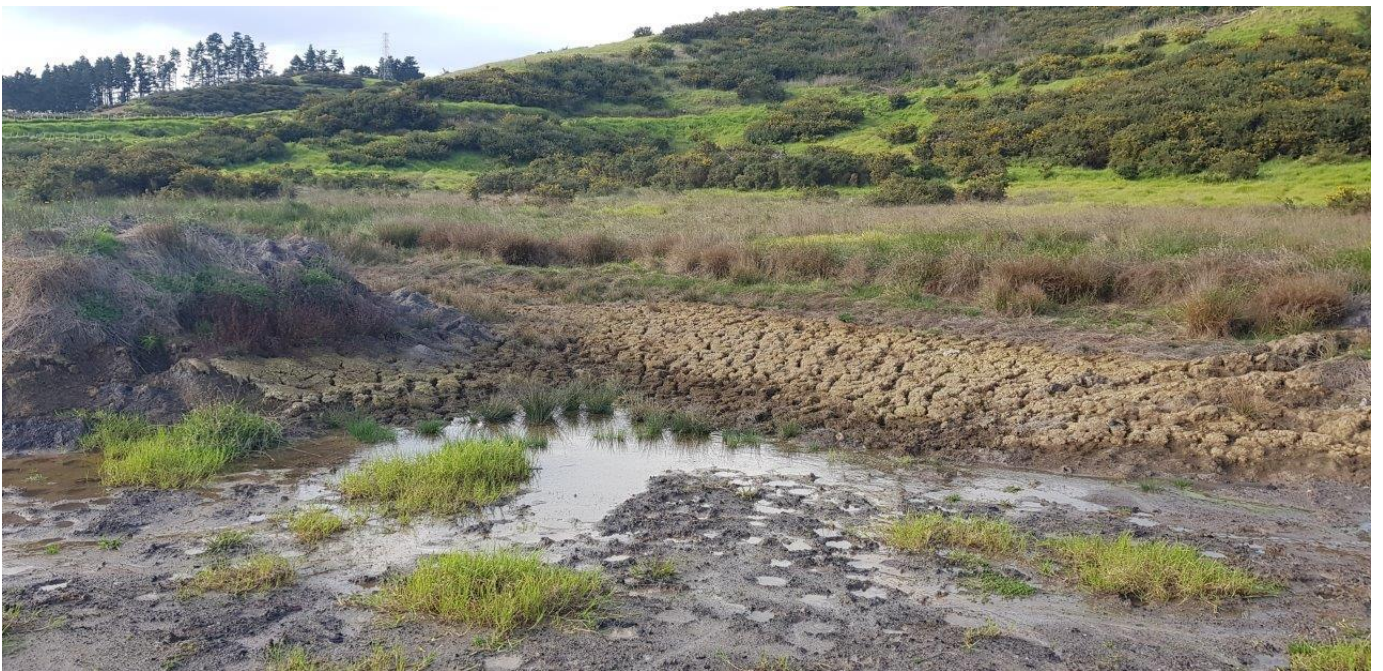
Figure 7: Standing water level in pond and dried out pond margins.

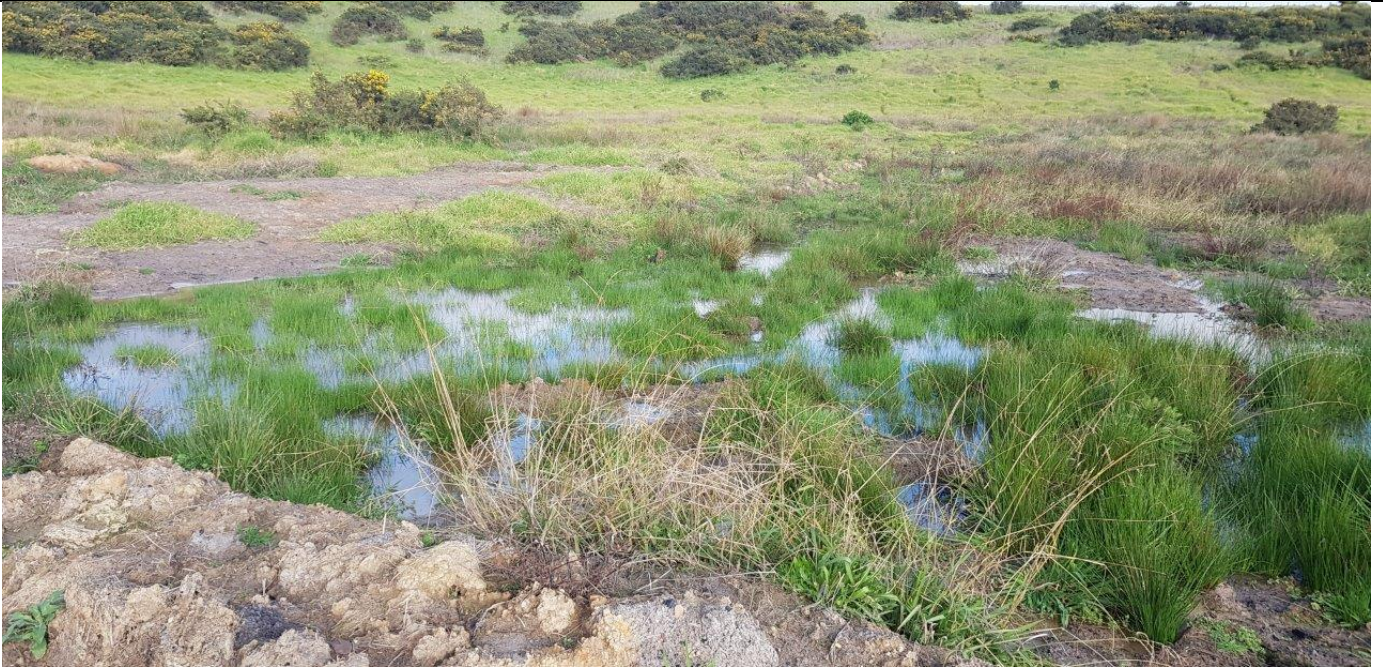
Now that the dam at the downstream end of the channel has been removed the channel retains a low level of ponded water (approx. 100-200mm). No seepage was observed from the channel sides.

Figure 8: Remaining standing water.

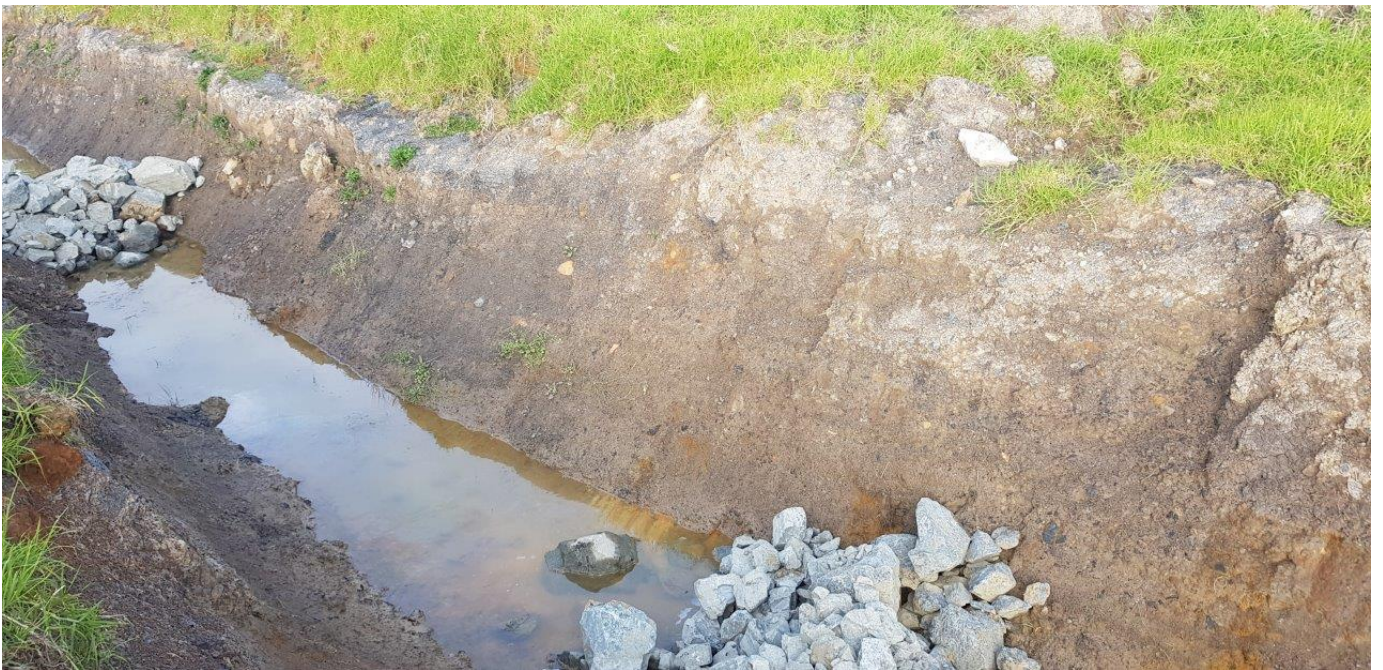
Figure 9: Existing channel sides and standing water. Channel sides to be hydroseeded.
