NGAARUAWAAHIA AND TAUPIRI CPTED ASSESSMENT

Prepared for Waikato City Council

by Beca Ltd (Beca)

28 April 2023

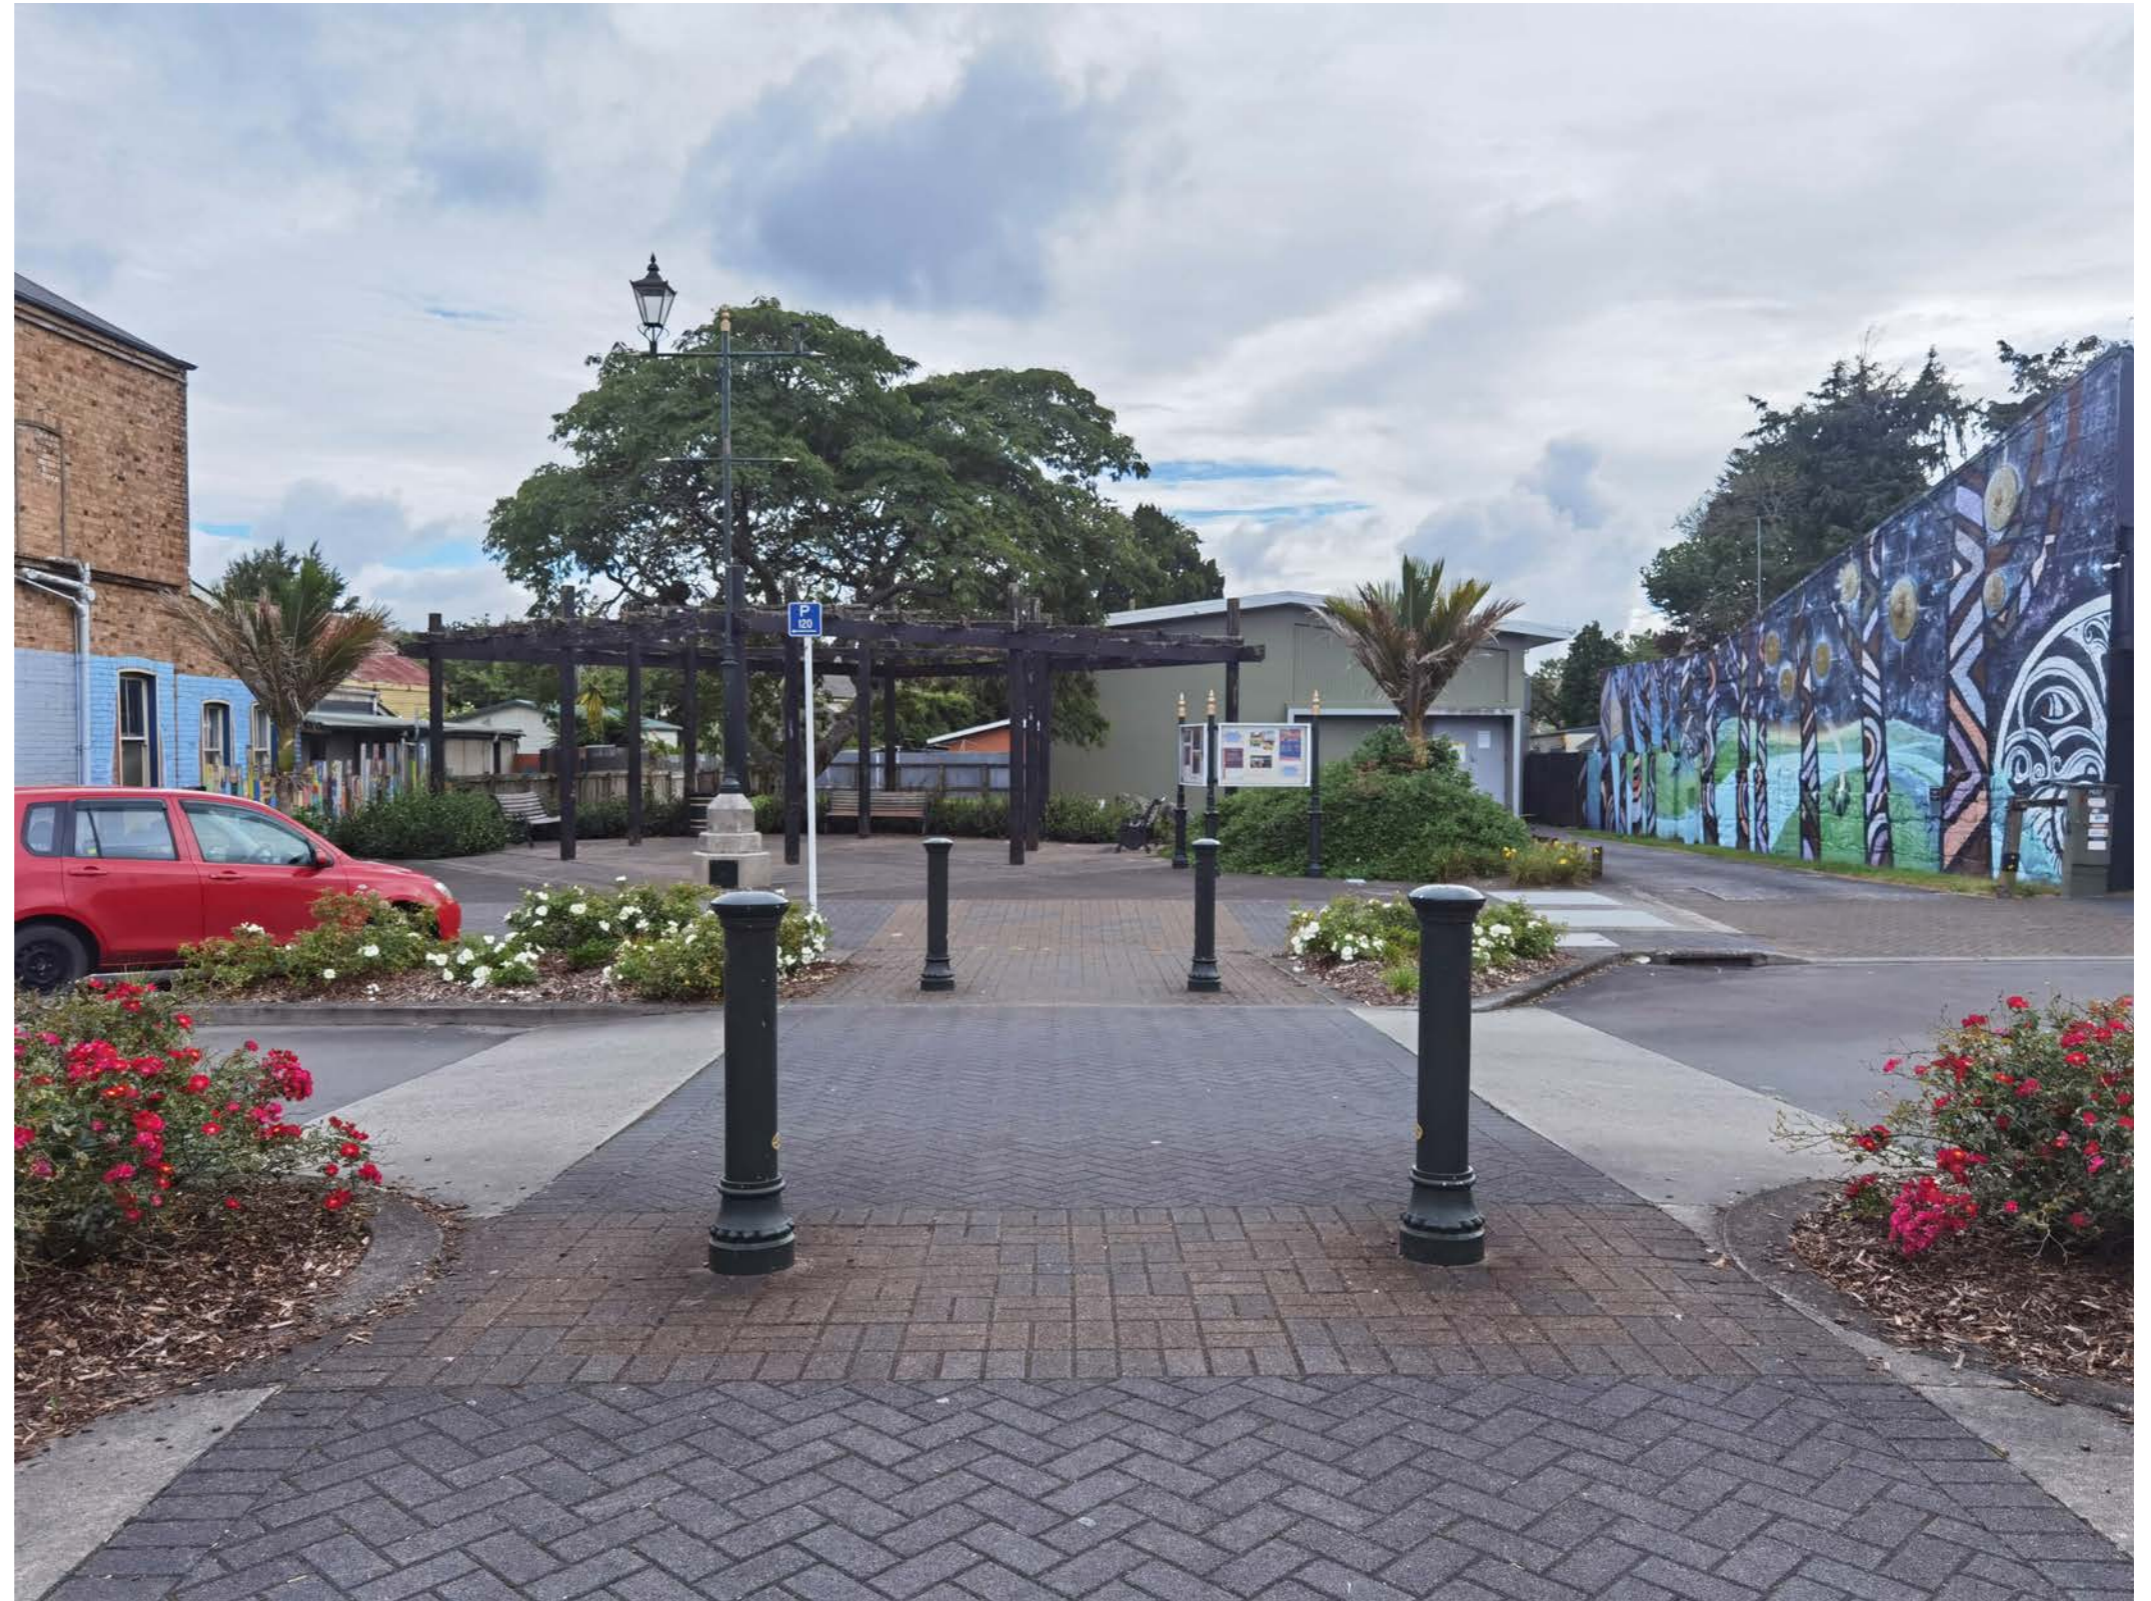
Figure 7. Market area on Jesmond Street

- c The mural along the wall at the market area shows no graffiti, a good strategy for blank walls with little passive surveillance (refer to Figure 7).

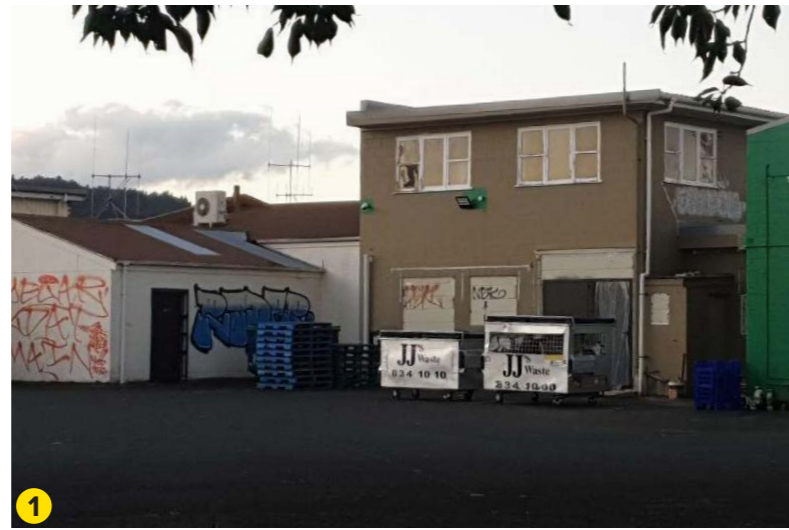
There are natural ladders behind Great South Road - owners to evaluate if this is an issue for access onto rooves etc. The bins can also be a place for people to hide behind at night.

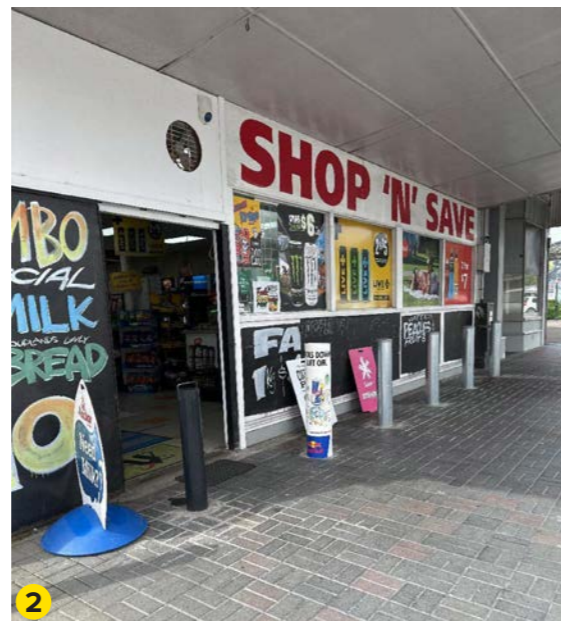
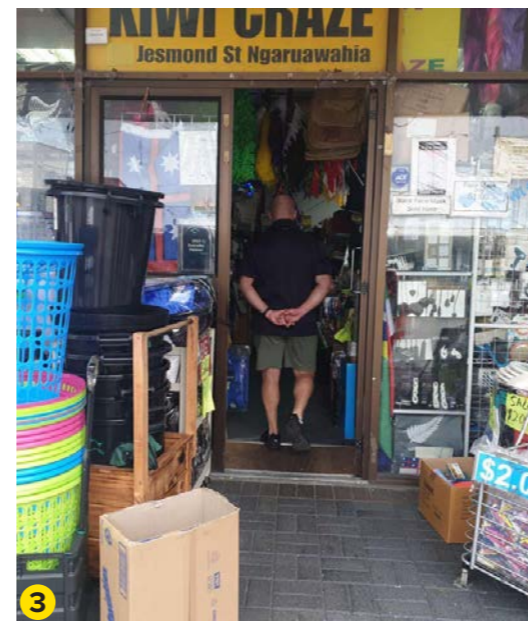
Shops have posters and screens obstructing views on Jesmond St.

Removal of posters to open sightlines into the shops and provide eyes onto the street.

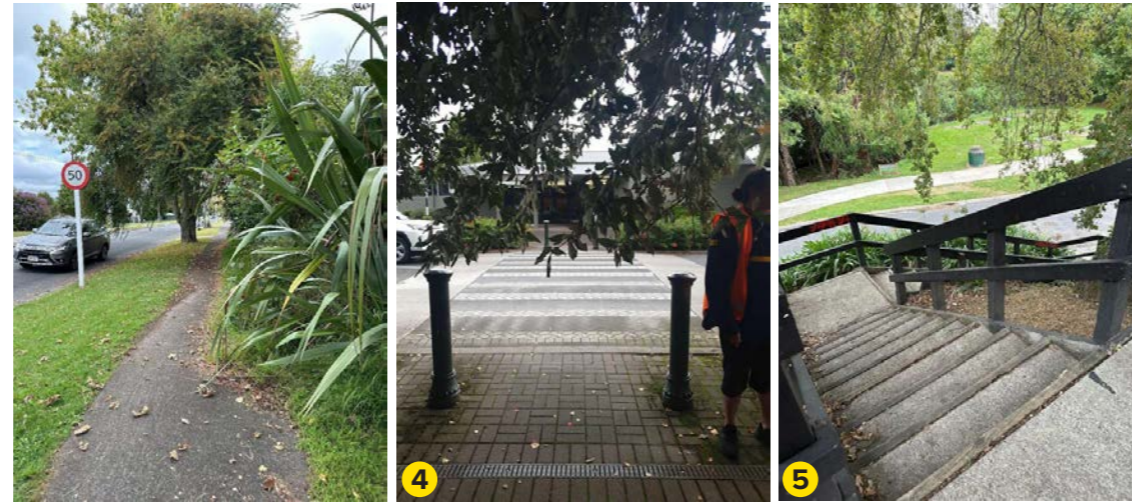
There are areas where vegetation is overgrown with incursion onto the footpath or there is a low canopy obstructing sightlines.

i.e. Paterson Park, stairs that connect the bridge and cycleway. All areas where this is identified are at the end of this section.

Trees (in all areas) should be canopy-lifted, allowing sight lines to be maintained. Trimming of trees surrounding to open sight lines.

CPTED best practice stipulates a vegetative clearance between 0.6m to 2.5m (refer diagram below).

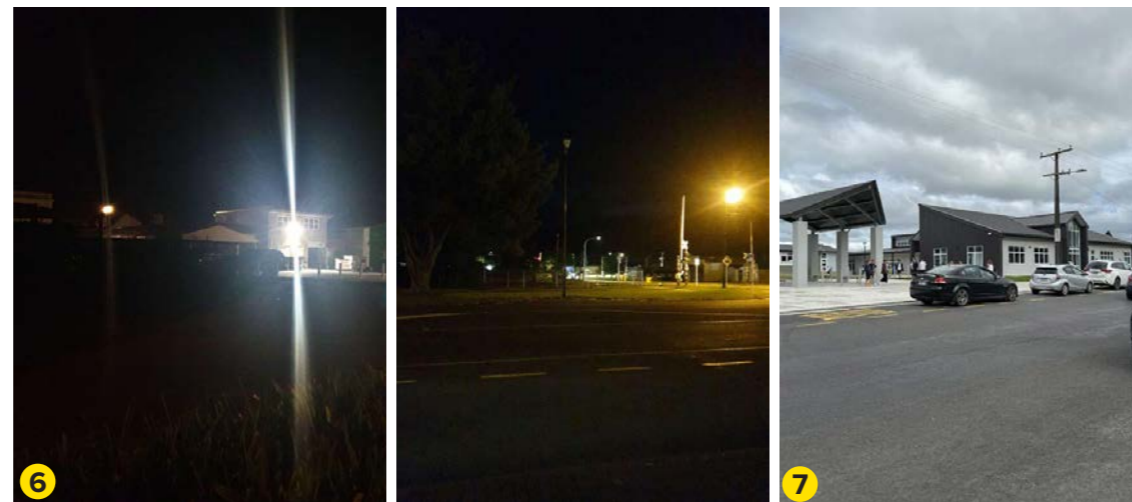
The space between the buildings along Great South Road has dark unlit areas which leads to a varying pedestrian experience (well lit to no lighting in the gaps). Pedestrian paths alongside the rail line on Great South Road are well lit but obscured by the tree canopy with resulting patchy lighting.

Along the rail line and in front of Ngaaruawaahia High School there is no lighting.

Conduct a review of the lighting (on the night of the walkover lights were being replaced) and an arborist review to determine where trees are blocking lighting at ground level.

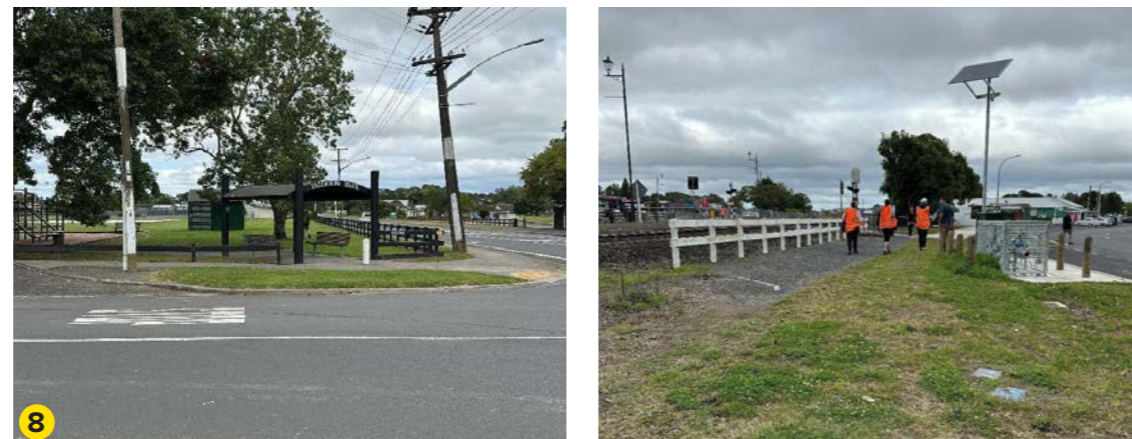
Lack of signage to connect the town centre to Te Awa Cycle Trail, along the Waikato River edge, bridge and to the Hakarimata Ranges walkway.

Consider a suite of signage that would assist pedestrians in identifying natural amenities, attractions and navigating around the town centre, i.e., consistent signage directing people to toilets, schools, library, and other public facilities. Ensure signage is clear and appropriately placed.

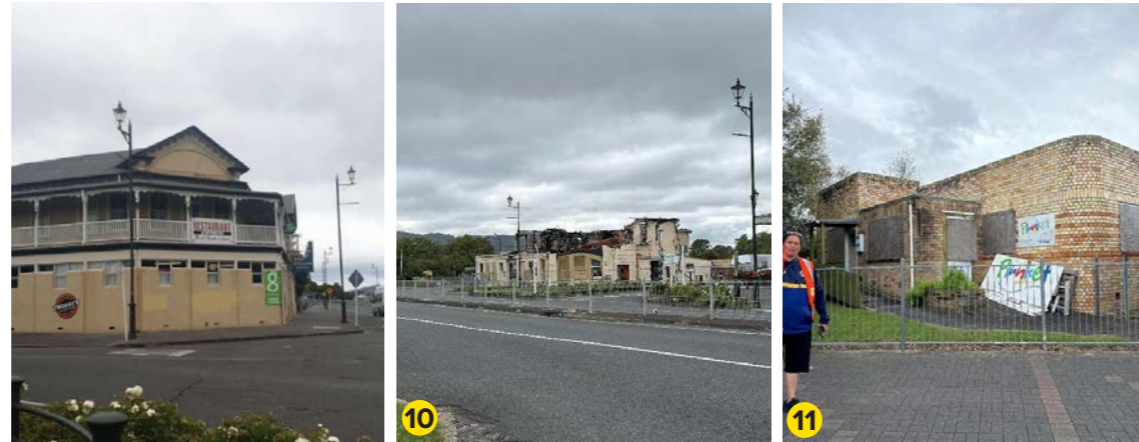
There are streetscape gaps along Jesmond Street, the old Waipa Hotel and carpark. In addition the former Plunket building is closed and unoccupied with no passive surveillance provided.

Buildings with blocked or opaque film on the windows also reduce the potential for passive surveillance to contribute to a sense of safety for people on the street.

Focus on land uses that activate the street and consider consolidation based on the economic projection for retail demand.

Consider uses that extend beyond daytime hours to provide more presence on the street, supplementing existing restaurant facilities.

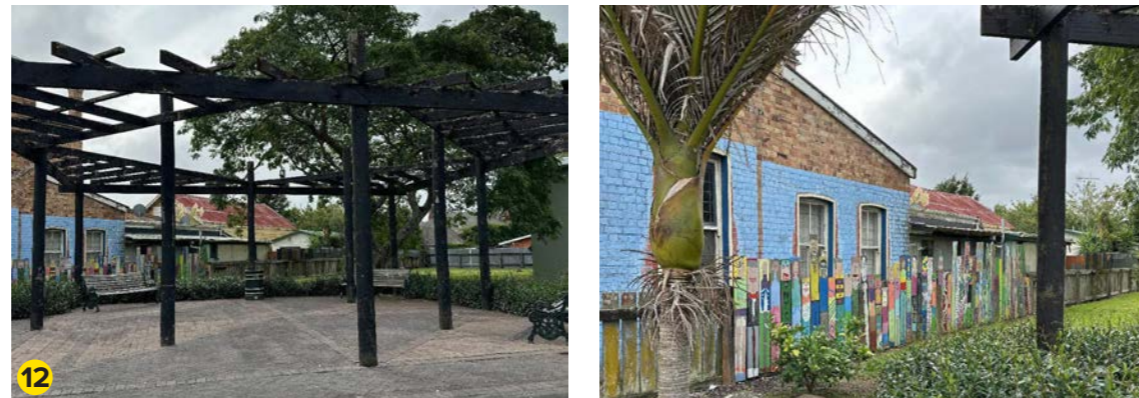
Market area on Jesmond Street needs care and a tidy up. The use of the space and the function is unclear when not in use.

There were discussions on the site visit about providing a covered area. Using the existing structure will require an engineer's review to determine whether the existing timber can support an additional load, or if a completely new structure is needed.

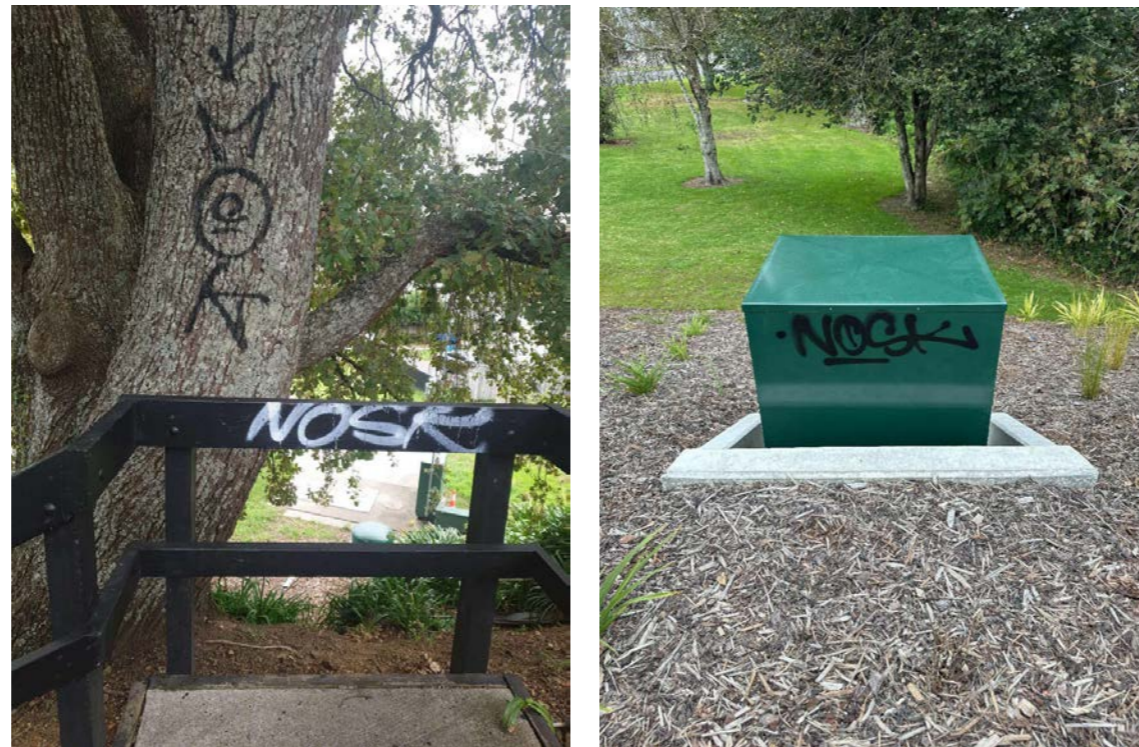
A number of graffiti tags were observed around the town i.e. Turangawaewae Marae, bridge, transformer boxes.

The presence of graffiti contributes to a lower level of perceived safety.

Address the issue using one of the following methods:

- Identify who the asset owner is of the elements that are commonly targeted for graffiti. Implement more regular reporting and maintenance. It was noted that several elements are not Waikato District Council assets and lowers the perceived quality environment.
- Plant dense foliage at the base to restrict access to the wall.
- Paint the wall using one of the precinct's theme colours from the agreed palette.
- Consider commissioning a mural artist where locations are identified that are a consistent target.
- Identify through the community if the taggers are from the wider area and reach out through the Police, community for effective ways to lower the incidence.

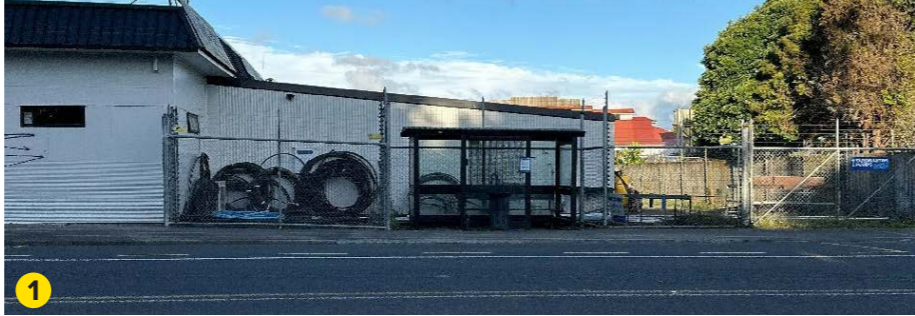
ISSUE	LOCATION & PHOTOGRAPH REFERENCE	BEST PRACTICE RESPONSE	PRIORITY
<p>a. Concealment opportunities</p> <p>Areas of possible entrapment including blind corners) should be avoided to improve the sense of safety and reduce opportunity for crime that is unobserved.</p>

<p>Increase lighting, consider gating areas where there is deep recess if this is an area where there is a level of heightened risk. Receiving wider feedback form users is important to establish whether change is warranted.</p>	<p>HIGH/ BEST PRACTICE</p>
<p>e. Lighting</p> <p>The underpass under Gordonton Road and the Rugby Field carpark are not sufficiently illuminated after dark.</p>

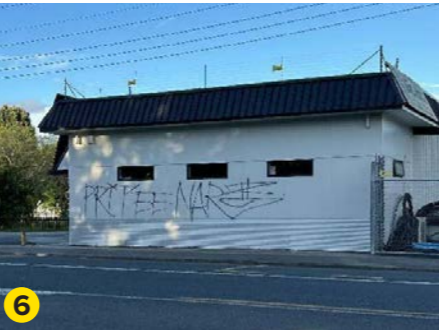
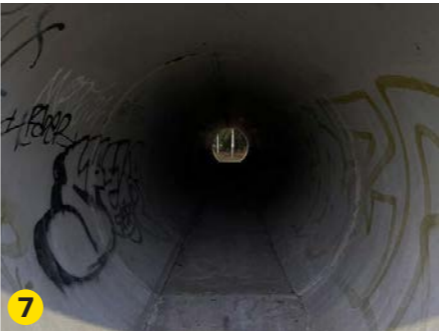
<p>l. Graffiti</p> <p>Large number of graffiti dotted around the town i.e Marae, bridge, transformer boxes.</p> <p>The presence of graffiti contributes to a lower level of perceived safety.</p>

<p>Address the issue using one of the following methods:</p> <ul style="list-style-type: none"> - Plant dense foliage at the base to restrict access to blank walls. - Paint the wall using one of the precinct's theme colours from the agreed palette. - Consider commissioning a mural artist to paint a mural. - Identify through the community if the taggers are from the wider area and reach out through the Police, community for effective ways to lower incidences. 	<p>EXTREMELY HIGH</p>
