**SUBMISSION OF MARK T MITCHELL
Consulting Geotechnical Engineer**

Re: Proposed Waikato District Plan – Natural Hazards and Climate Change

4. SLOPE STABILITY REMEDIATION – 37 & 39 BAYVIEW ROAD, COX BAY AREA

Project: Landslip Repair and Timber Deck Extension – No. 39 Bayview Road, Raglan

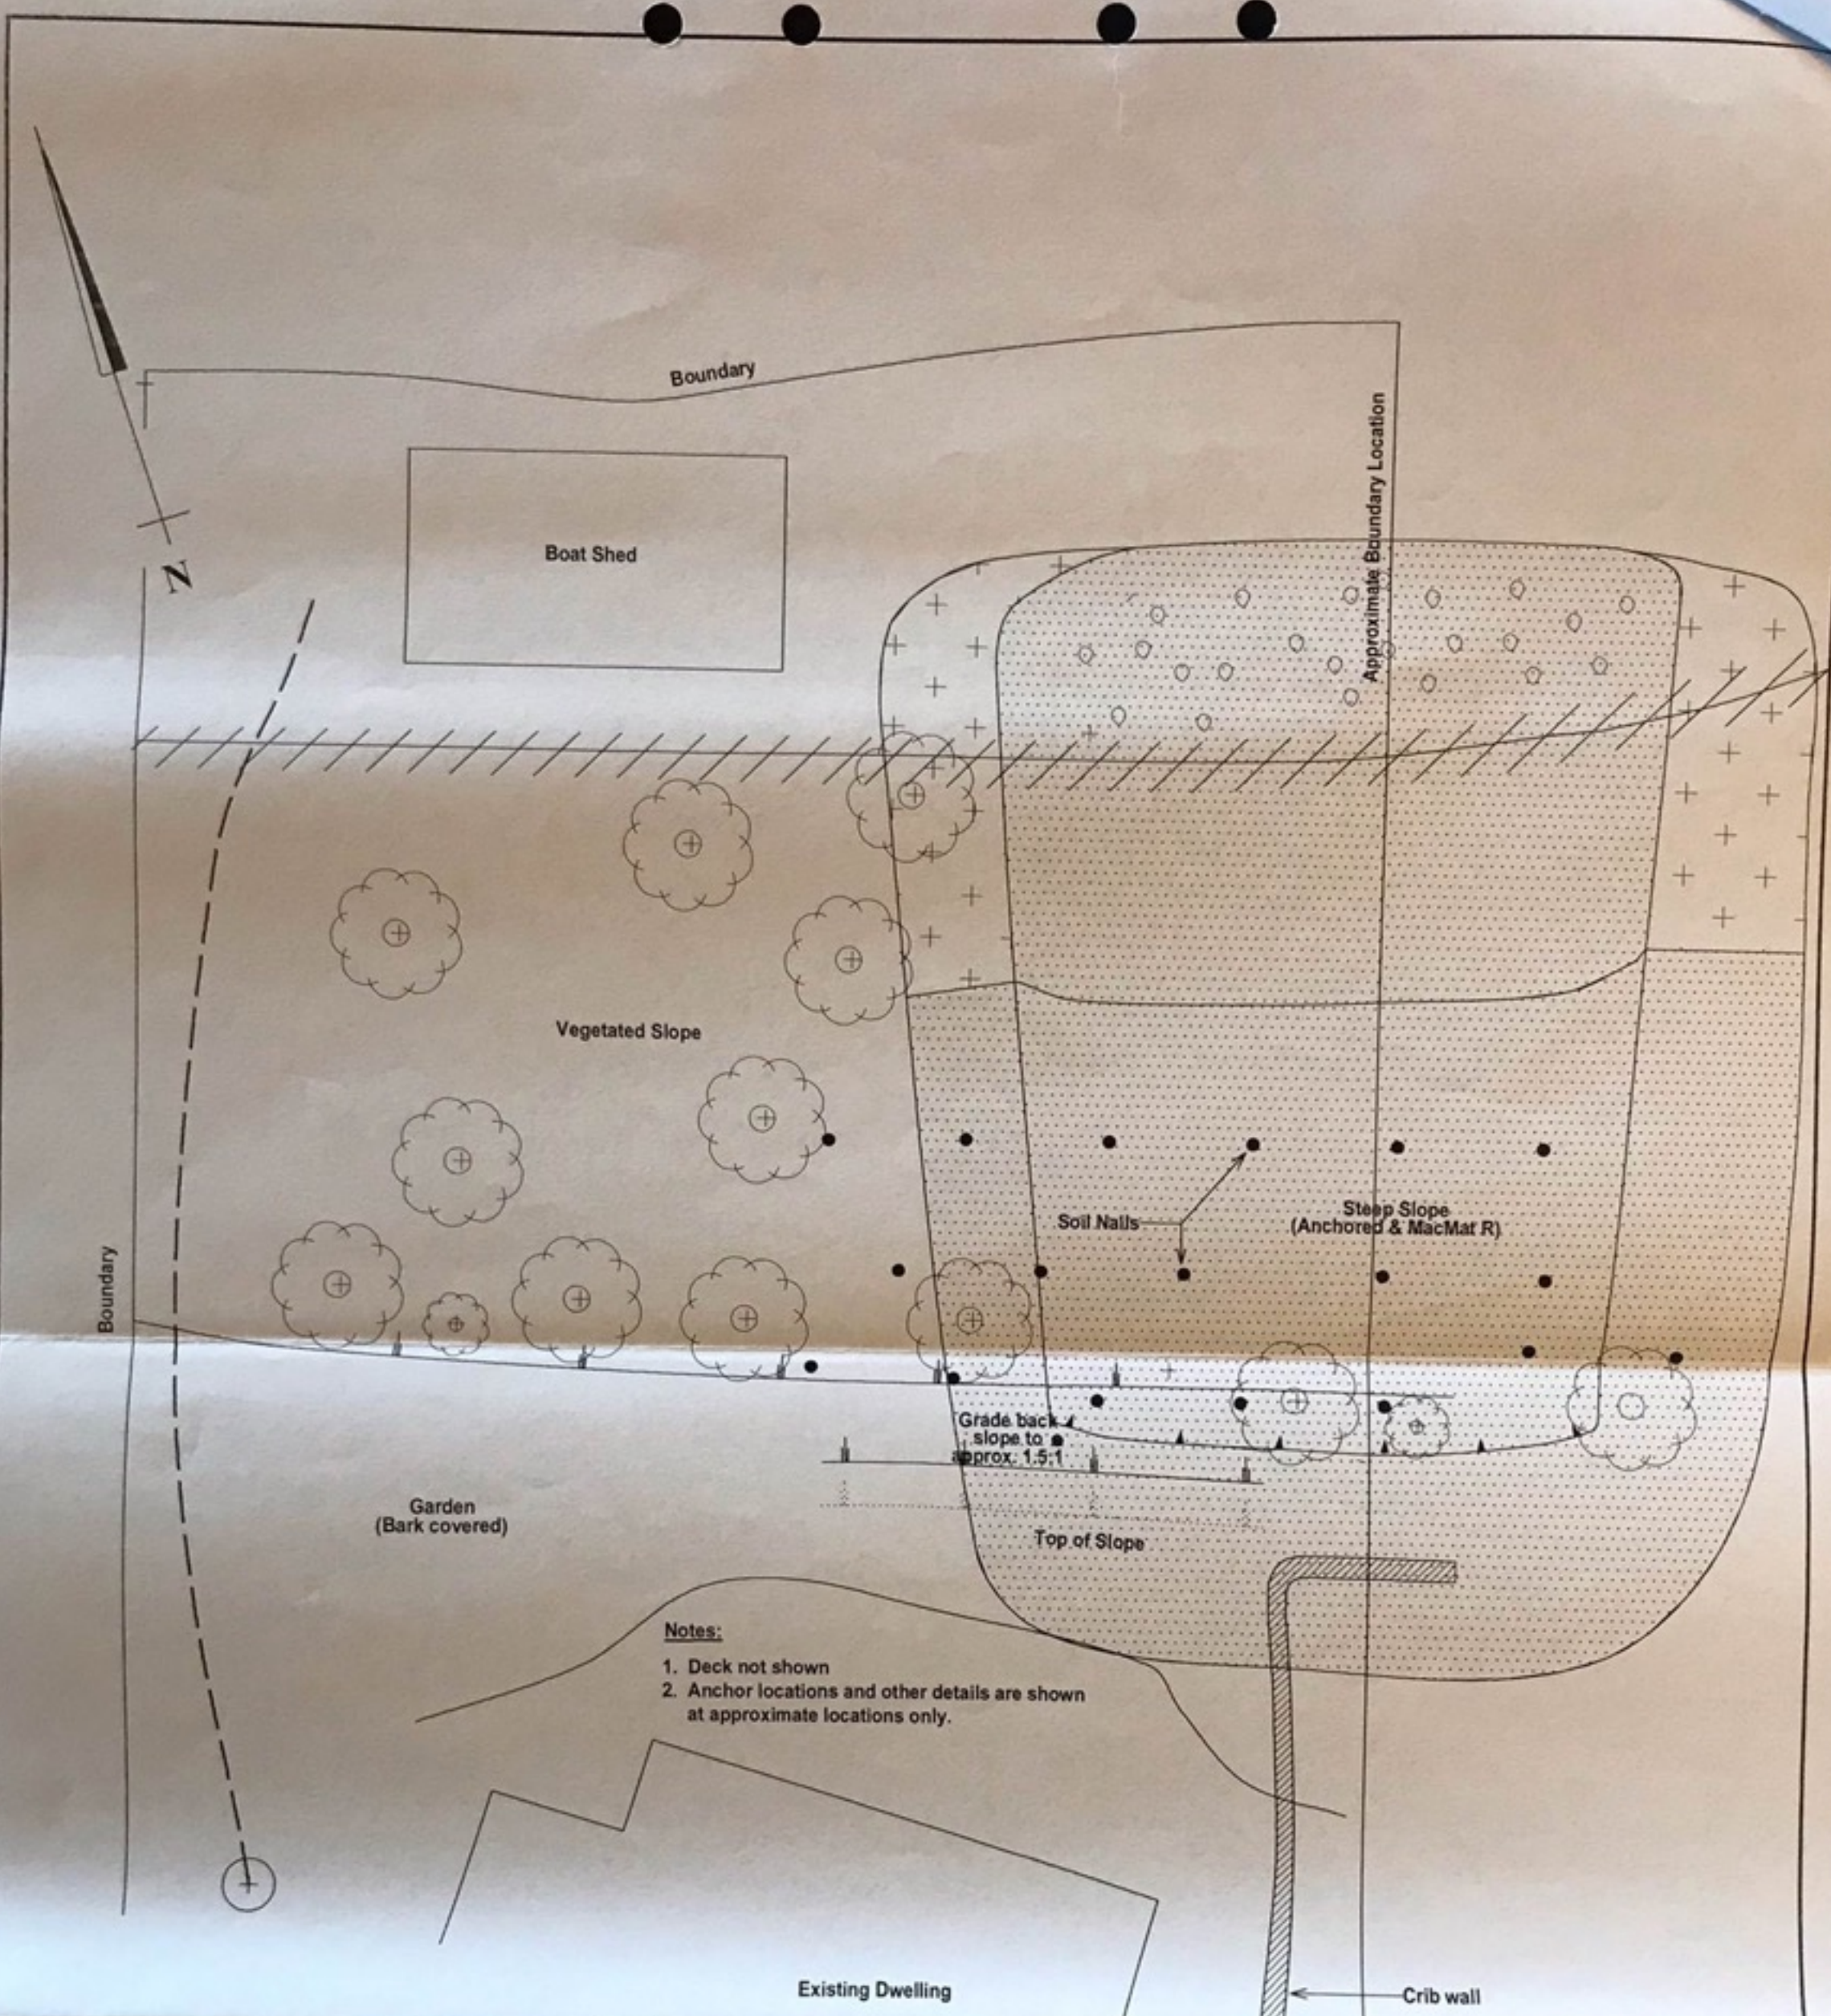
<p>Mark T Mitchell Ltd Consulting Geotechnical Engineers 1150 Victoria Street, P.O. Box 9123, Hamilton</p>	<p>WALDEN LEE-SMITH HOUSE</p>	<p>AS BUILT - SITE PLAN SHOWING ANCHOR LOCATIONS</p>	<p>DRAWING No. 12385-20</p>
	<p>Slip Repair No. 39 Bay View Road, Raglan</p>		<p>DATE March 2012 ISSUE One</p>

- All soil nails were installed at the locations shown on the As-Built Site Plan, Drawing No. 12385-20
- Site inspections were carried out during the installation process and we confirm that the soils nails were installed in accordance with the details as specified in the Mark T Mitchell design, Drawing Nos. 12385-02A, B & D, 12385_-03 & -04, but with some amendments to the original soil nail layout.
- These amendments included the deletion of some nails on the eastern side of the slip escarpment as the owner of that property advised that retention of the slip face area was not required. The soil nails that were actually installed on that property are only provided to contain the eastern edge of the Lee Smith/Walden property and not the adjacent property to the east.
- A contractor Producer Statement (PS3 has been supplied by the contractors Ancor Loc NZ Ltd.

Remedial work carried out on this site which followed the landslip consisted of a series of inclined, drilled-in steel rods encased in concreted holes (termed “soil nails”) at specified 2.5m centres. The exposed slope was then covered with an open fabric matting that is commonly used for slope protection (MacMat R) and then topsoil covered and seeded.
