## Waikato District Council

Sunset Beach Erosion Project

December 2014

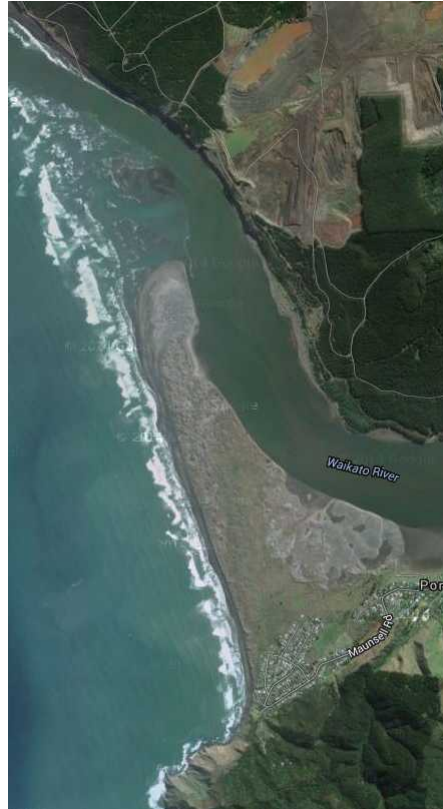
Figure 3: Spit in 2014 (Source: Good Earth)

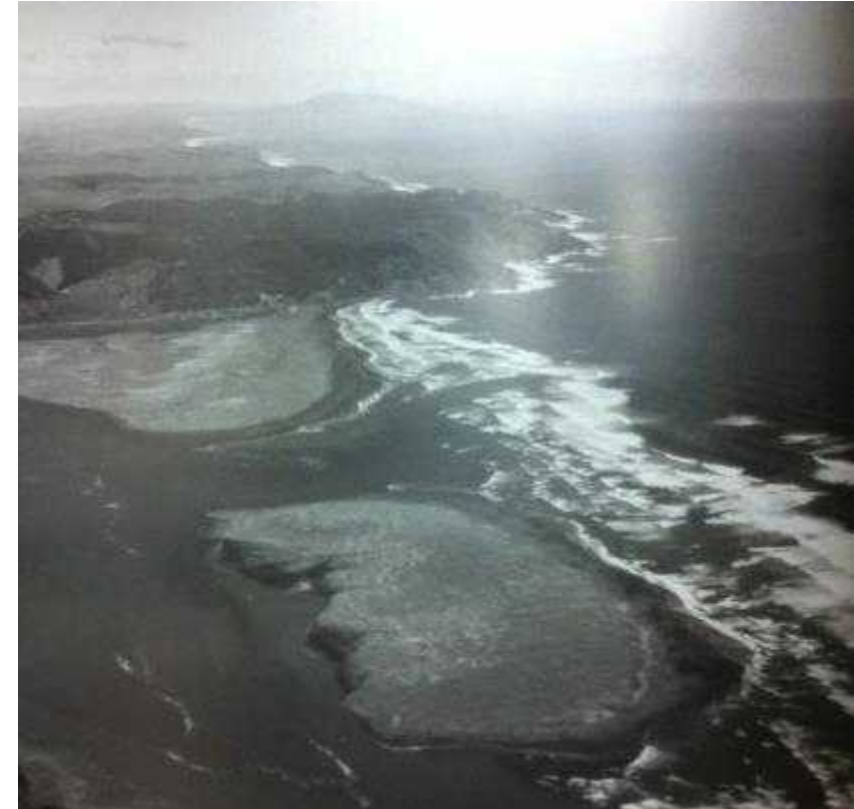
Figure 4: Spit Breach in October 1960 (Source: Port Waikato Dairy)

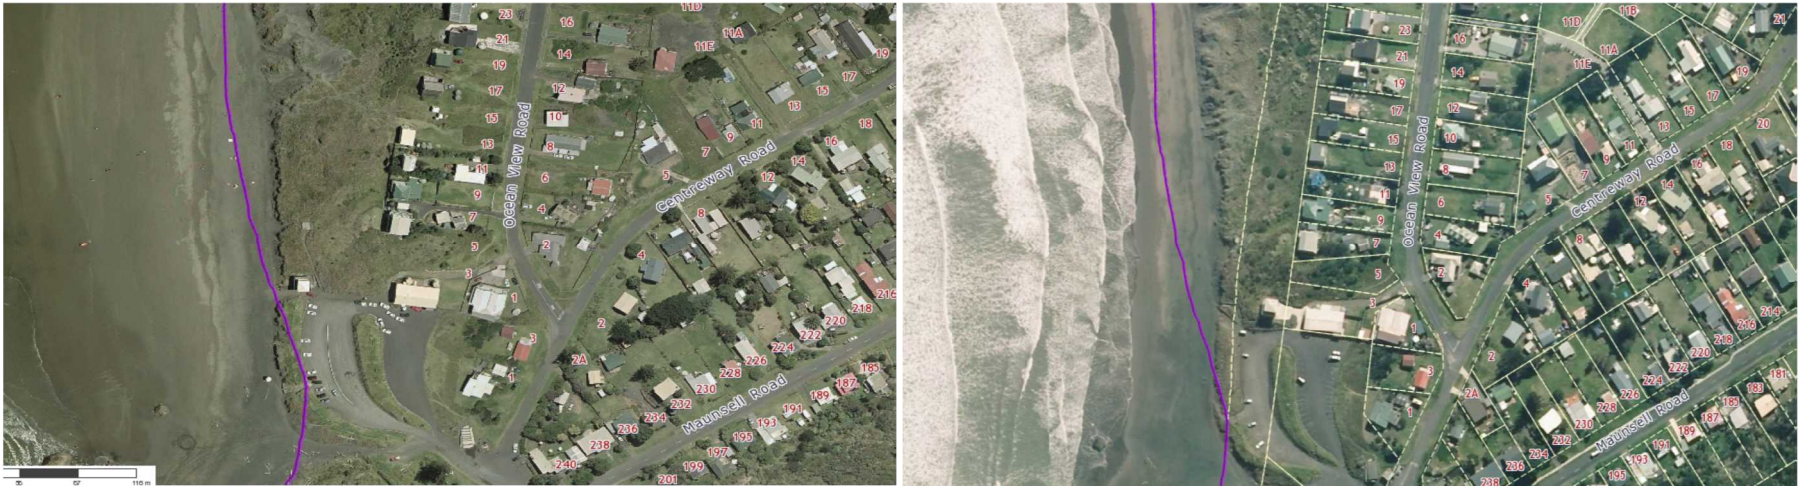
Figure 5: Aerials of Sunset Beach in 2002 vs 2012 (Source: Waikato District Council)

More recent aerial and Google Street imagery from 2002 and 2012 shows that the foreshore directly in front of the existing car park at Sunset Beach has begun retreating (Figures 5 & 6). Throughout this period the surf lifesaving lookout tower has been relocated (in 2008), moving back approximately 20 metres from its original location. Both images also show the lower car park intact with vegetated embankment onto the beach. It can also be seen that new dune restoration planting had recently taken place at the northern end of the car park in 2008 but this has been washed away with further storm events.

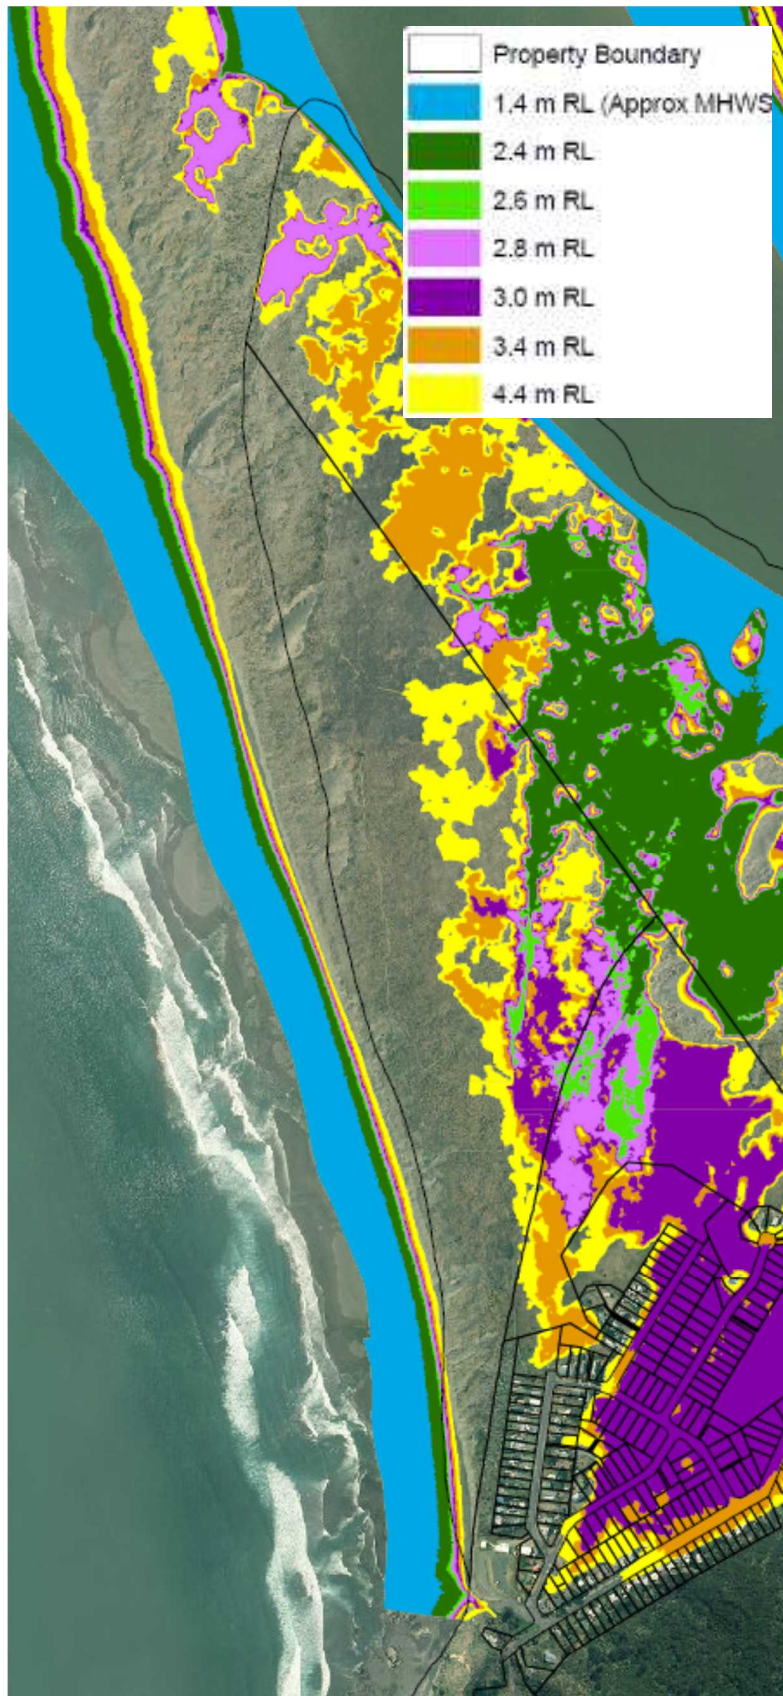
Figure 8: Coastal inundation modelling based on LIDAR Model (Source: Waikato District Council)

The Waikato Regional Council, in partnership with City and District Councils in the region, have been modelling coastal hazards and inundation scenarios from a change in sea levels. Figure 8 shows modelled areas of inundation for Port Waikato based on varying levels of sea level rise up to 1 meter. Information presented in the maps show a change in sea level and does not include effects of wave action along the open coast. Due to the height of the dune system along the Port Waikato spit, a 1 metre rise in sea level is not expected to breach the existing dune system, even with significant wave heights or storm surges as the current heights of the dunes are 4.5m minimum (as measured during site visit on 8<sup>th</sup> October 2014). Inundation inland, through the mouth of the Waikato River into lowland areas is of higher risk for wider consideration of future development in Port Waikato.

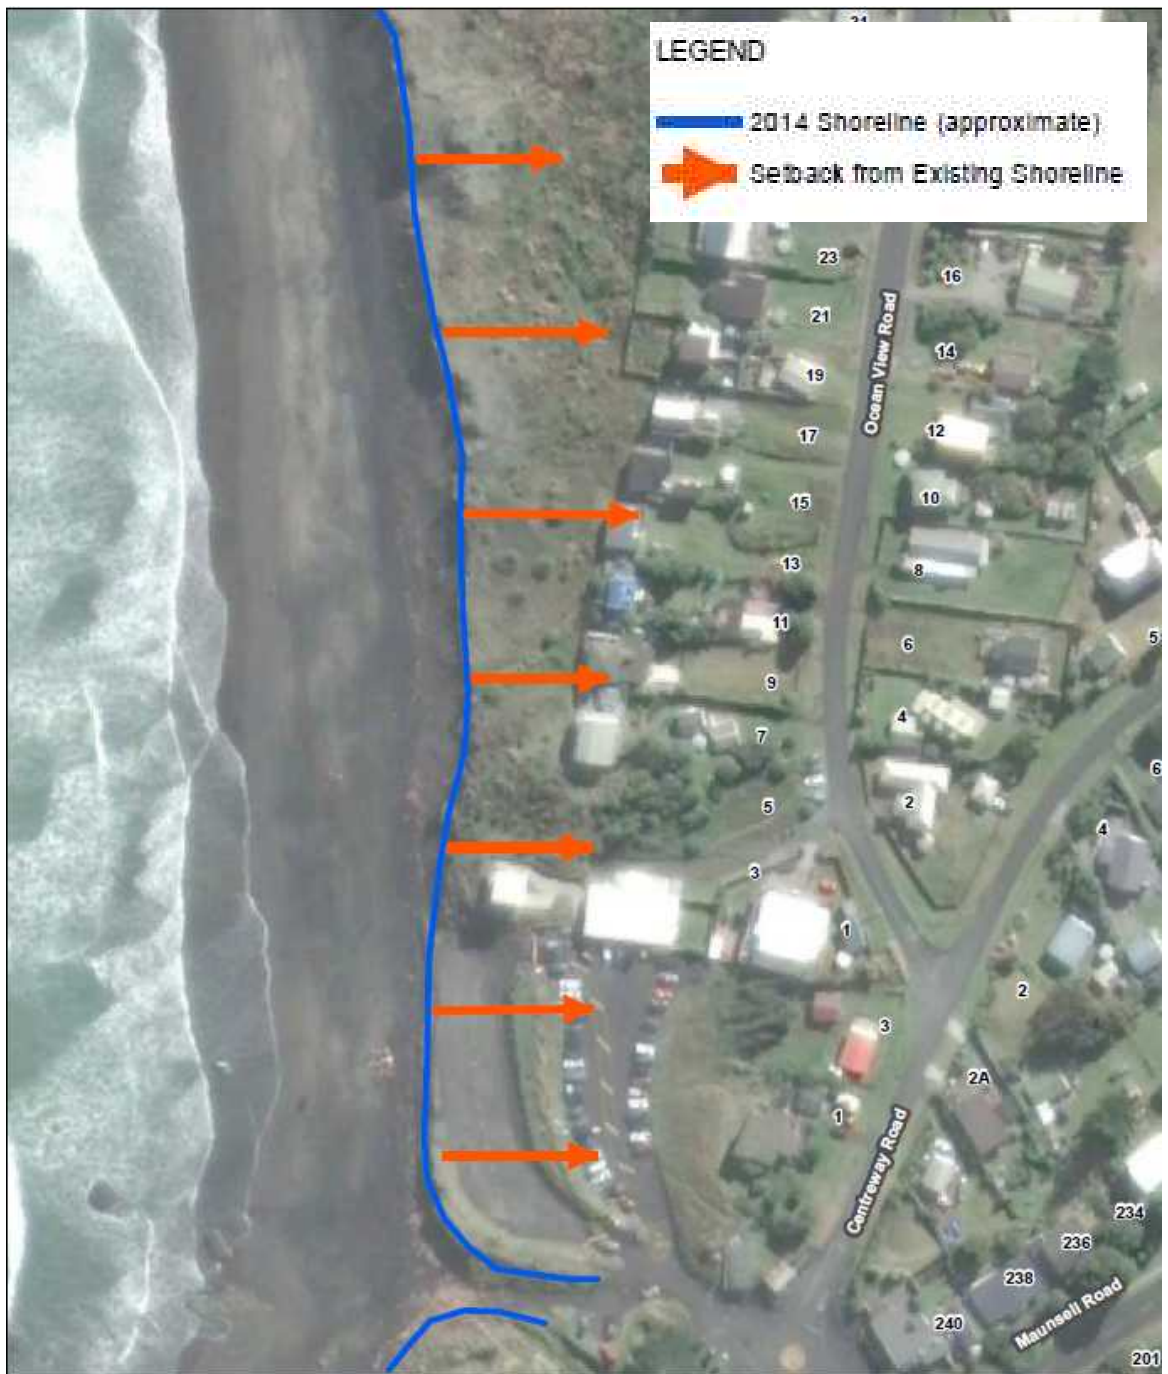
Figure 9: Setback from the Existing shoreline

Recent trends suggest that the beach is eroding at a rate of 2 to 5m per year. If the current rates of erosion persist community and private assets could be further impacted in the next 10 years. It is recommend that additional investigations and monitoring be undertaken over a period of years to establish more definitive trends. It is also recommended that geotechnical investigations are undertaken in the area to establish the exact nature of bed rock material available for longer term protection should erosion continue.

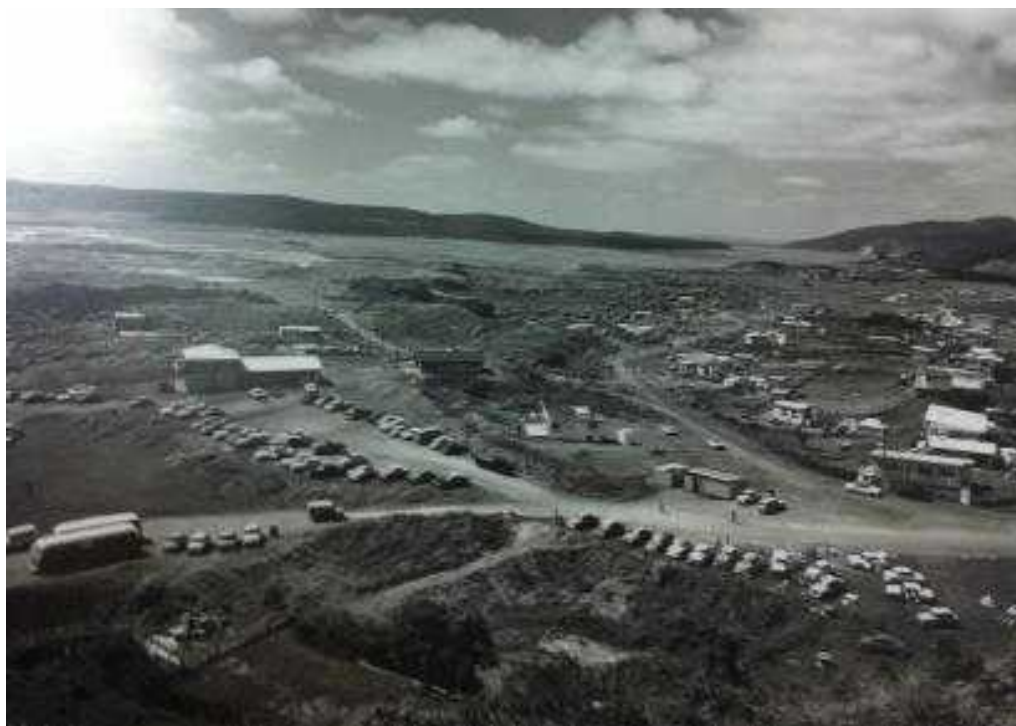
Figure 10: Port Waikato in 1970 looking north towards Port Waikato Township and the Surf Life Saving club (left of photo) (Source: Sunset Surf Life Saving Club)

The immediate beach area in front of the existing car park has been altered significantly over this time. Information received from stakeholder discussions, historical photographs and previous reports suggest the spit was, at one point, used for grazing cattle before the fore dunes at Sunset beach were turned into a car parking area for users of the beach (see Figure 10).

Over time fill, including soil, small rocks, wooden posts and disused concrete telephone poles have been used to provide a base for buildings, create and shape areas for car parking or to create barriers in an attempt to protect assets (see Figure 10). The fill under the existing car park will need to be taken into account when consider appropriate options for managing erosion in the future.

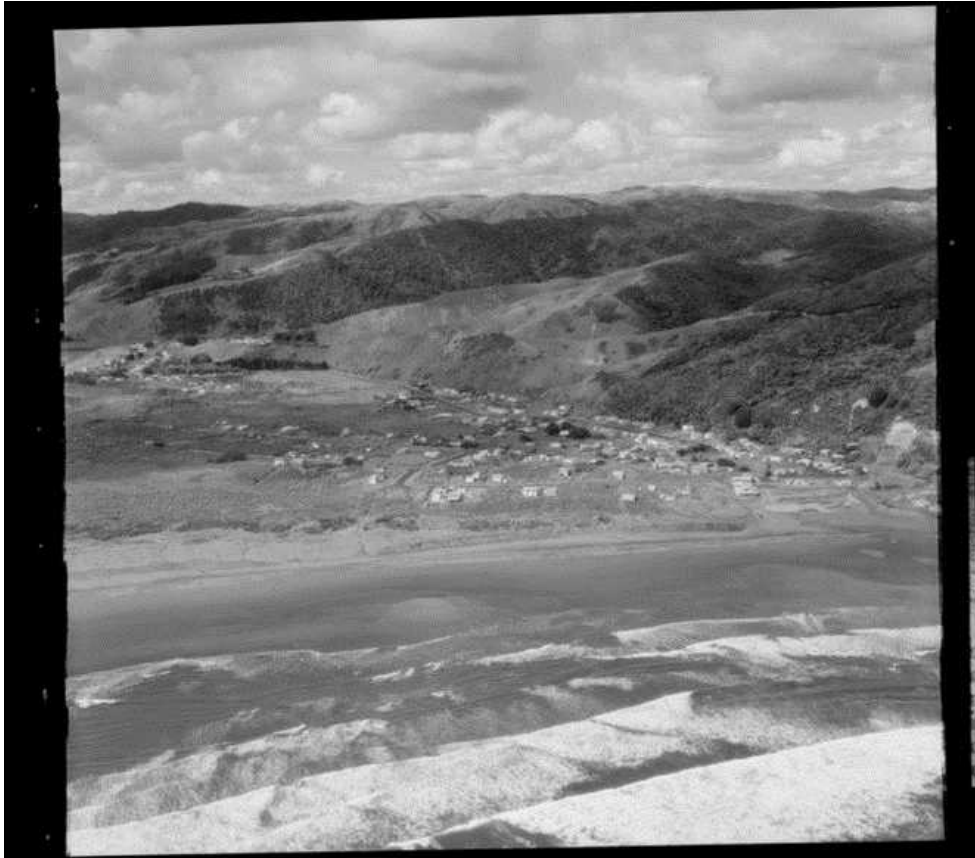
Figure 11: Port Waikato in 1984 looking east towards Port Waikato Township.  
(Source: Port Waikato. Whites Aviation Ltd Alexander Turnbull Library)

Several aerial images from 1984, sourced from the Alexander Turnbull Library, indicate that the lower car park was non-existent and there was a gradual gradient down the beach. There is an existing foreshore dune system north of the project area which suggests that in 1984 this area had been engineered for some purpose.

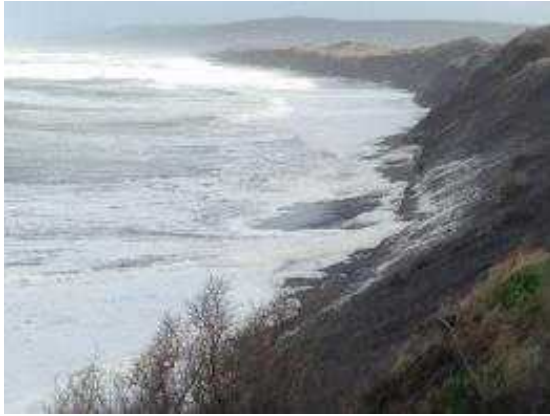
- a) Erosion was ongoing with high wave energies continuing to erode both the dune face along the spit as well as undermining the lower car park, confirming that the recent period of erosion continues to impact on assets.

Photograph 1: Hightide waves at Sunset Beach (looking north) hitting the sand dunes.

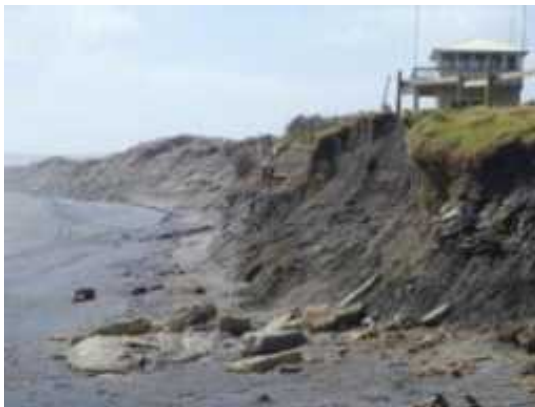
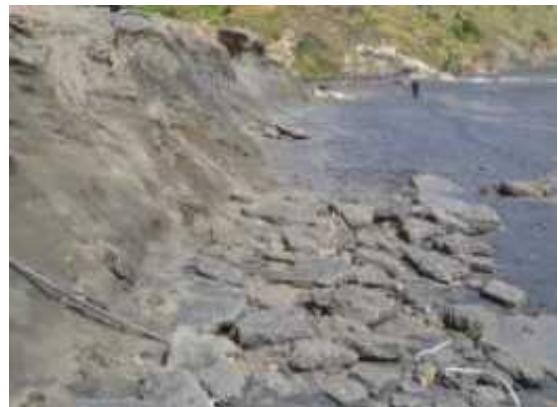
- b) Any further erosion would put the existing surf lifesaving tower at extreme risk.
- c) The lower car park was first closed in the winter of 2013. An assessment by a GHD senior geologist has recommended that the lower car park not be reopened to public access due to the instability of the shoreline.
- d) Erosion has resulted in fill and pavement material periodically falling into the beach and washing into the surf zone. This is considered to be a safety risk for swimmers and recreational users of the beach.

Photograph 2: Debris from the car park on the beach. Surf tower in back ground (looking north).

Photograph 3: Debris from the car park on the beach (looking south).

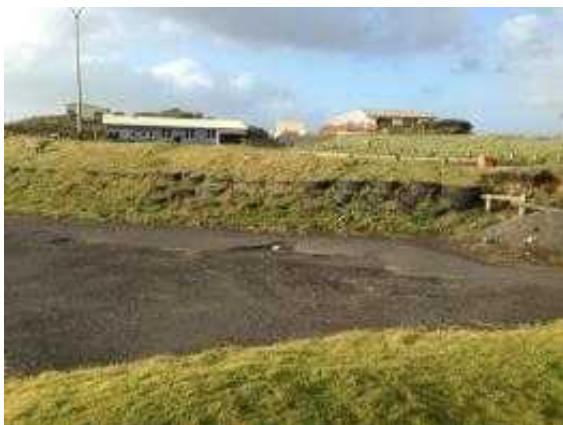
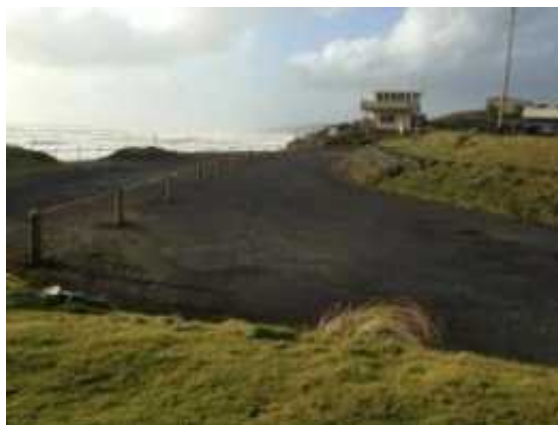
- e) Noted were a second level defence with a tyre wall and vegetated bank and then 3<sup>rd</sup> level of defence with a ridge of planting behind the upper car park.

Photograph 4: The lower car park with tyre retaining wall at the rear.

Photograph 5: Lower car park (looking north) with tyre retaining wall to the right of the photo.

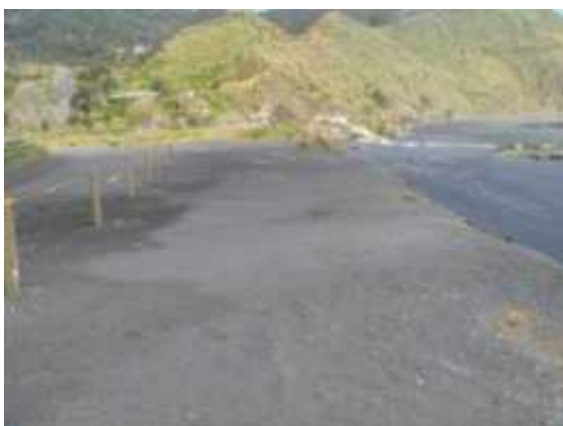
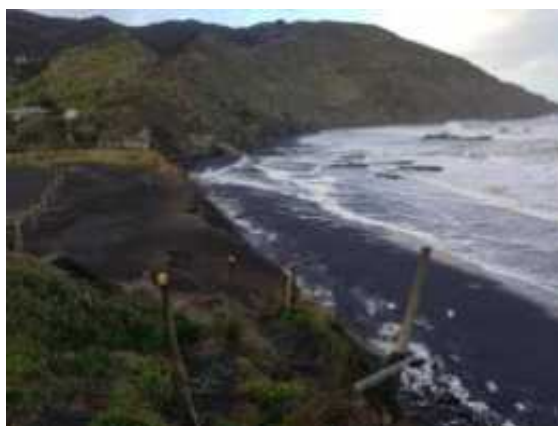
- f) There was no access to the beach from in front of the car park. Visitors would continue to make their own way down the vertical cuts which is considered a hazard and safety risk to visitors. It is recommended that access is closed and signage pointing to agreed access points is installed.

Photograph 6: Failing car park edge looking south (low tide). No pedestrian access to the beach available from this car park now.

Photograph 7: Failing car park edge looking south (high tide). No pedestrian access to the beach available from this car park now.

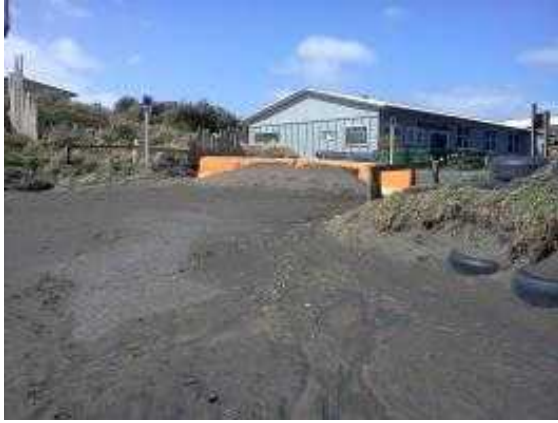
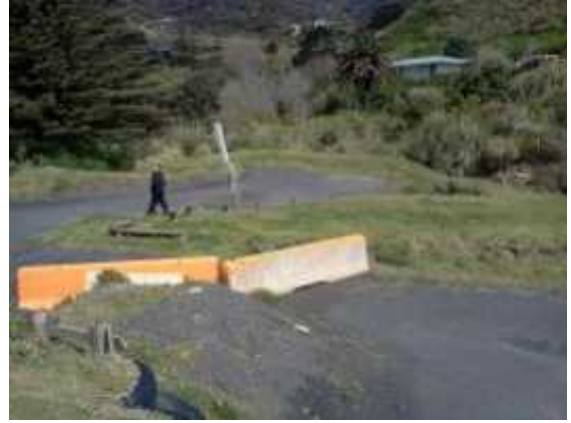
- g) Sand was being deposited by strong onshore winds on the upper car park and on the barriers in place. Westerly facing walls should be avoided when looking to create additional space for car parking unless this extra weight is designed for. Planting along such walls could also help to establish a further dune system.

Photograph 8: Sand being deposited against temporary concrete barriers in the middle of the upper and lower car park, northern end. Looking east toward the community hall.

Photograph 9: Sand being deposited against temporary concrete barriers in the middle of the upper and lower car park, southern end. Looking towards the beach access.

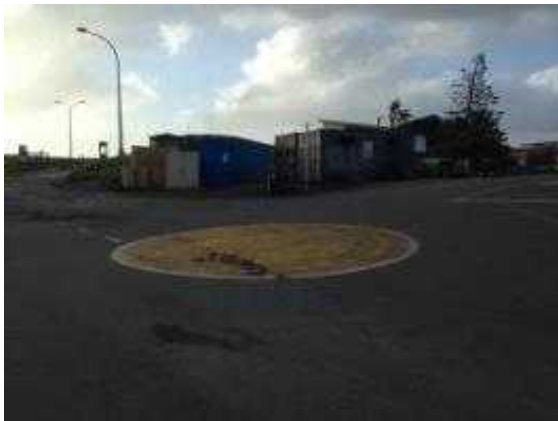
Photograph 10: Large area of paving currently used for road roundabout that could be more efficiently utilised. Recycling facilities behind round about.

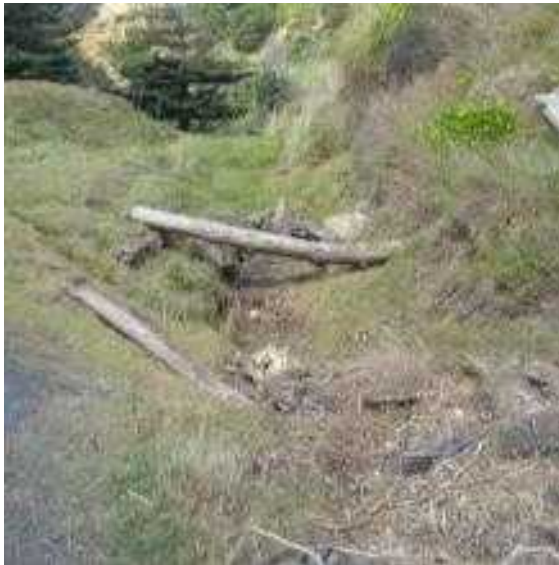
- n) The river next to the vehicle access was blocked. This appeared to be caused by the deposition of storm material.

Photograph 11: Natural stream at the base of the southern cliffs looking east, blocked with debris.

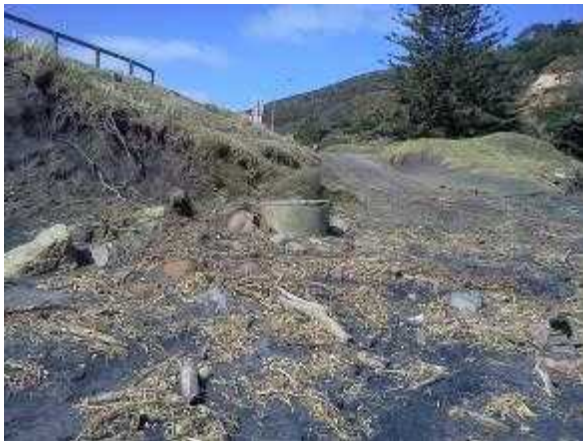
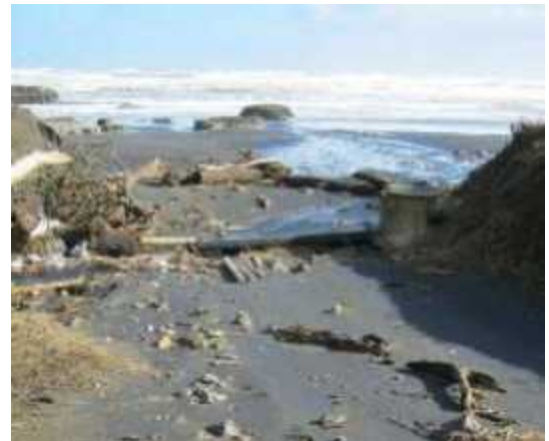
A storm water pipe connecting the culvert at the base of the vehicle access way with the stream has been removed or covered in sand. The culvert appears to be operating with no records or information available on where stormwater is derived. In the past the pipe has been exposed, preventing vehicle access. It is recommended that the culvert and storm water pipe under the car park would need to be removed or reinstated to discharge into the stream in the future.

Photograph 12: Site visit in 2014 showing stormwater culvert being covered by further sand.

Photograph 13: Photo from 2011 showing connecting pipe that has been removed.

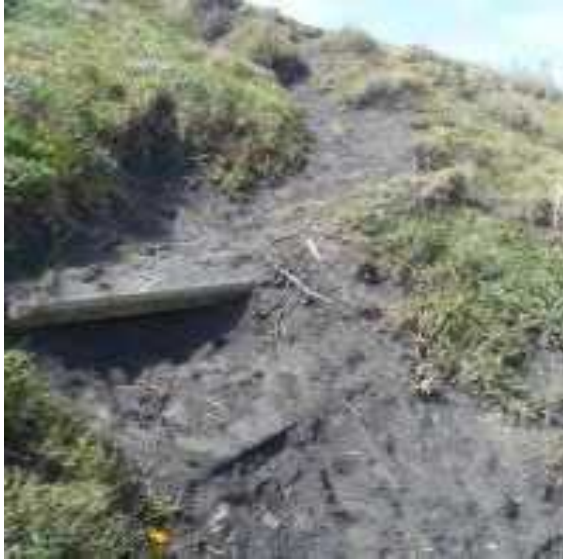
- o) Fill used (including concrete telephone poles) to raise the car park will constrain establishment of native dune species. Should dune revegetation be desired existing fill will need to be removed.

Photograph 14: Concrete telephone poles showing through eroded areas of sand dune below the car park

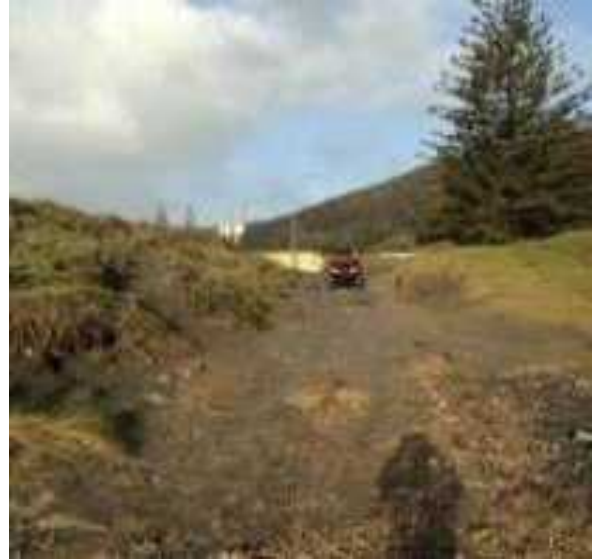
Photograph 15: Vehicle access to the beach at the southern end covered in debris washed in from storms.

- p) The vehicle access to the beach was limited due to debris (wood and debris from the car park) and sand. A decision is required on the provision of vehicle access to the beach in the future. Emergency vehicle use is required and the majority of stakeholders wanted to retain vehicle access. Should the vehicle access way be kept at this location it is recommended to include grid matting, timber or some form of base to help reinforce the road.

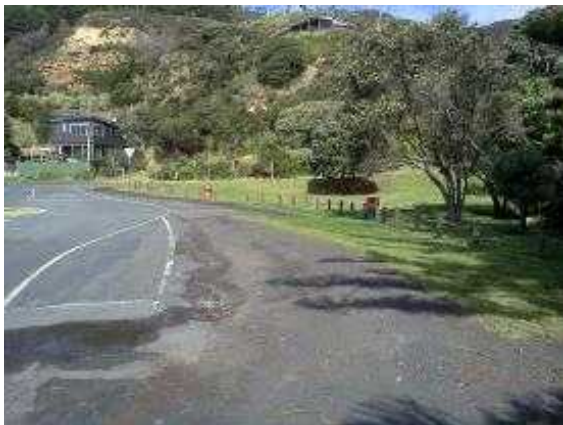
Photograph 16: Sheltered green space to the east of the beach with septic filtration area in the foreground to the right.

- r) The septic system for the ablution block is large and provides a solid planted barrier with trees that screen the area to the east from strong onshore winds.

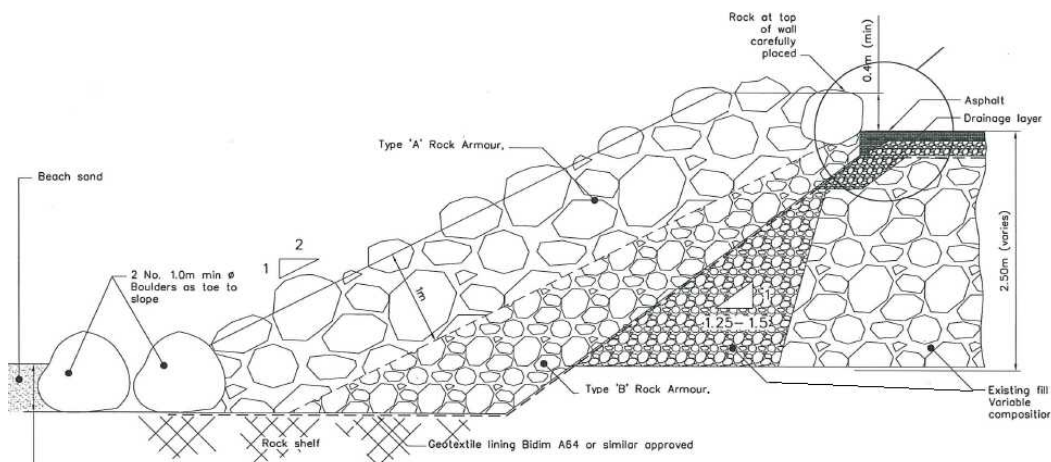
Figure 13: Profile of rock wall design (Source: Previous project by GHD)

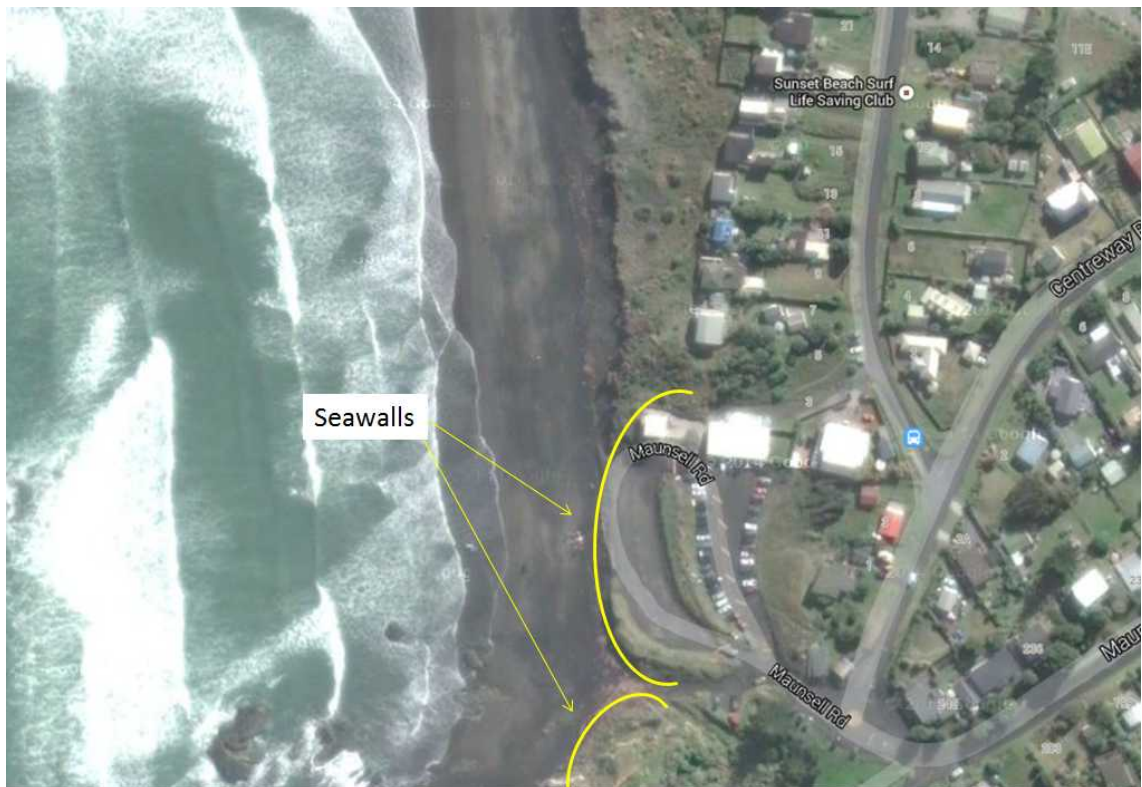
Figure 14: Plan view of potential rock wall location

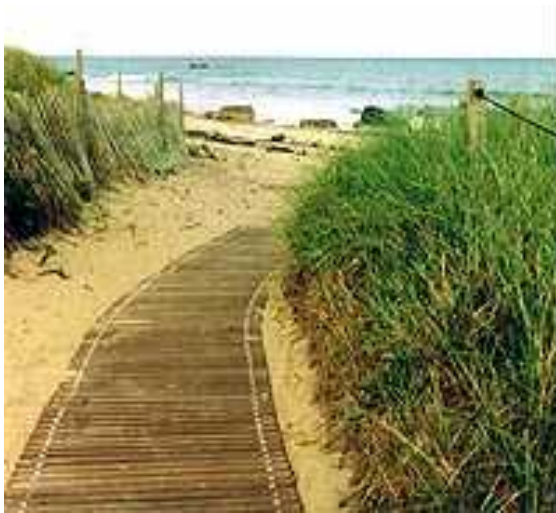
Figure 16: Potential flexible vehicle or pedestrian dune ramp

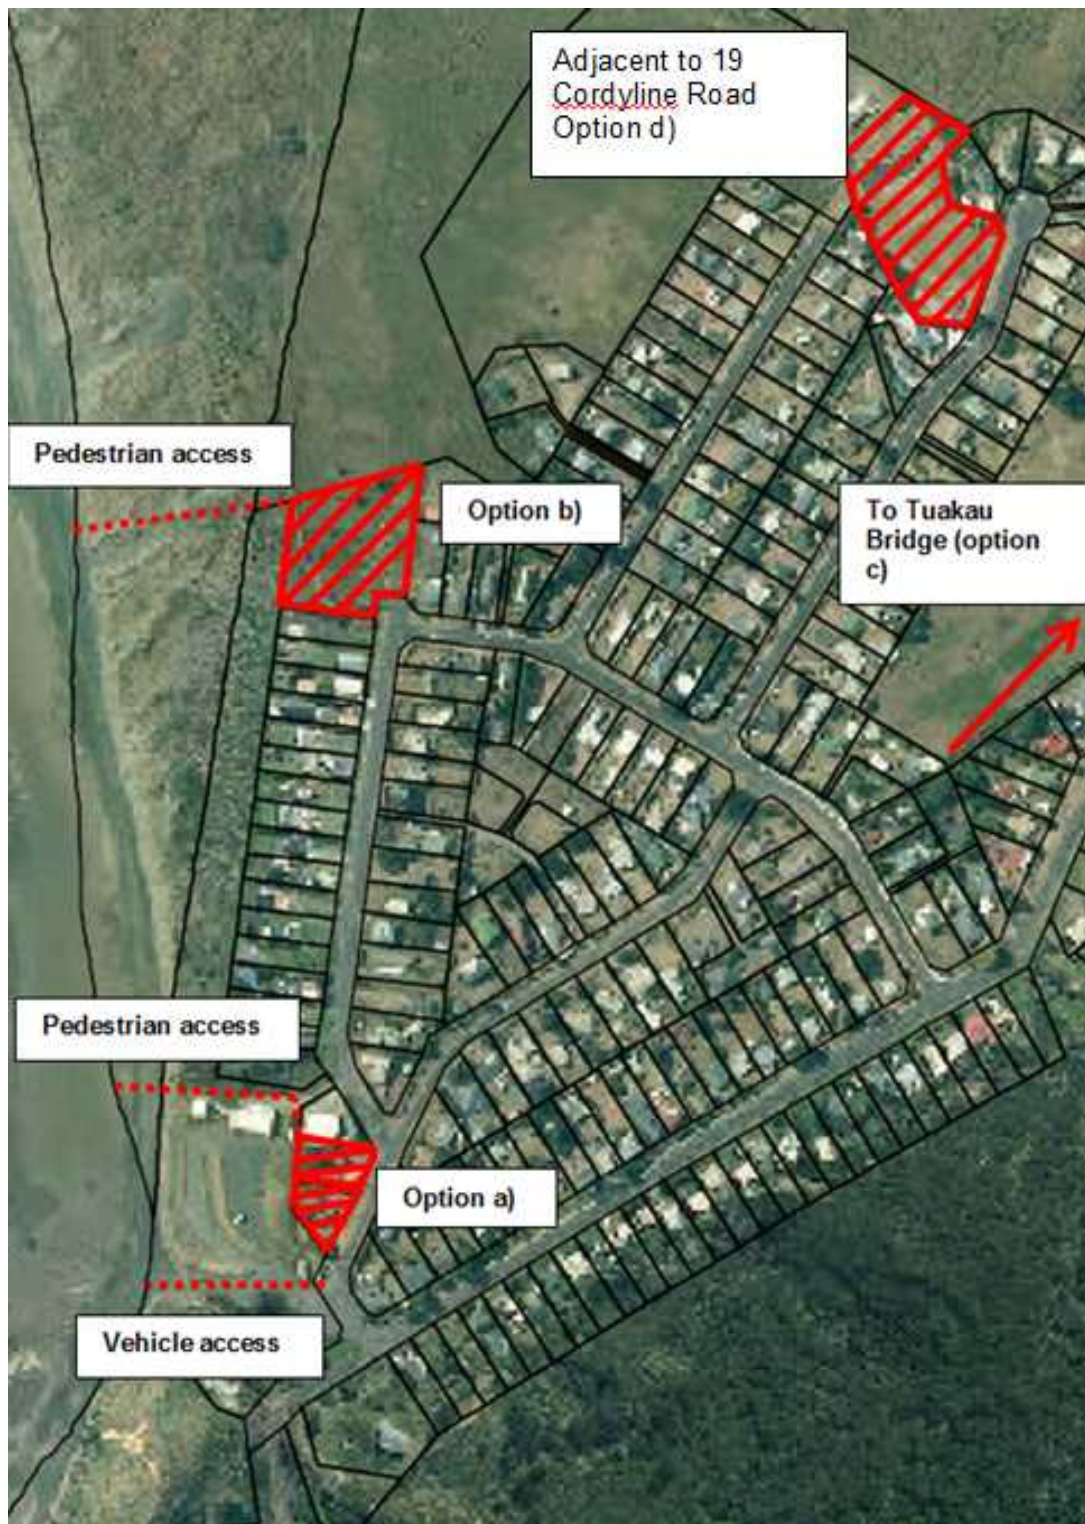
Figure 19: Map of Port Waikato indicating retreat locations reviewed

Option 4 is to retreat, by moving the car park and community facilities to a location outside of the identified hazard zone. Four alternative locations have been reviewed (see Figure 18):

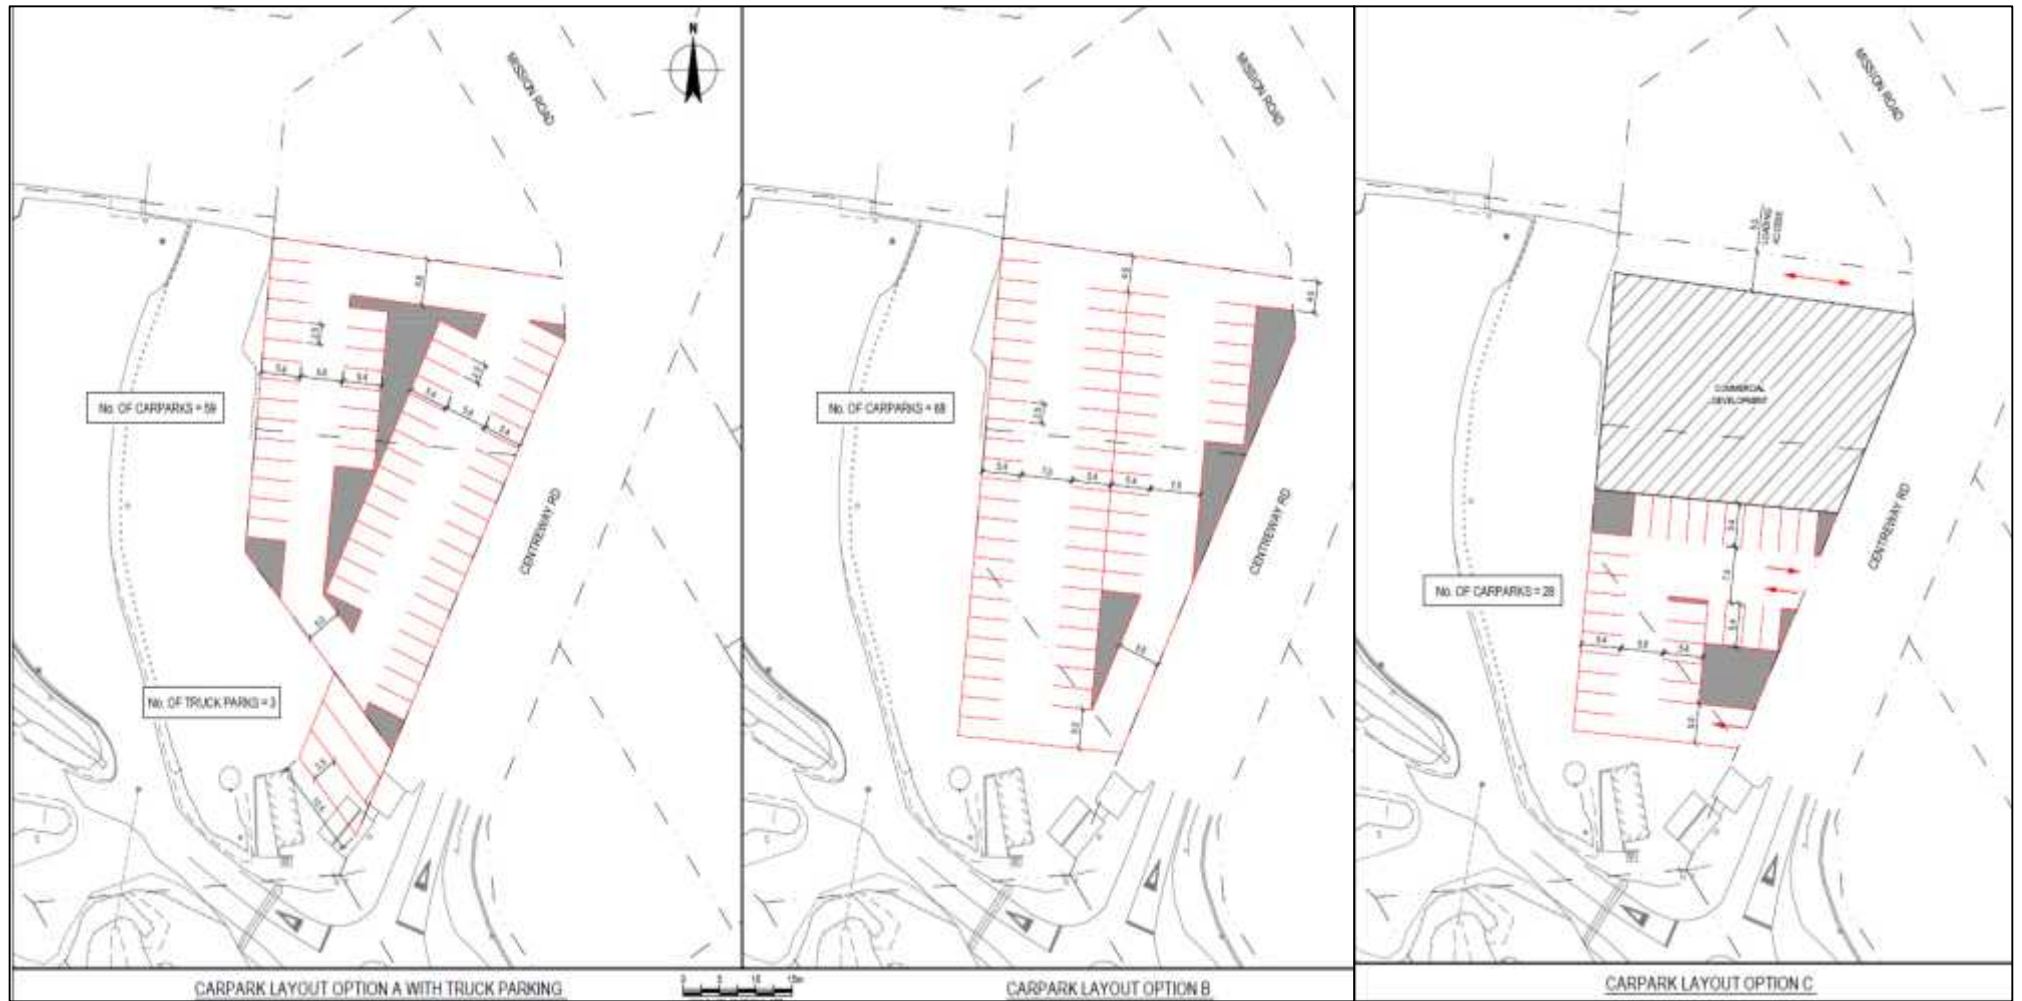
Figure 20: Options for car parking at 1-3 Centerway Road

- Move all community assets further outside of the predicted hazard area.
- Increase the amount of car parking available to approximately 107 car parks.
- Allow for the opportunity to separate public and private vehicle access to the beach.
- The tower location for the surf patrol could be moved or retained depending on the needs of the surf life saving club to do their duties and the integrity of the dunes.
- Assumes the community hall is moved to Cordyline Road or combined with the Surf Live Saving club.

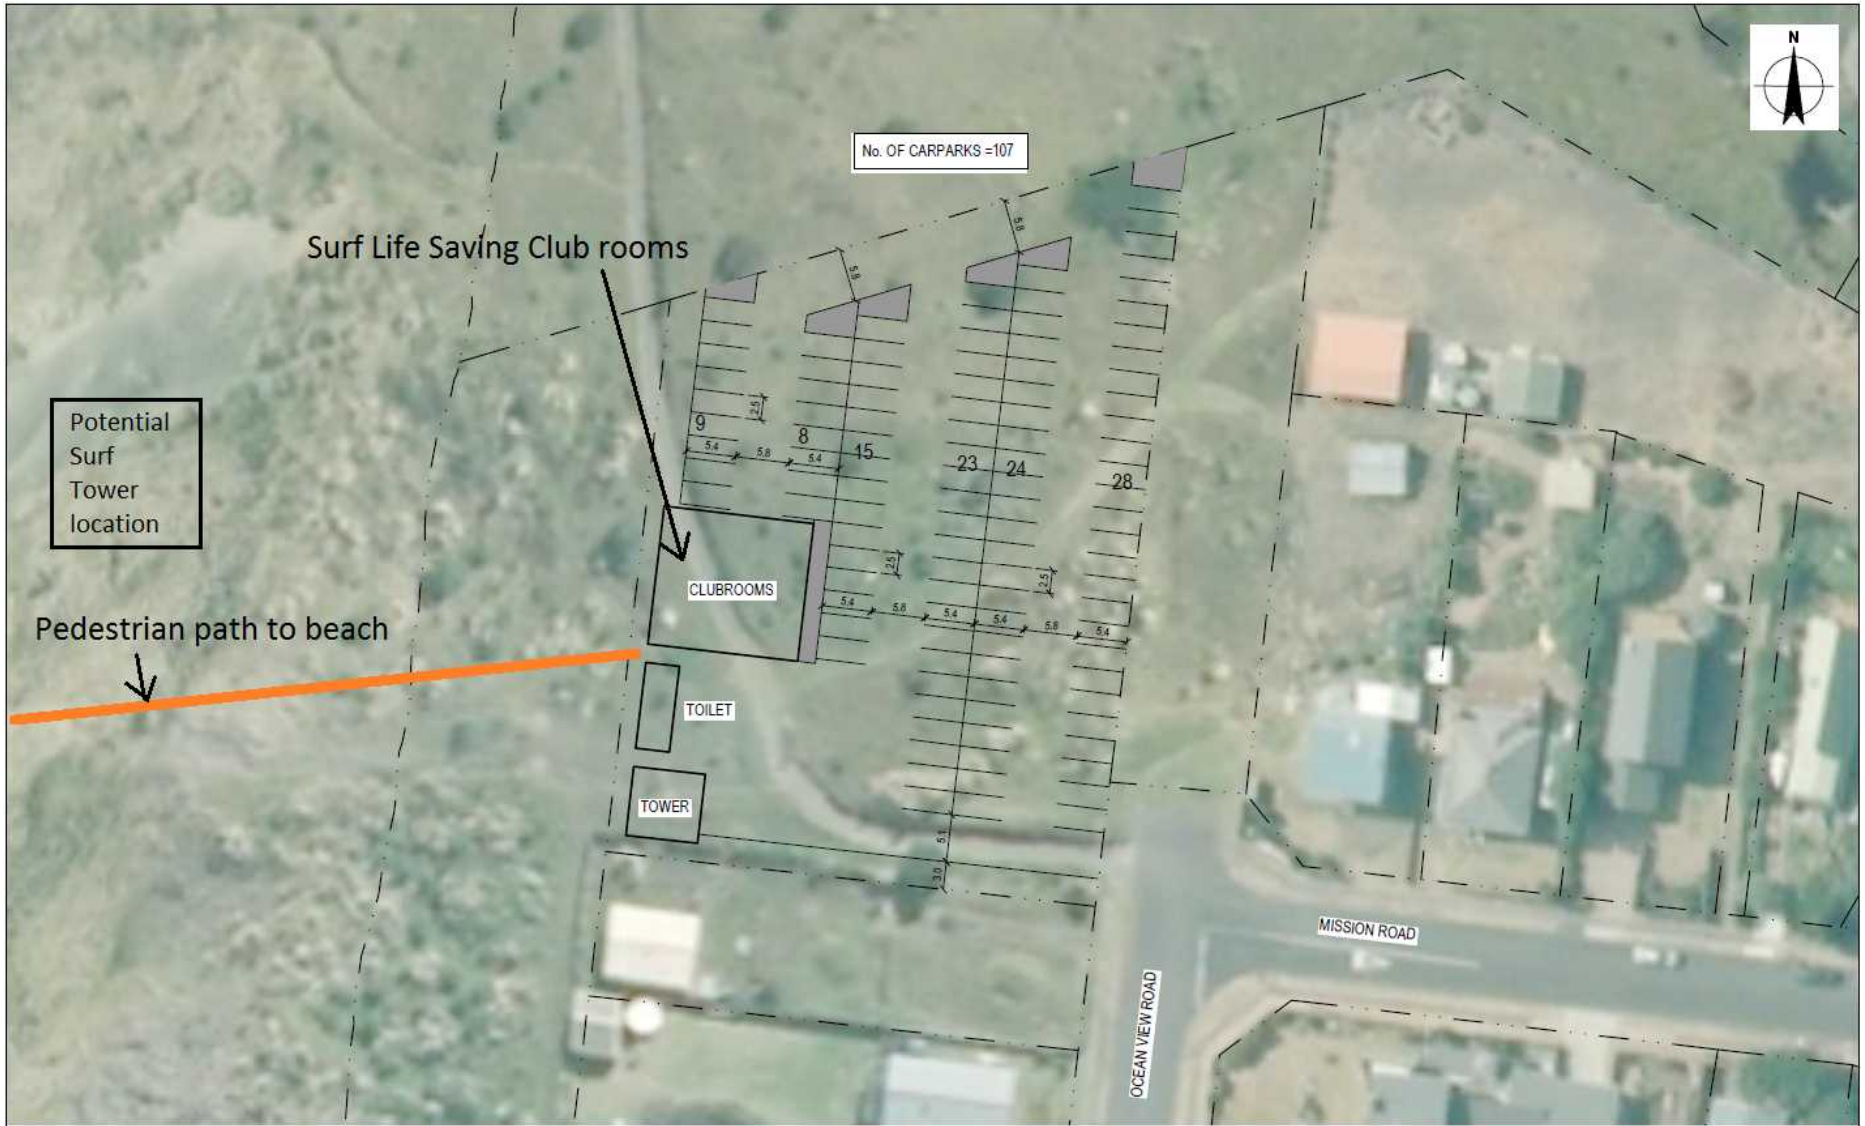
Figure 21: Proposed layout for Ocean View Road

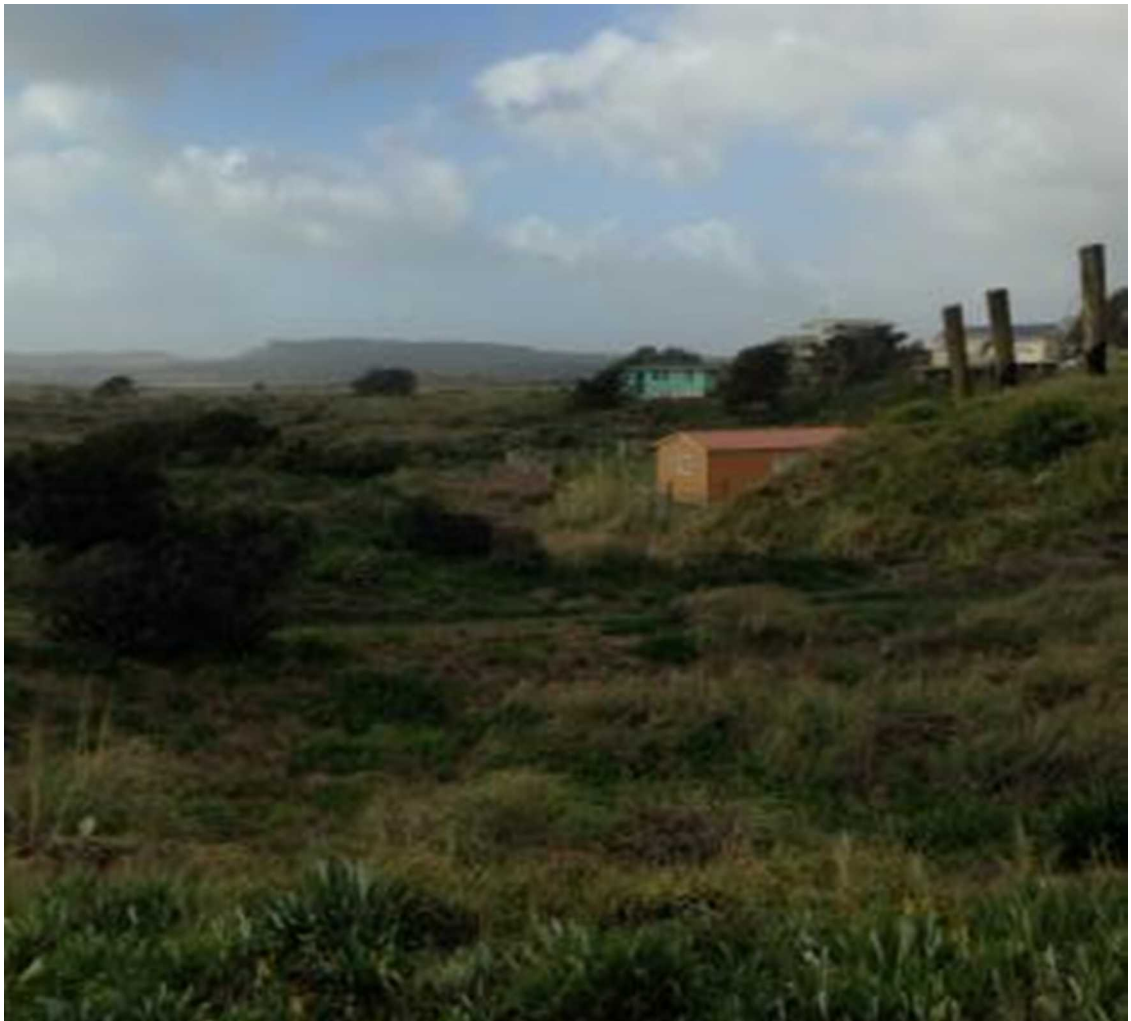
Figure 22: Photo of the potential site at 39 Ocean View Road

39 Ocean View Road, an area currently owned by Council provides an alternative location that could accommodate 107 car parks alongside the surf club (see Figure 21). In this scenario the community hall is also relocated to the site adjacent to 19 Cordyline Road. Should this location be considered it is recommended that the surf club should also move to support this location and the current location and beach access closed. Views received from stakeholders strongly support only having one main access point to the beach to ensure recreational users are only located in one area of the beach to support surf patrols.

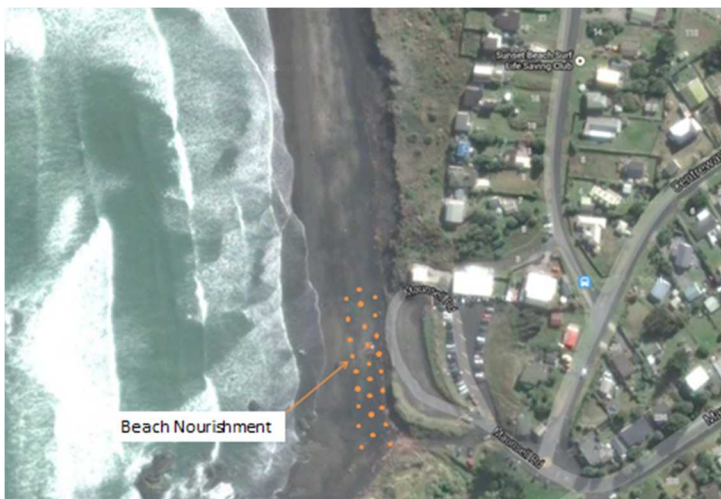
Figure 23: Diagram of Potential Beach nourishment at Port Waikato

Berm nourishment or profile nourishment (figure 21) involves bringing in sand from external sources and placing either above or below the water line to provide a temporary net benefit in sand accumulation. Beach nourishment has been used with little success on low energy beaches like Orewa Beach, Mission Bay in Auckland and Oriental Parade in Wellington (National Hazardscape Report 2007). On a high energy beach like Sunset Beach this option is not considered to be not feasible. High energies, longshore drift and northerly currents would take and introduced sands out of the immediate catchment.
