## Waikato District Council

Sunset Beach Erosion Project

December 2014

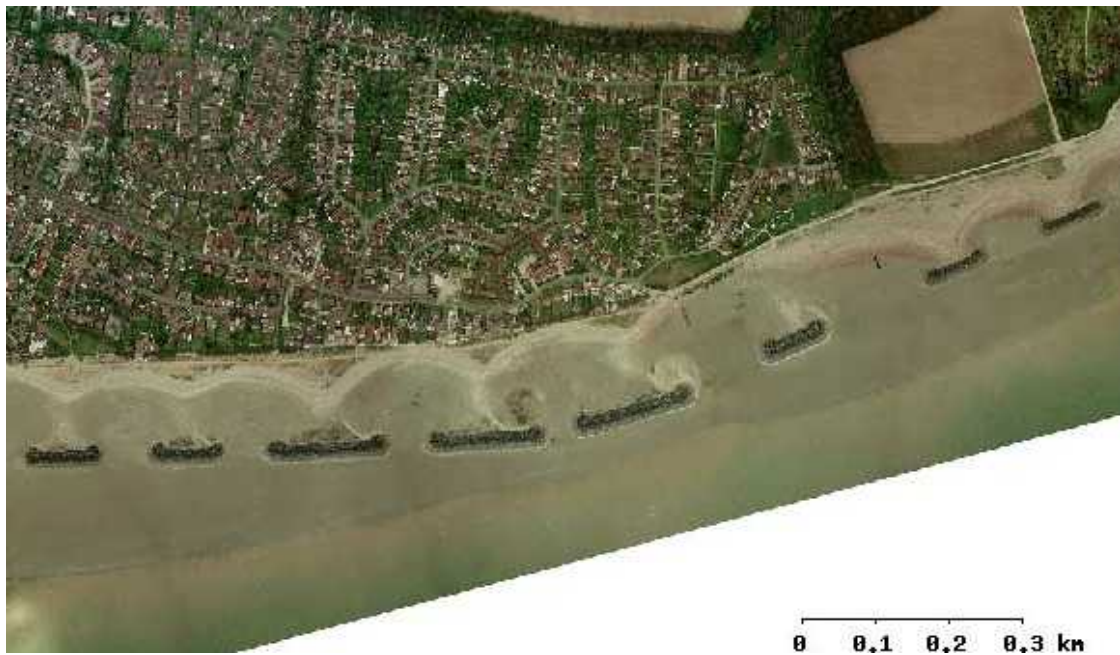
Figure 24: Breakwater Example at Elmer, UK (courtesy of Wikipedia)

The amount of wave energy reaching the beach is controlled by the width of the gap between breakwaters and the wave diffraction through the gaps. Offshore breakwaters need to be constructed at sea and due to the high energy waves at Sunset Beach the construction process would be complicated and extremely expensive.

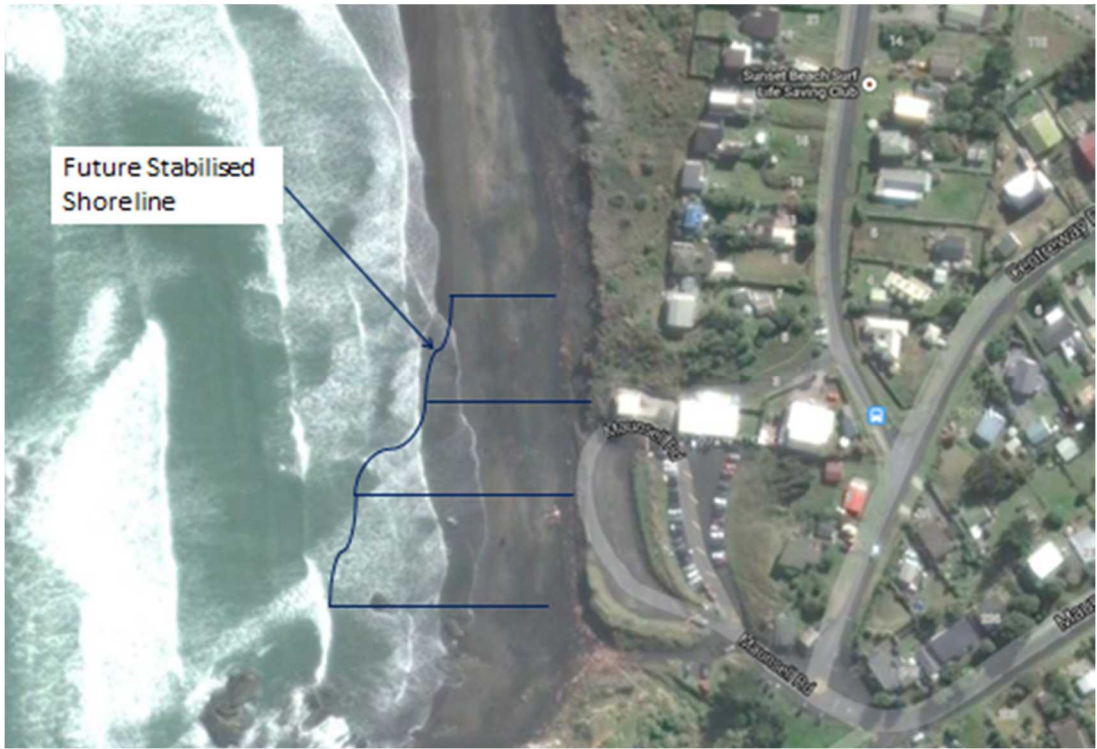
Figure 25 : Diagram of Potential Groins at Port Waikato

The aesthetic of the beach goes might also be hampered similar to offshore breakwater and it will be expensive for construction. Therefore, it may not be feasible for this beach.

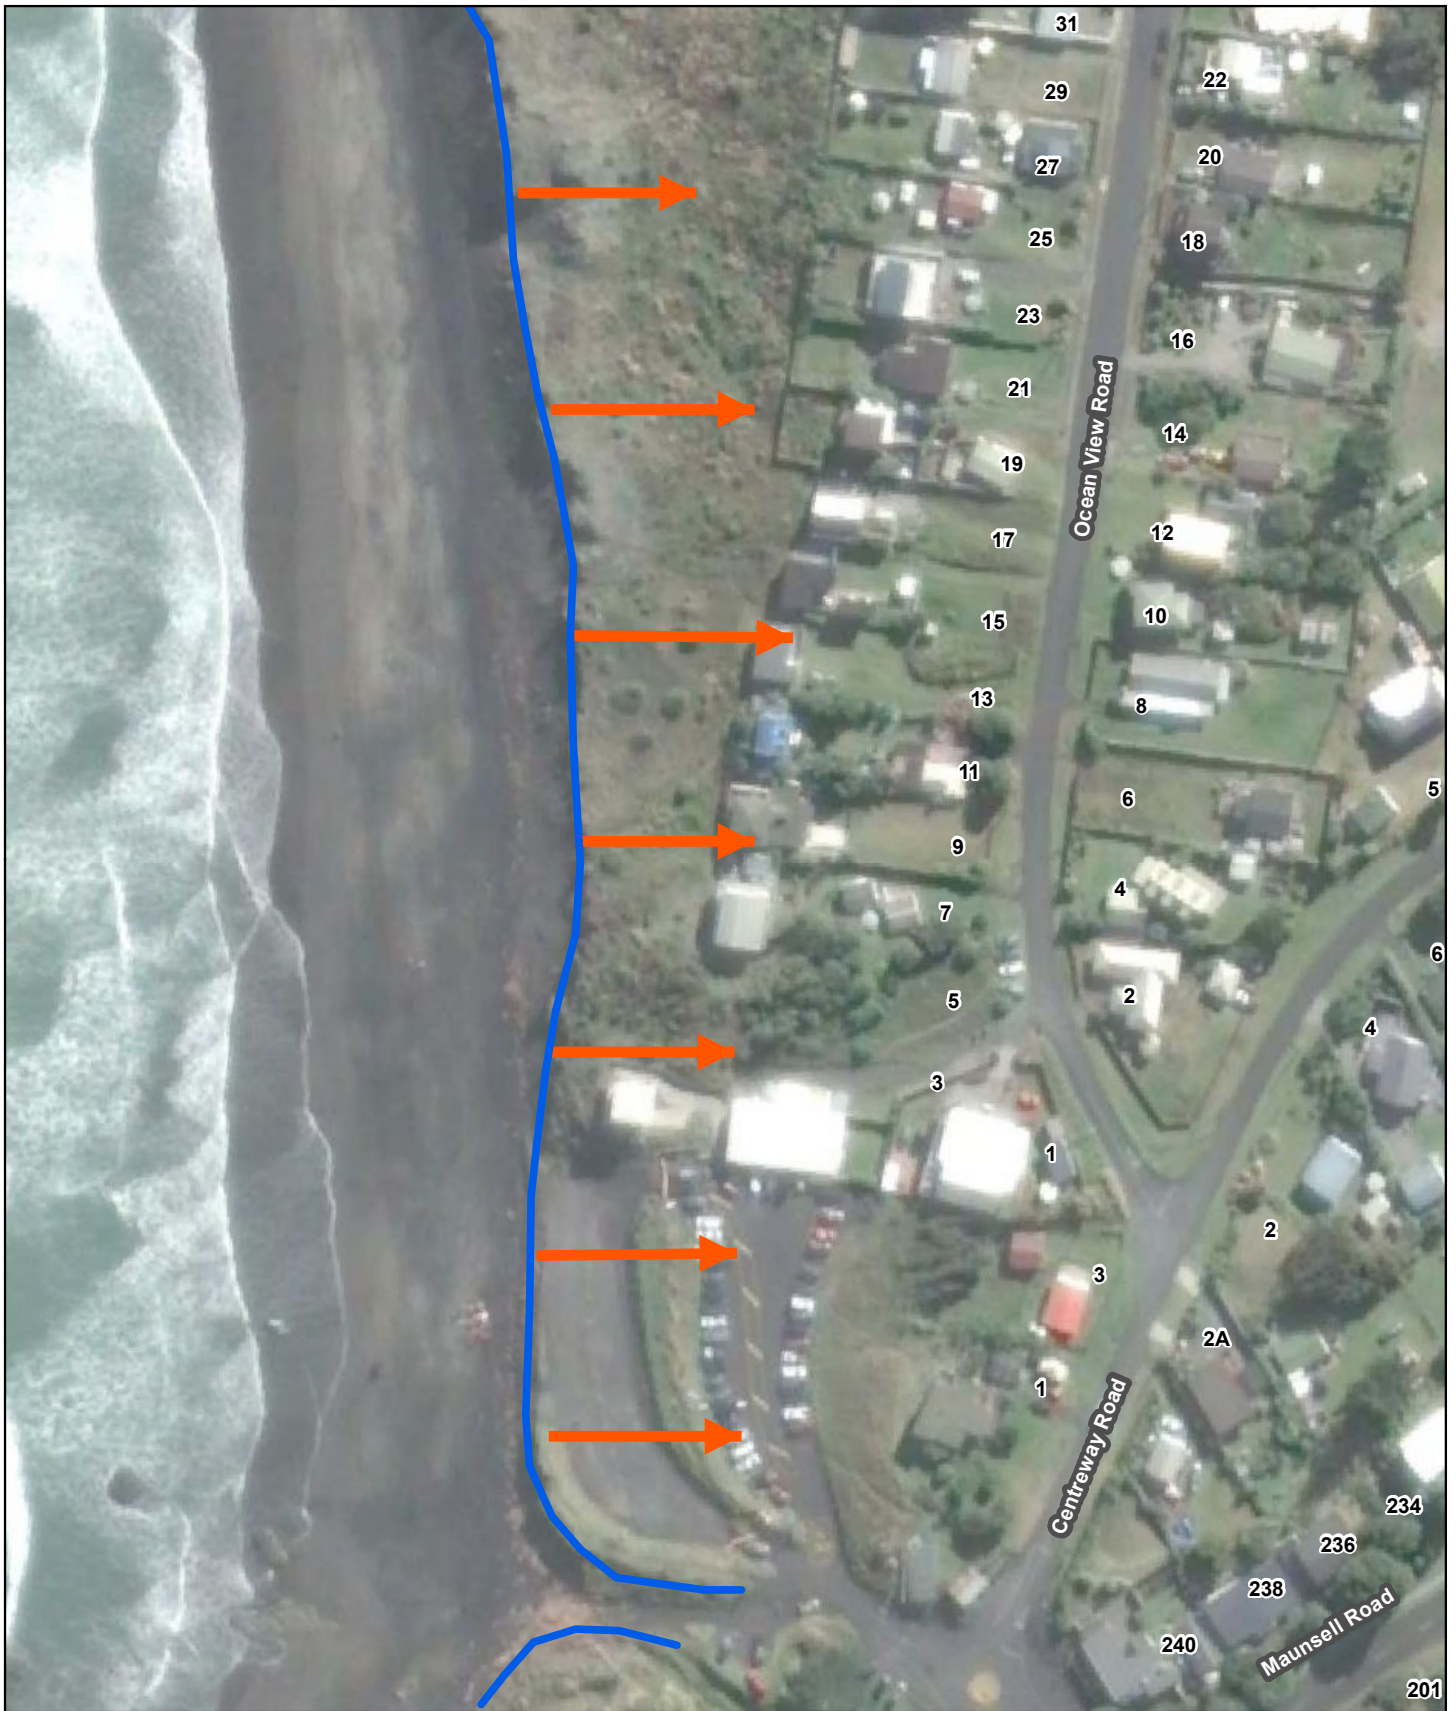
**Figure 2**

- 2014 Shoreline (approximate)
- ➔ Setback from Existing Shoreline

Figure 9: Setback from the Existing shoreline

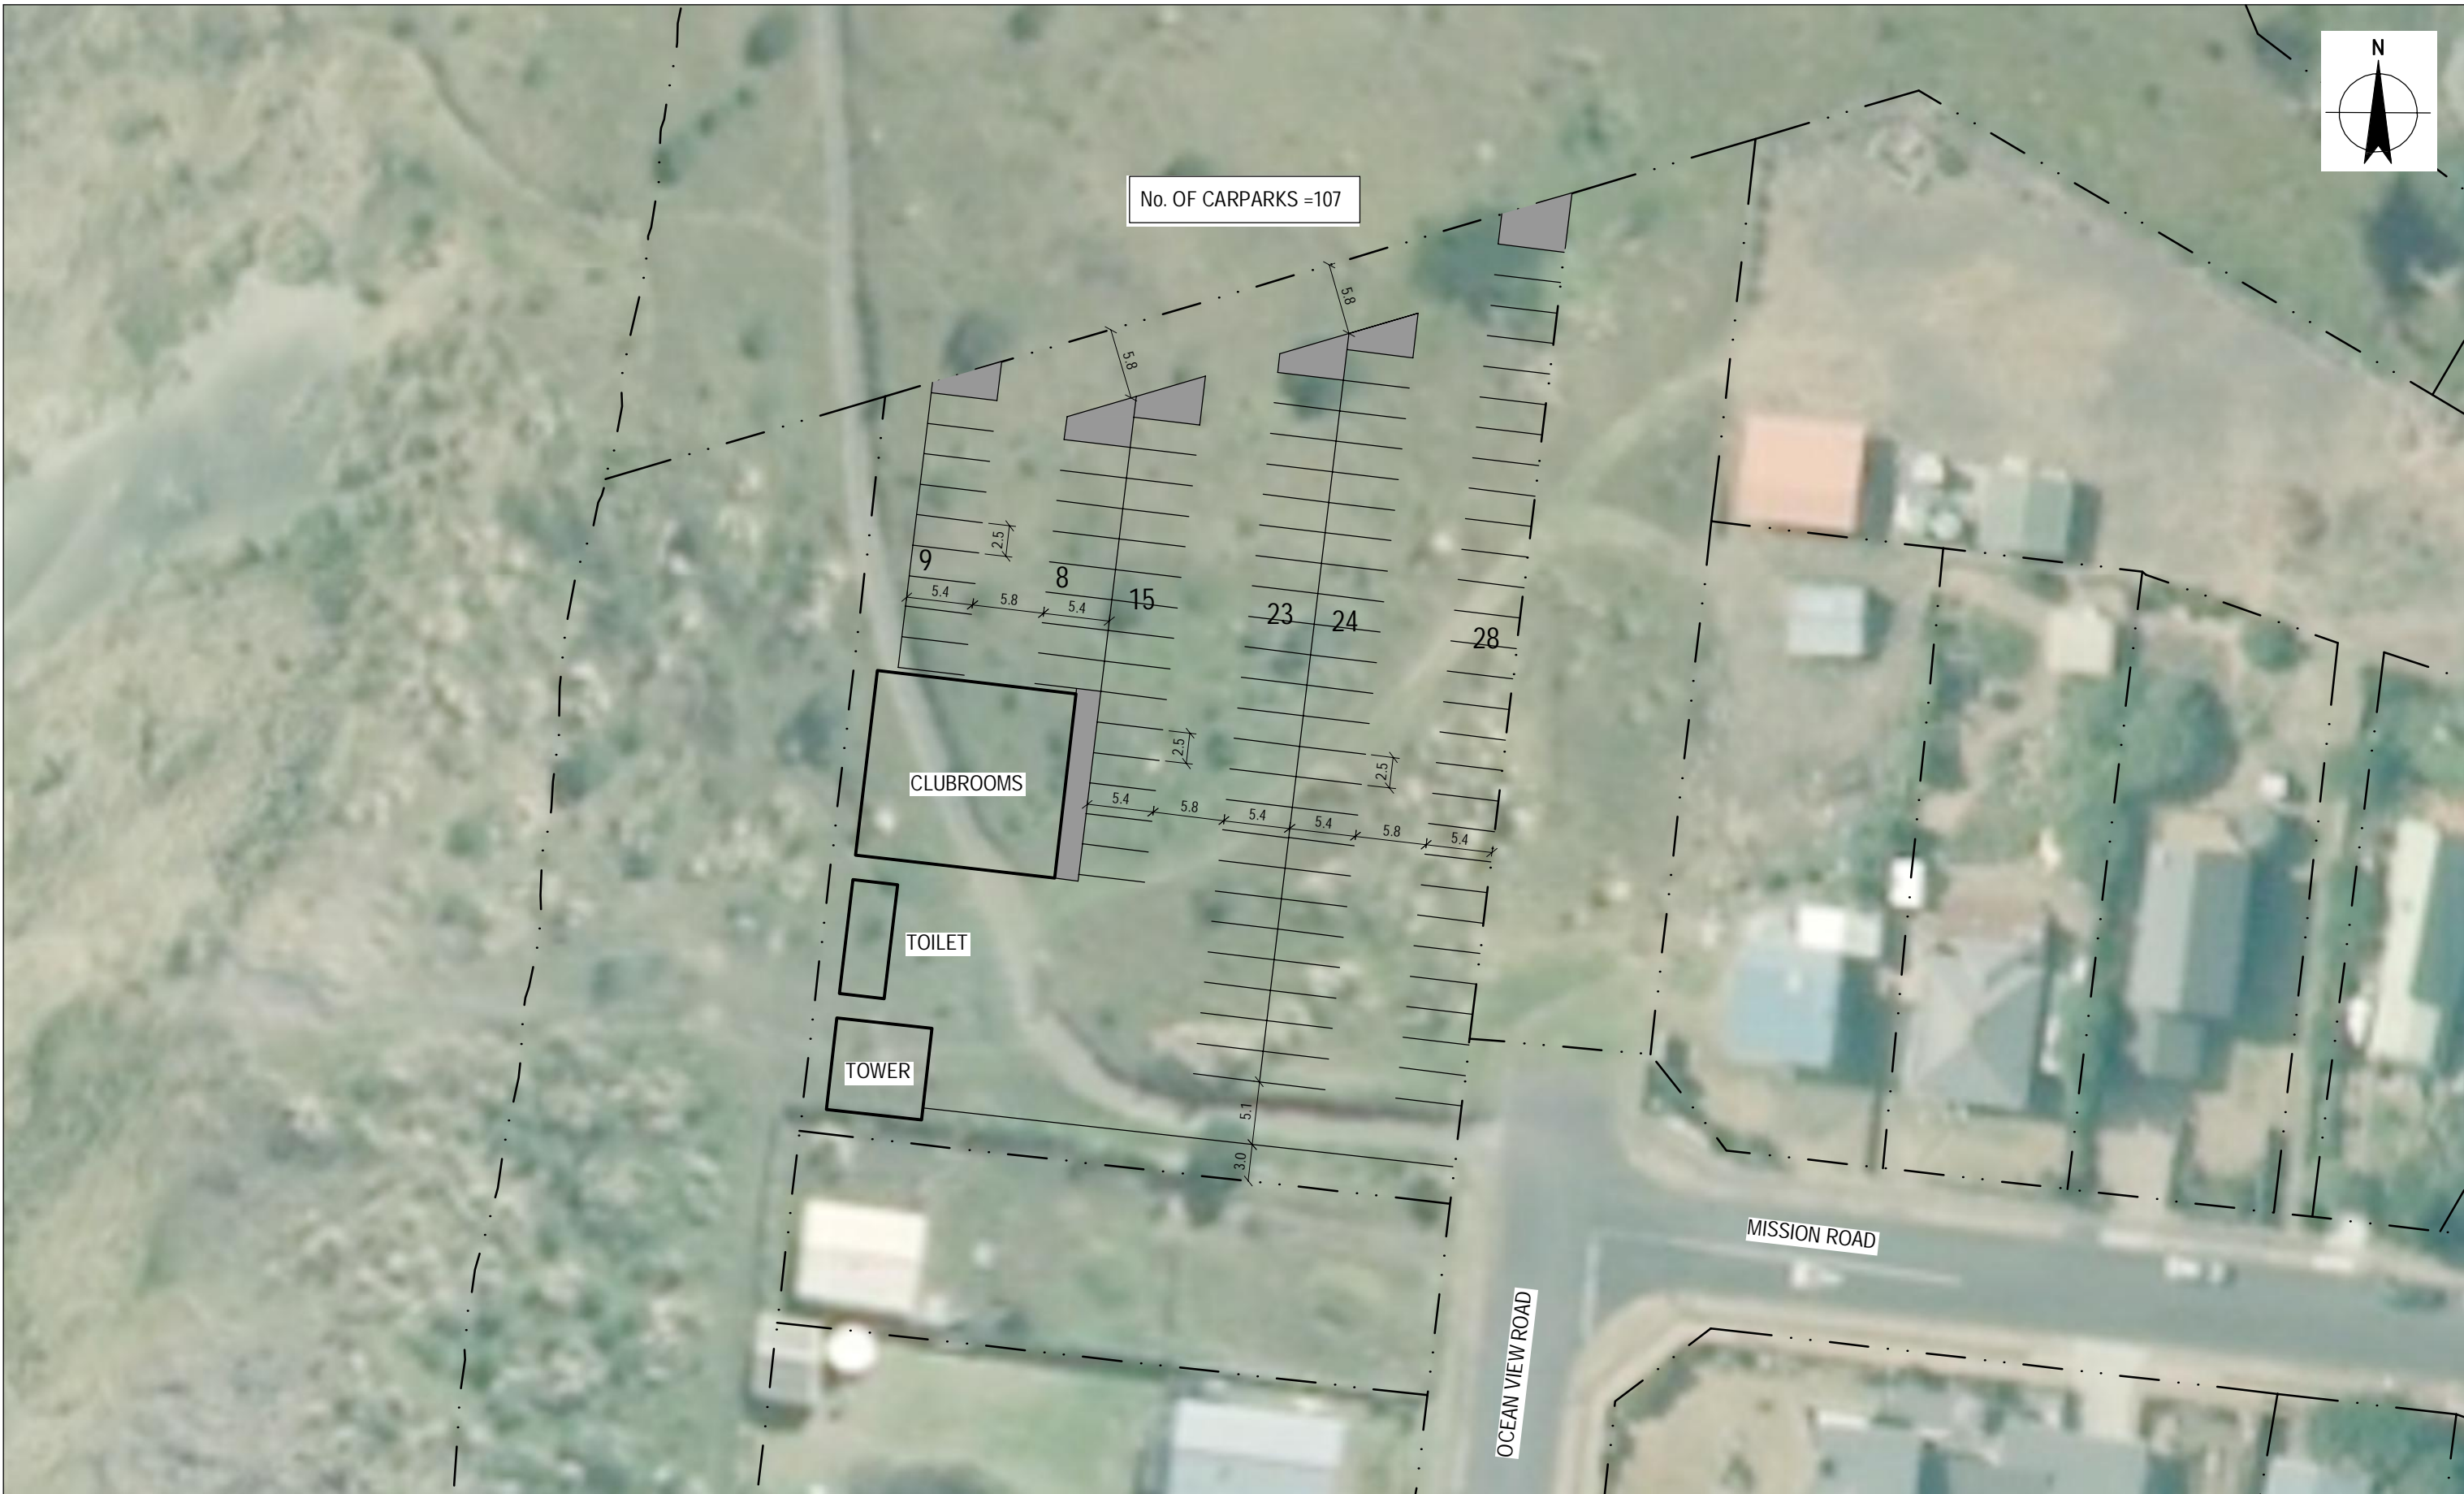
No. OF CARPARKS =107
