Agenda for a meeting of the Huntly Community Board to be held in the Huntly West Community Hub, Harris Street, Huntly on **TUESDAY, 8 DECEMBER 2020** commencing at **6.00pm**.

MINUTES of a meeting of the Huntly Community Board held in the Riverside Room, Civic Centre, Main Street, Huntly on **TUESDAY, 27 OCTOBER 2020** commencing at **6.00pm**.

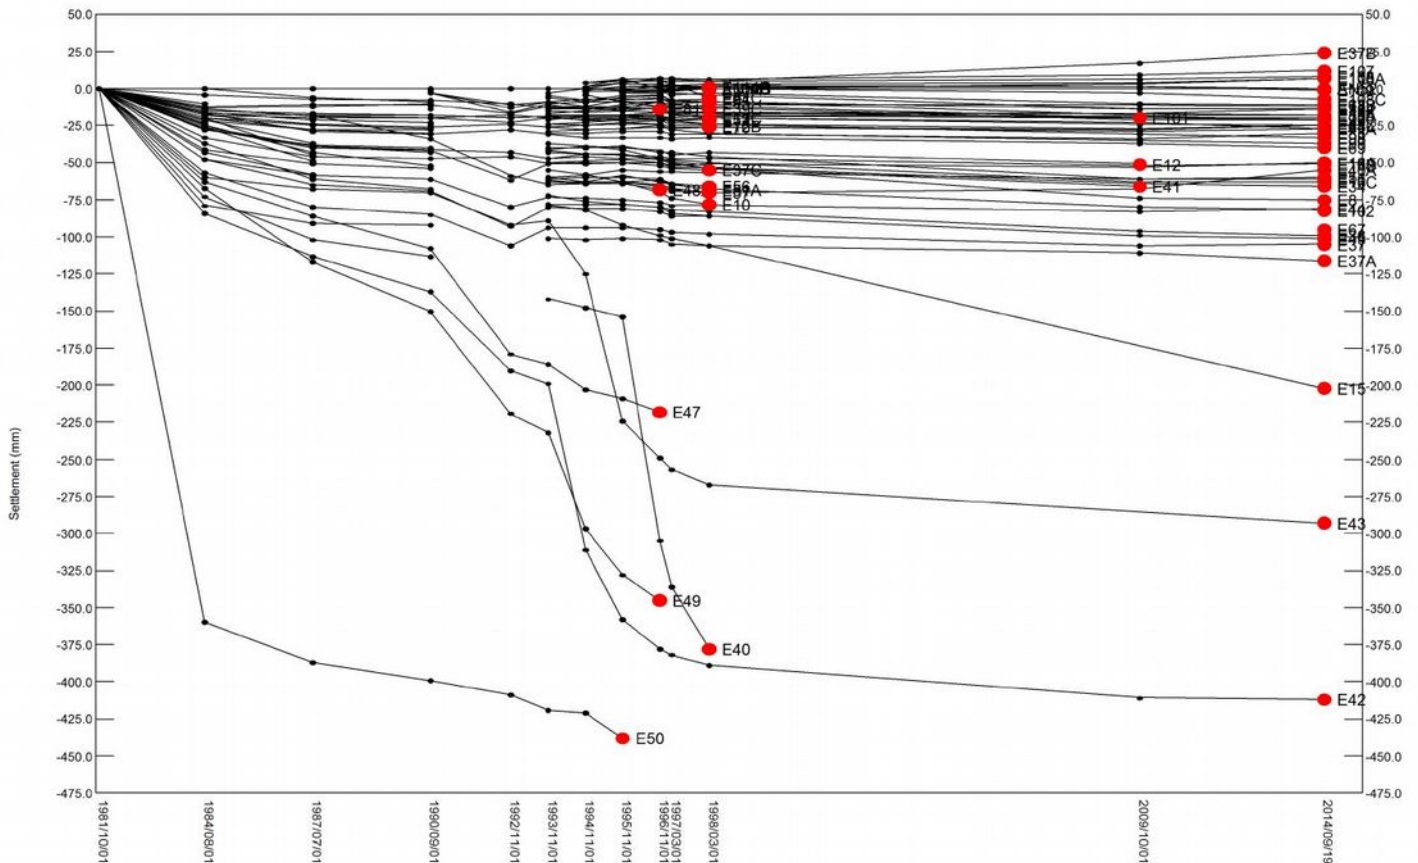
A graph taken from this report is shown below. Where x axis is time and y axis is earth movement. Although specifics are hard to read at this resolution, what it shows is that the movement was rapid initially and then decayed away.

So what can be concluded, is that if the mine was still in operation that the risks for subsidence within the subsidence zone were effectively the same as the risks outside the zone.

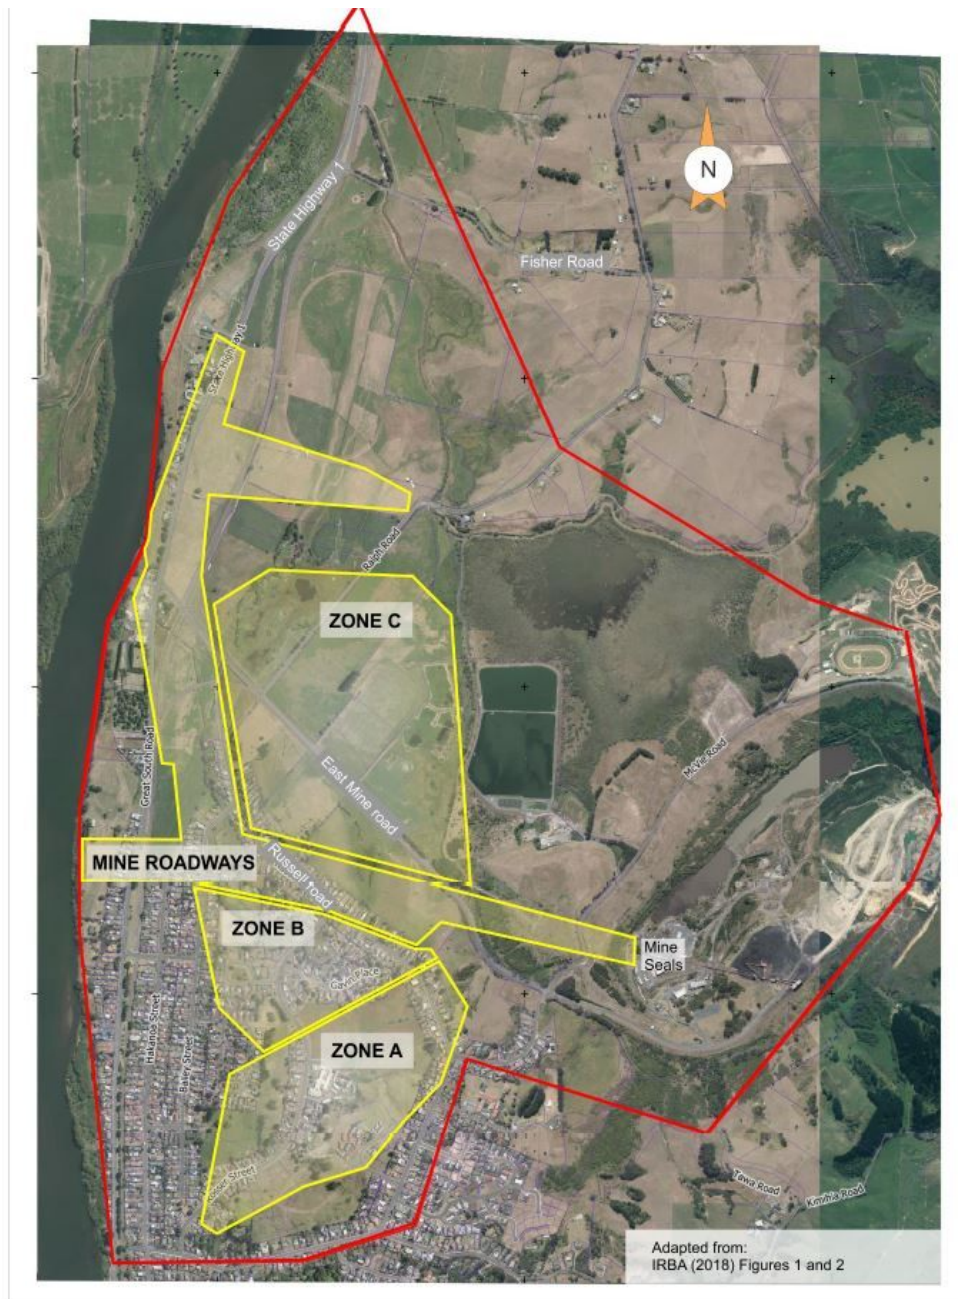
FIGURE 6 – ZONE LOCATIONS

The other issue that is well known locally is that the type of mining affected the risk of subsidence. This is stated in the a report⁴, from which this figure is taken.

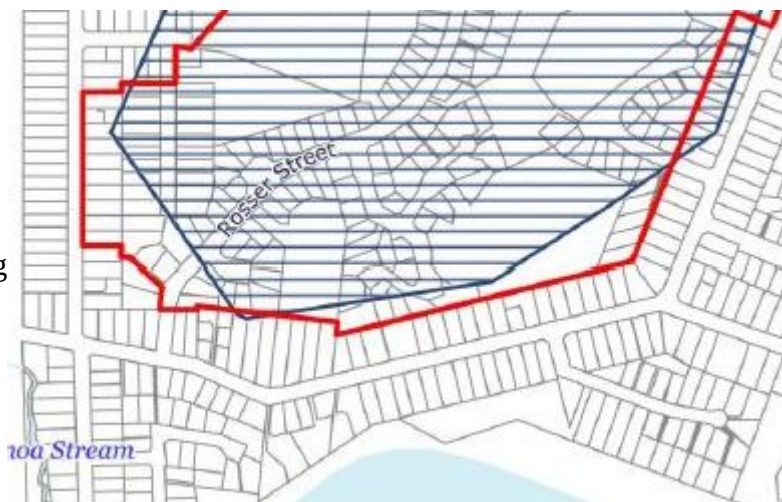
We are open to the small changes that are proposed, on the southern and south-west corner, as illustrated in the figure. Reducing the zone to where the shallow mine workings are actually located.

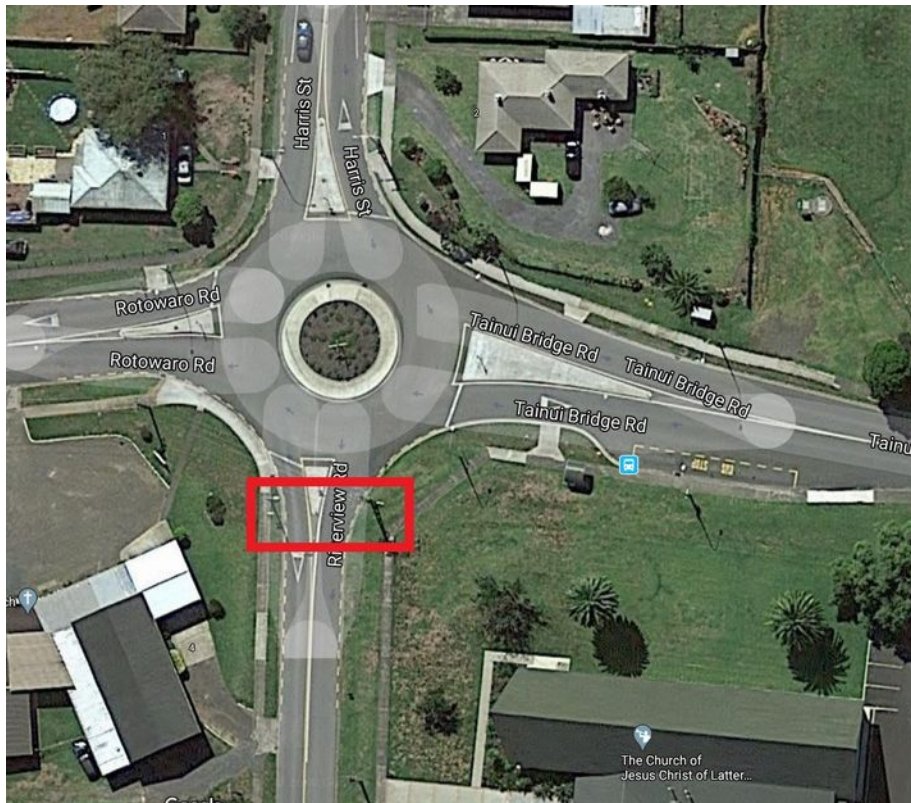
Tainui bridge round about. Connecting of footpaths either side of riverview road. This is shown below, and the other three roads have the ability for pedestrians with say push chairs to cross. But this road does not have this ability. This work is scheduled in for the 2021/22 financial year.

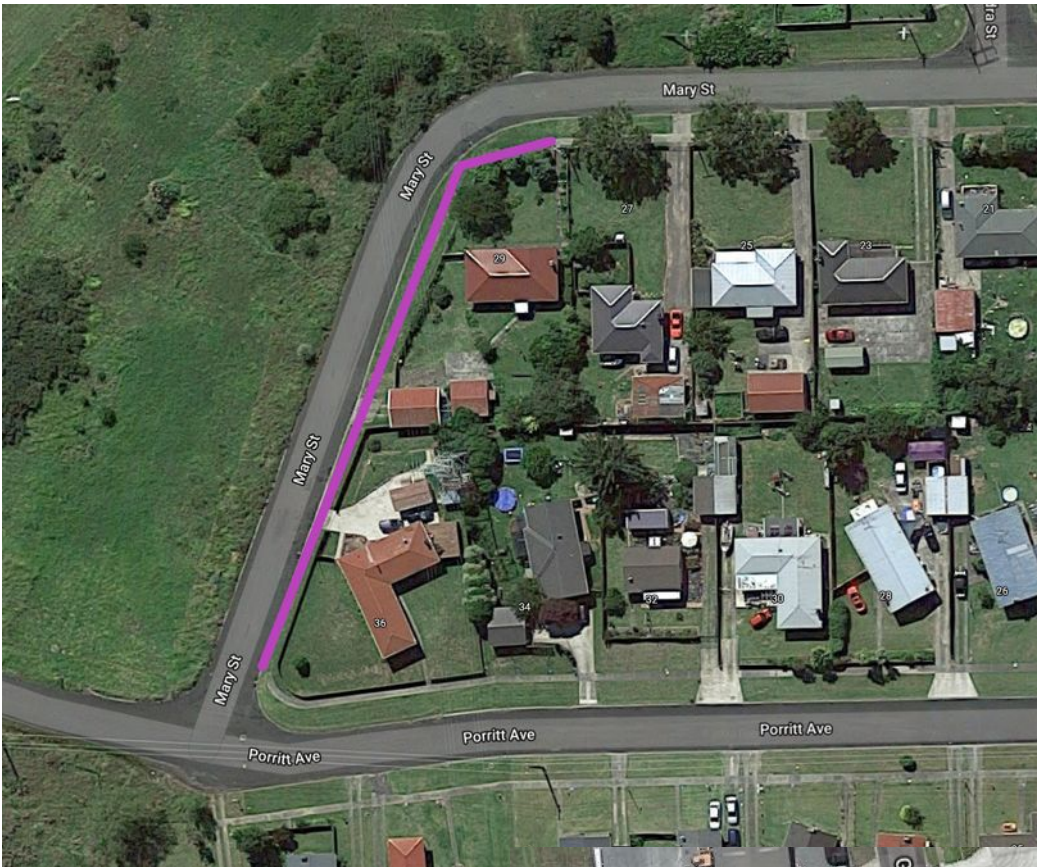
Mary street. The West part of Mary street that presumably wasn't developed as part of the original street development, now has two houses that come off it. Also with the footpath missing it means families can't walk around the block without going on grass or the road, ie the block of Porritt Ave around to Mary can't be walked.

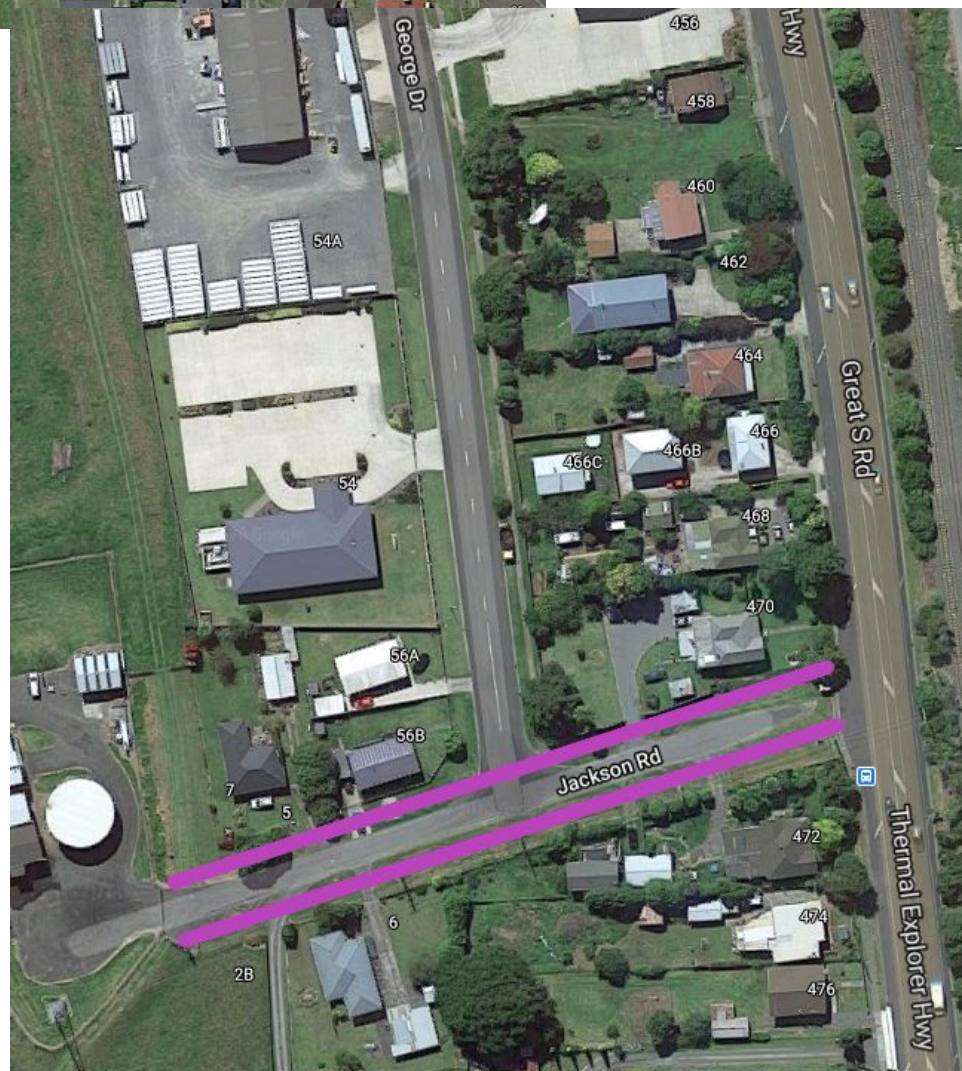
Jackson street. This street and surrounds is an island of residential surrounded by industrial zoning. There is not a footpath on either side of this street. Thus no connection to Great South Road footpath or to the footpath on George Drive.

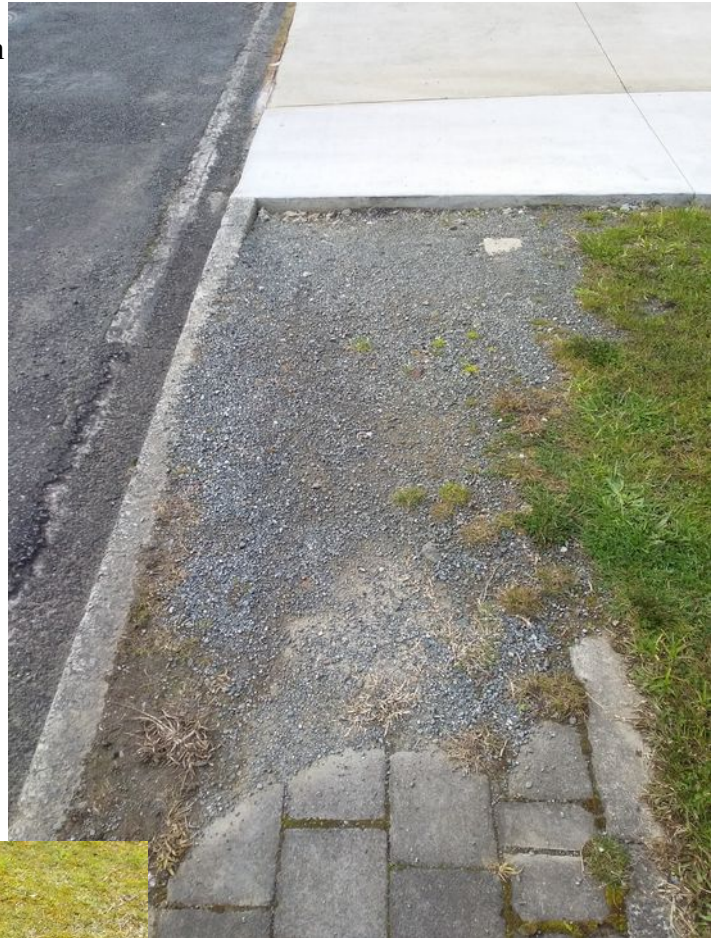
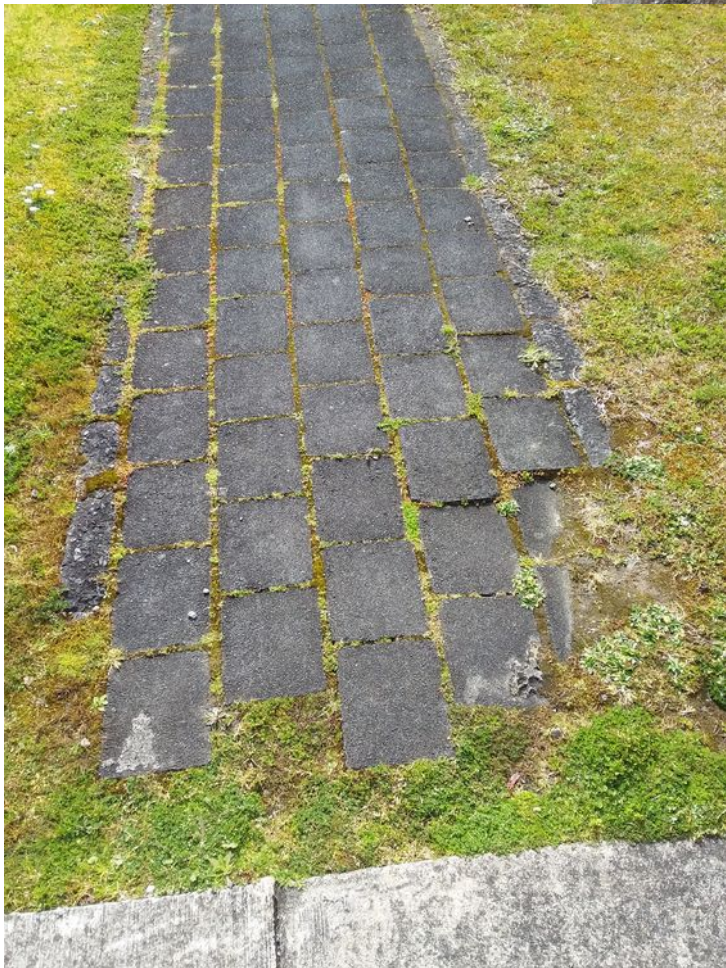
The first is large sections missing, as illustrated in the photo below. This is supposedly due to fibre installation. The contractors who did this work did not reinstall as required, and subsequently are not interesting (or maybe not even in business?)

Given the large lip between the gravel replacement and the concrete driveway this is a hazard for users, and makes difficult for those mobility impaired or wheelchairs etc.

Surface requests have been raised for these in the past, (need to check progress or lack of)

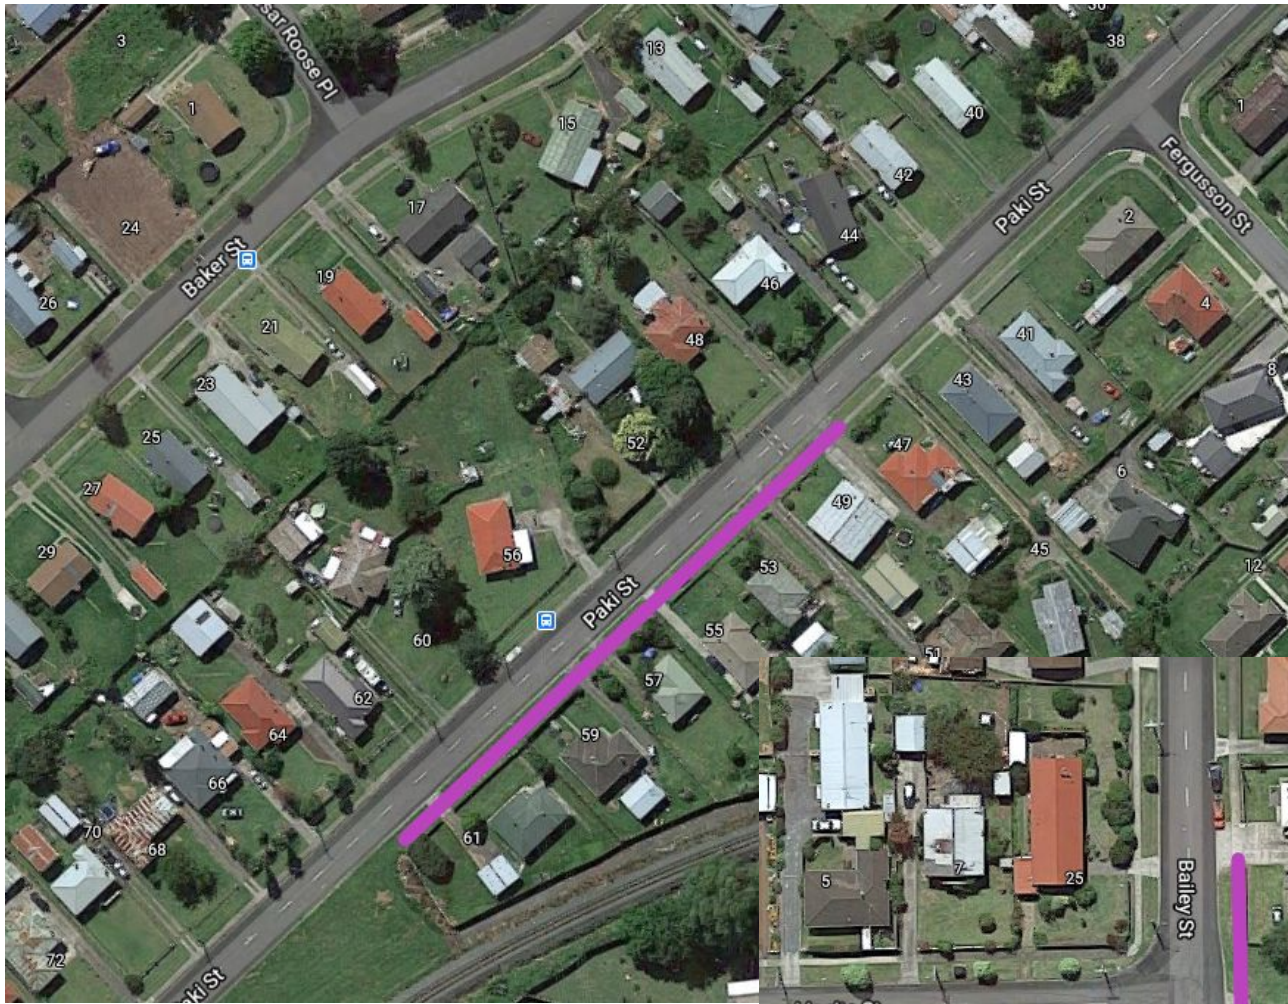
Paki Street

The footpath stops at 49, although the homes continue till 61.

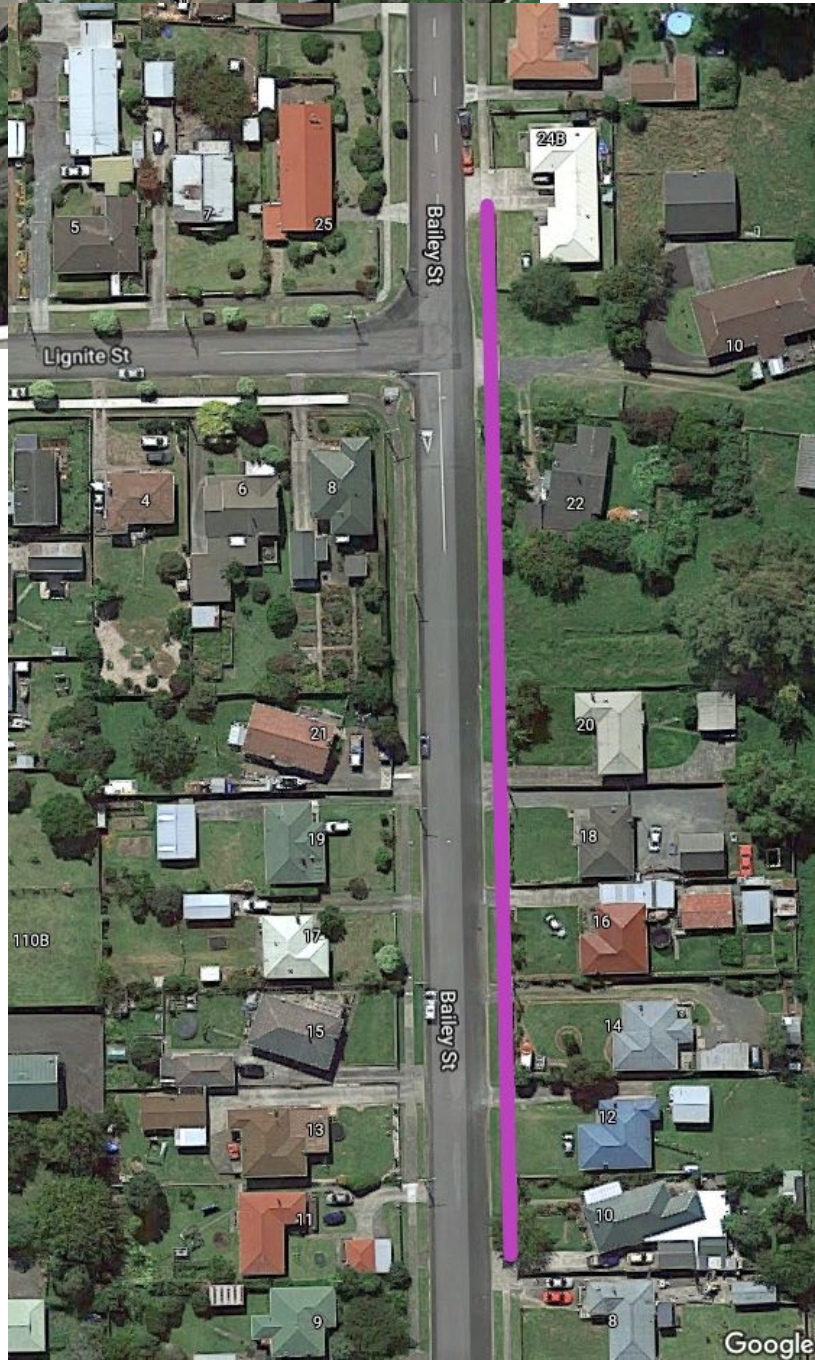
Bailey Street. There is a section missing from #8 to #24B. This is very random as it is a missing section, ie had footpaths either side.

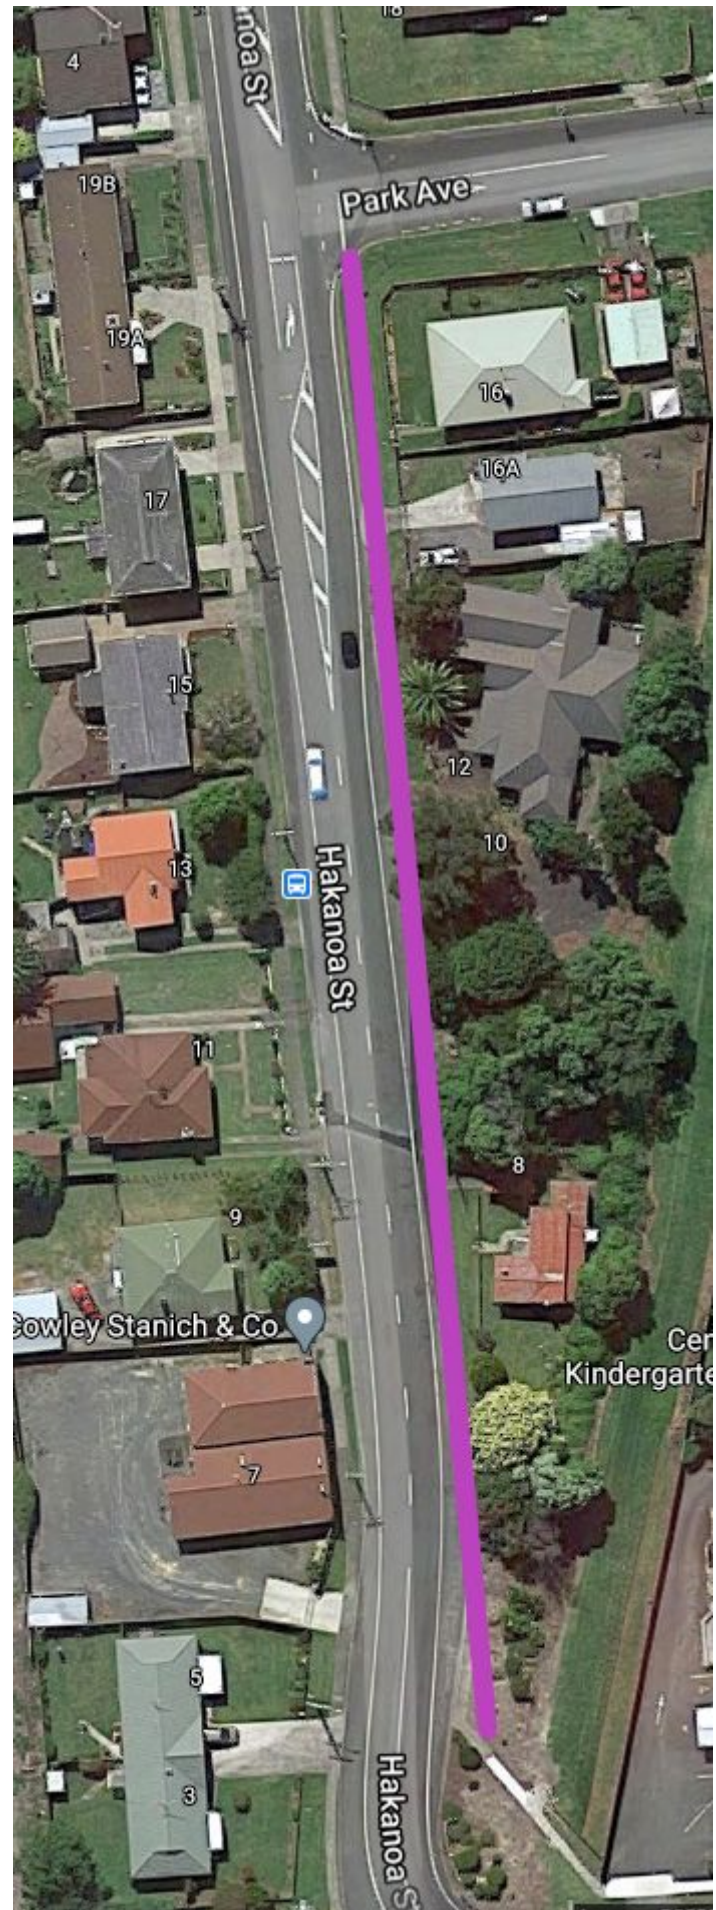
Hakanoa Street. There is a section on Hakanoa street that is also missing. Again having footpaths at the start and end of this section.

The footpath stops at Park ave and also at Onslow street.

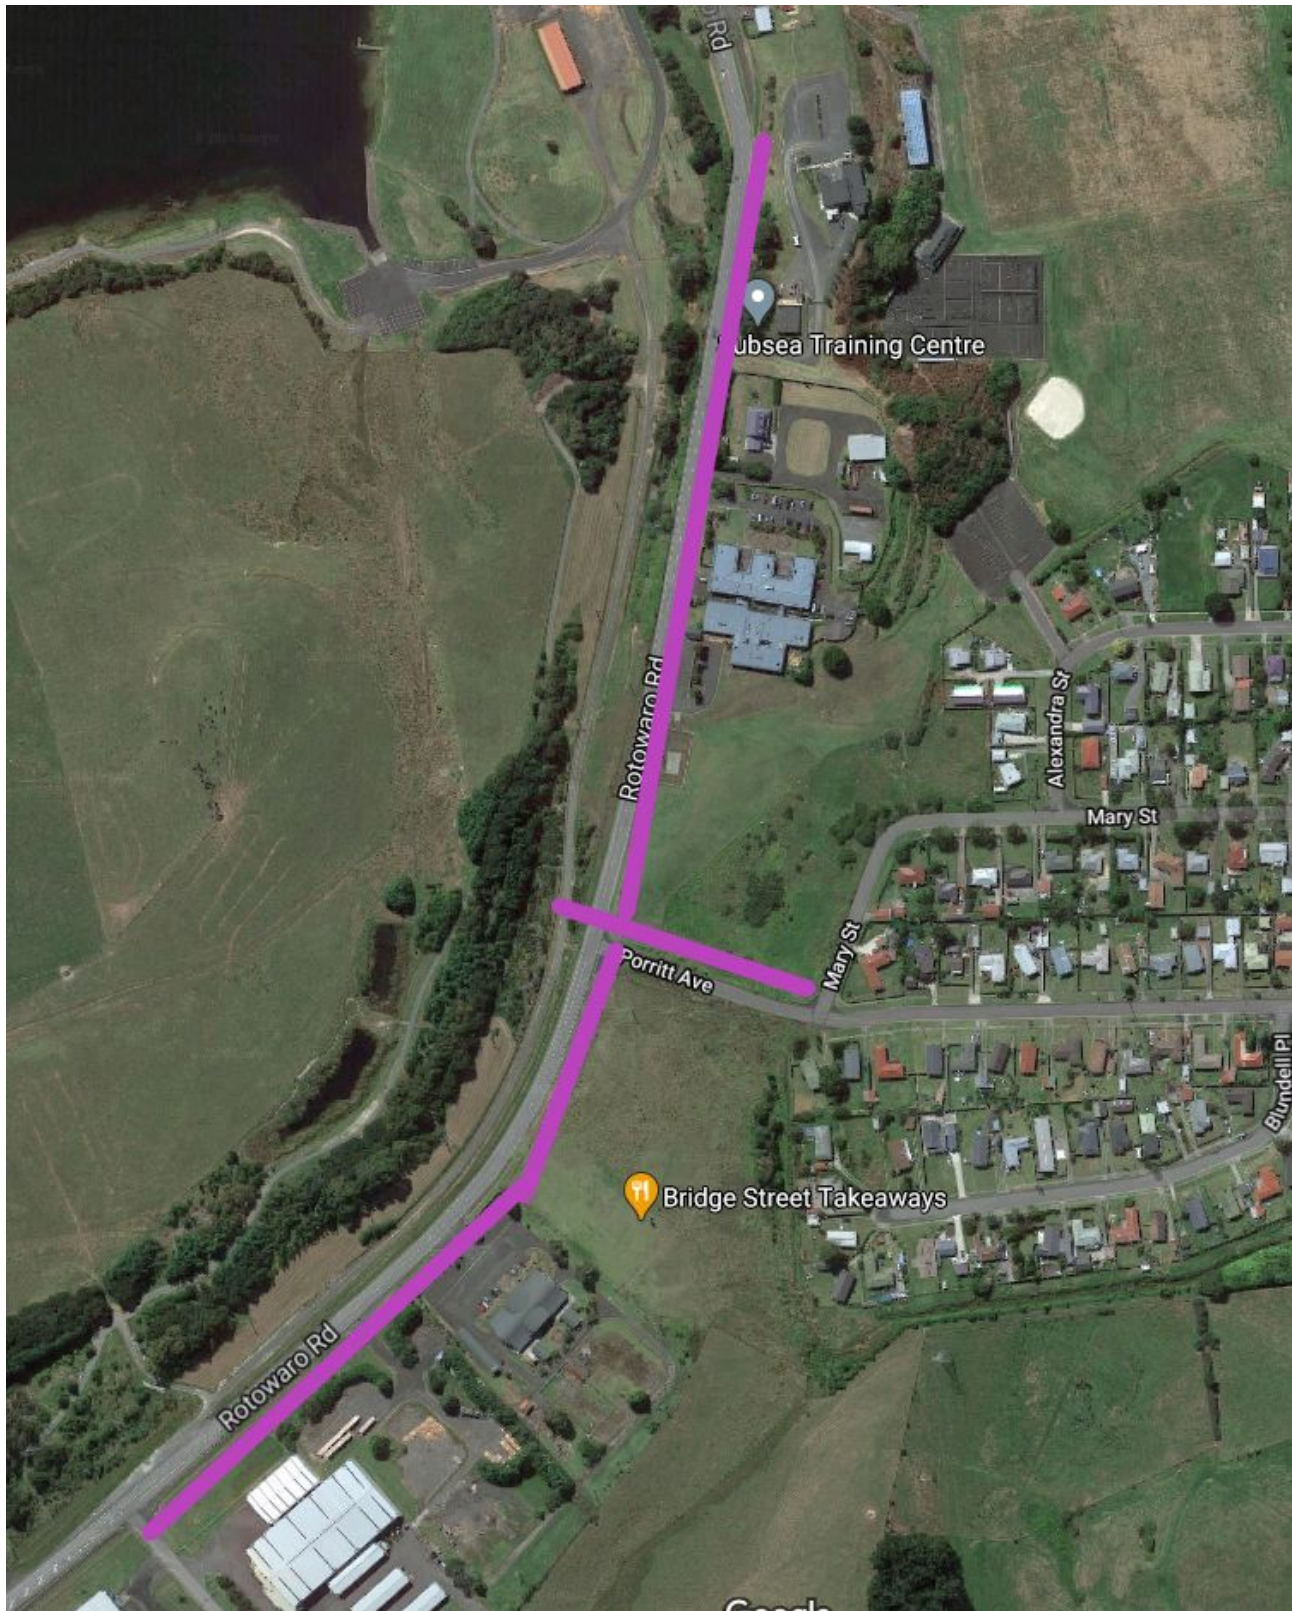
Porritt Ave and surrounds. There is no connection from the suburb next to the River to the Puketirini Reserve. Therefore there needs to be a connection, including access across the road, into the Reserve, which is currently blocked by fencing.

There is also no pedestrian access to the business, including the Te Waananga o Aotearoa south of Porritt Ave. Thus no way for students or teachers to access this educational facility without the use of private motor car.

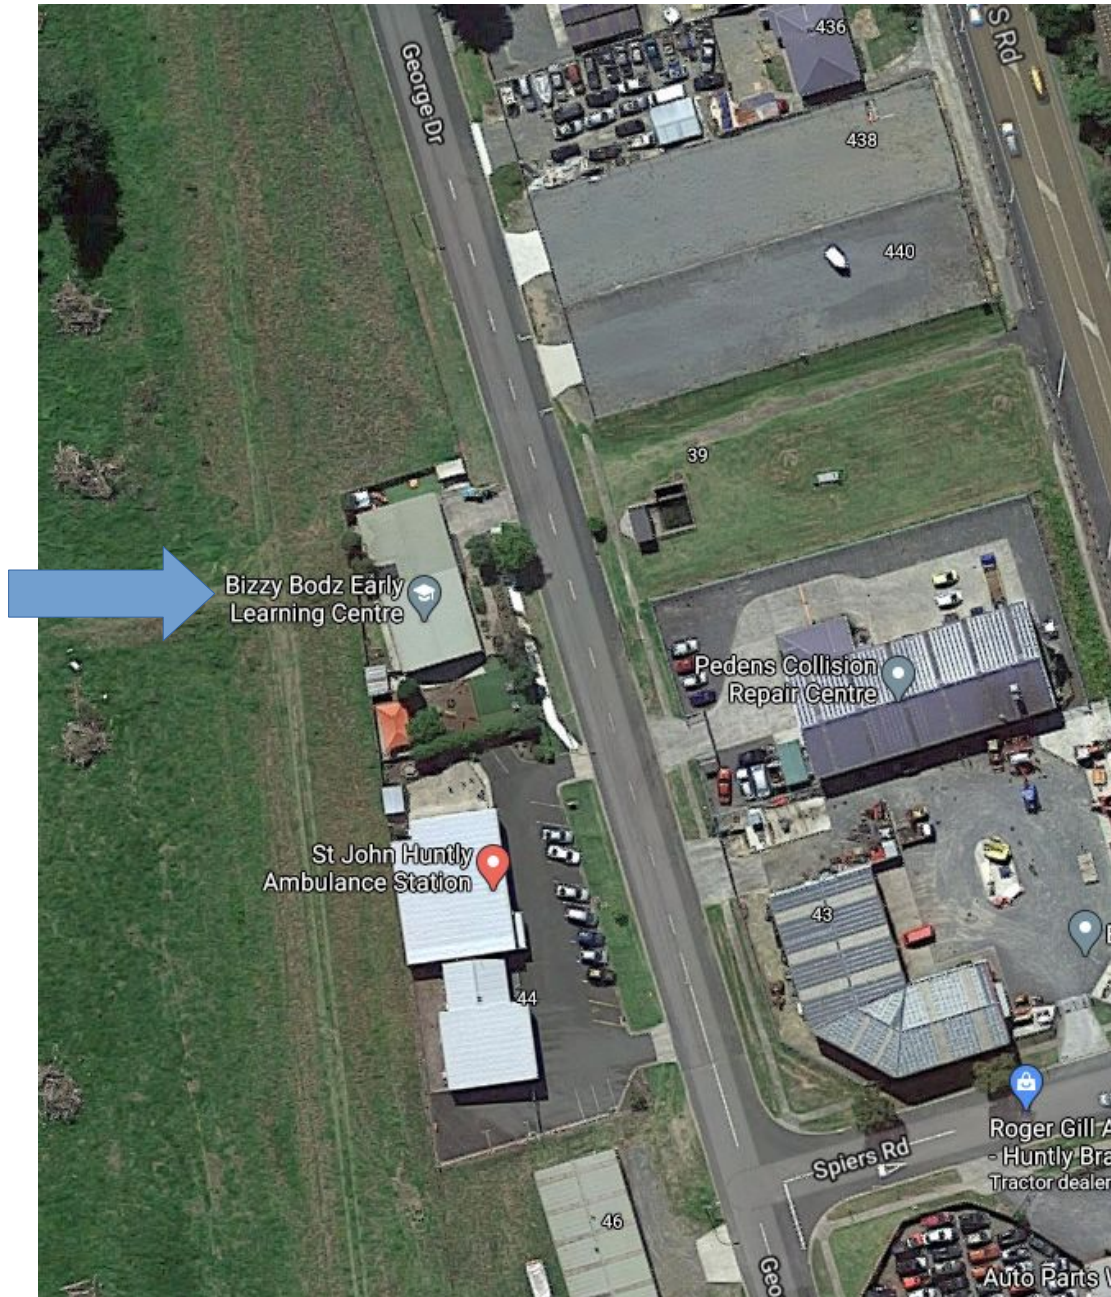
George Drive. On the East side of George drive there is a footpath from the Southern start ending opposite the child care. There is also a very short section of footpath outside the child care. However it does not progress very far.

There is always a large number of cars parked around the childcare and concerns about where folk are walking. So a proper analysis of the situation, including talking to parents and staff, before development of a plan would be appropriate.

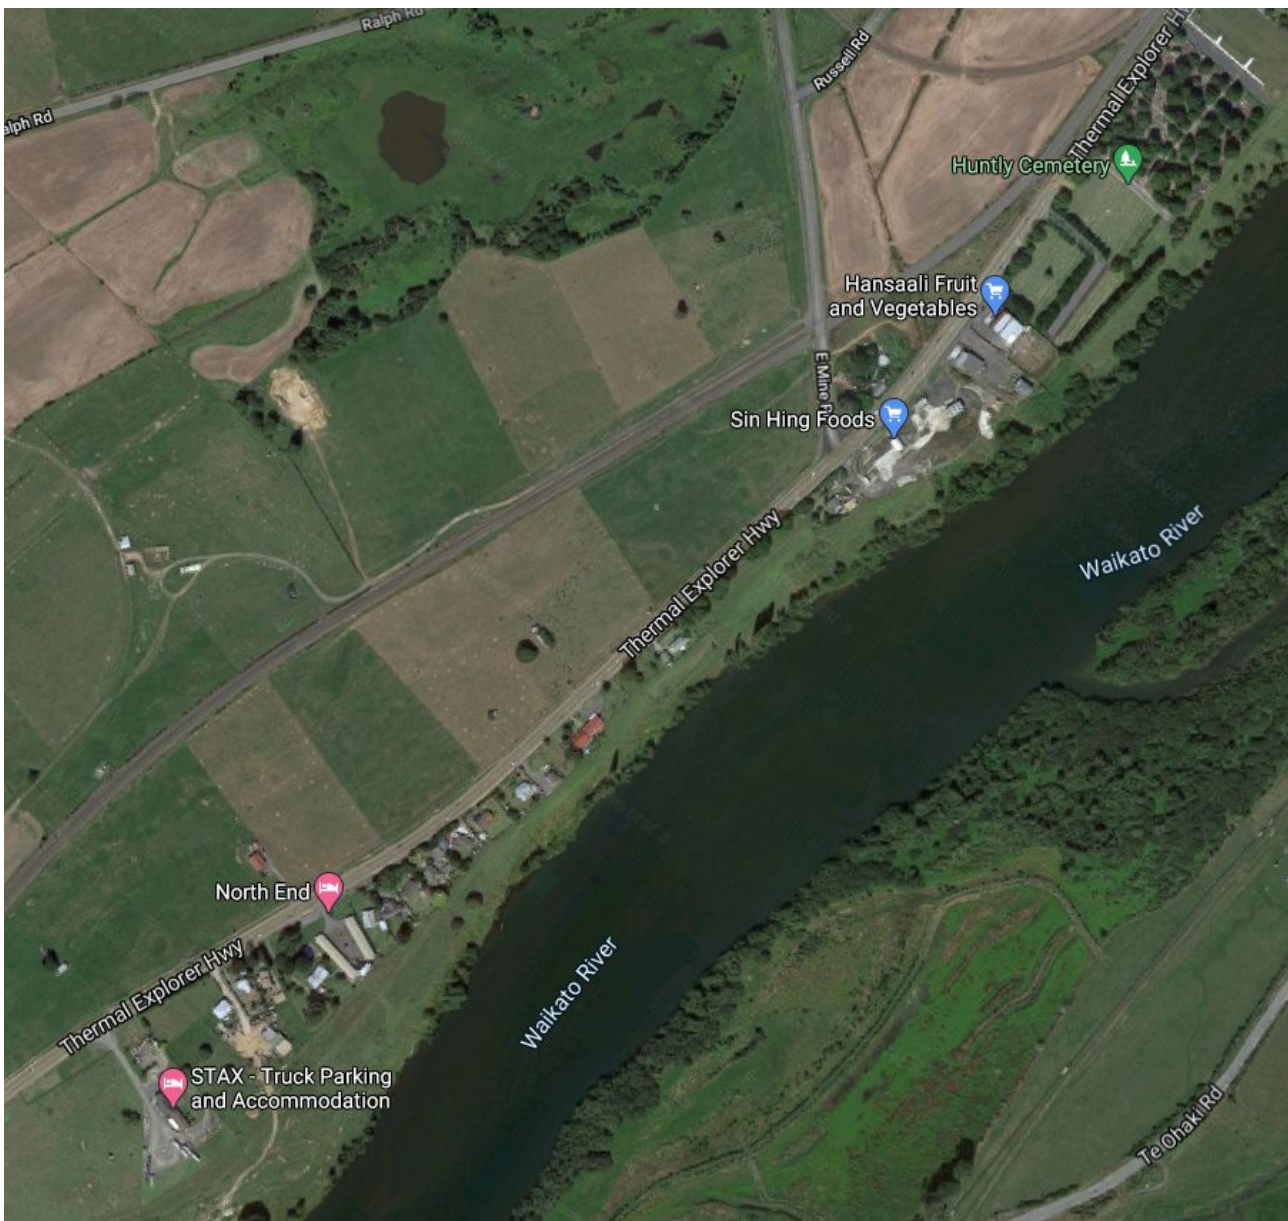
Great North Road, North end.

The footpath network for Huntly ends at the end of Kimihia (Huntly) Cemetery. Thus the homes and business north of this point do not have access to any pedestrian network. I have not drawn in the missing section as the line width would obscure to much of the illustration. This area is zoned rural, although the density of homes at the north cluster is similar to that of a typical residential street.

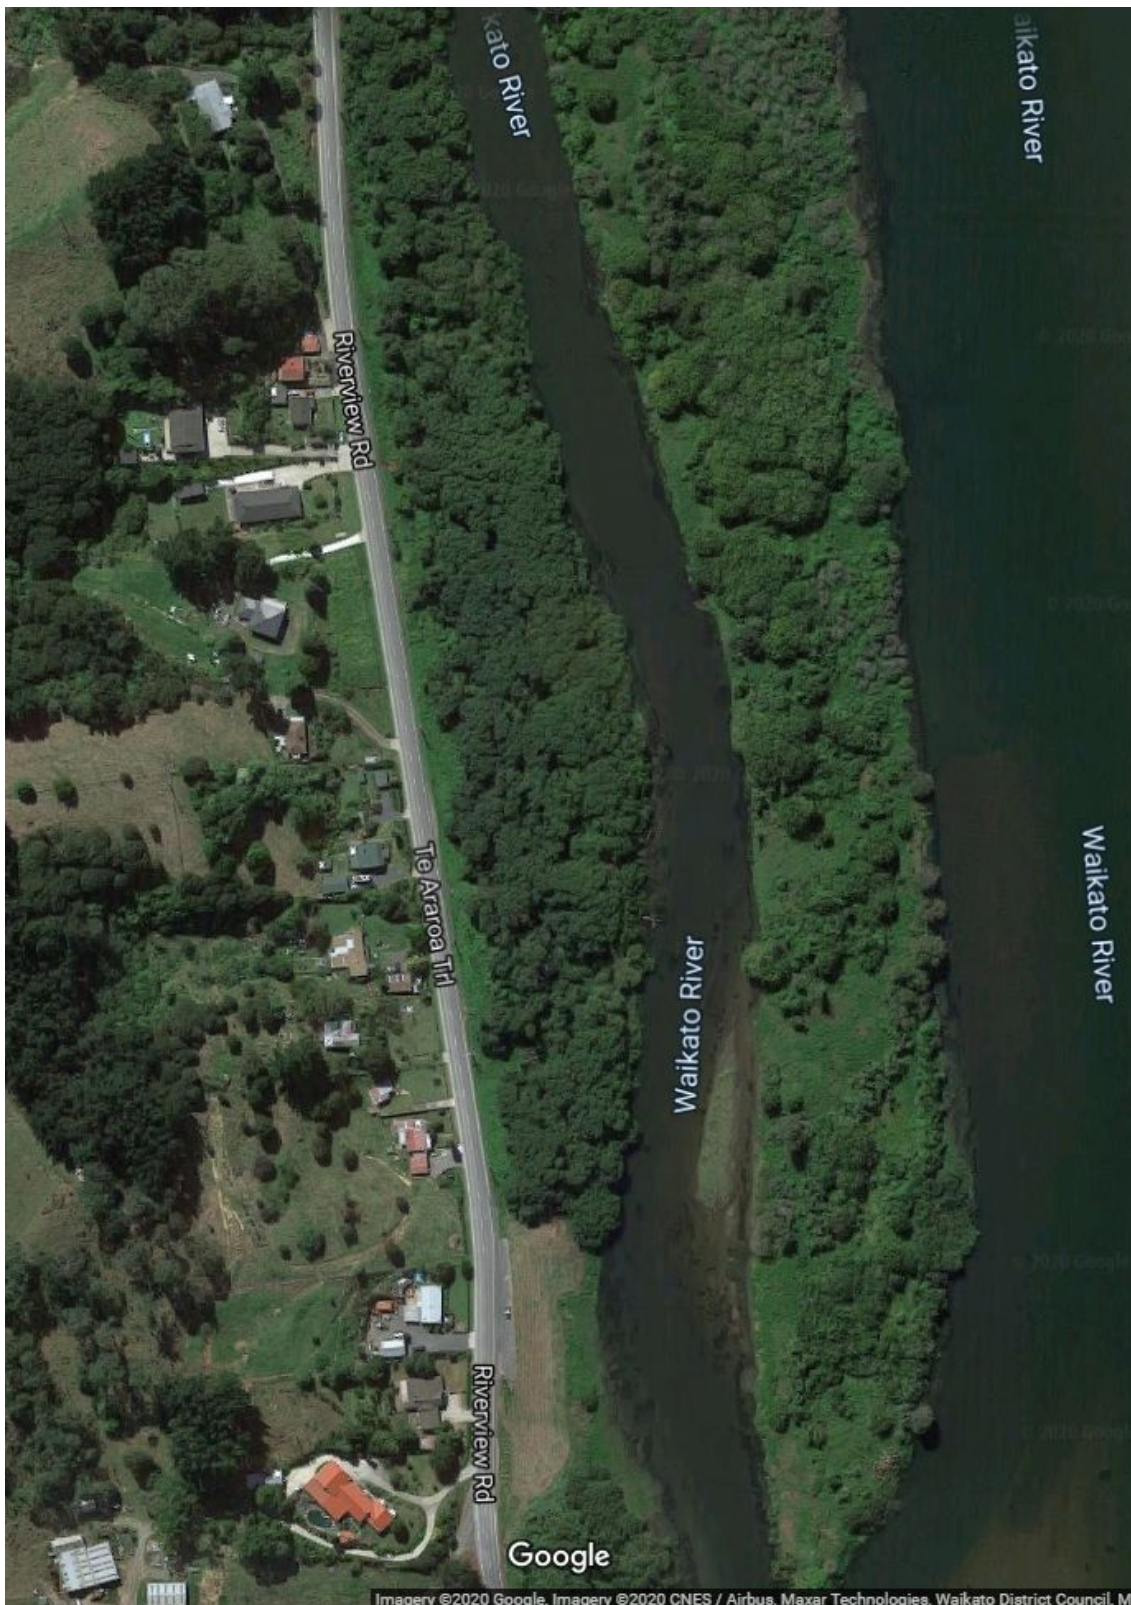
River view road, south end. There is a currently a footpath that ends at 160 river view road, which is at the top of the aerial photograph below. Again this is zoned rural, but has a density of homes very similar to residential extending to 206 Riverview at the bottom of the photograph. There is overlap between this and the Te Awa trail in the strategic section.

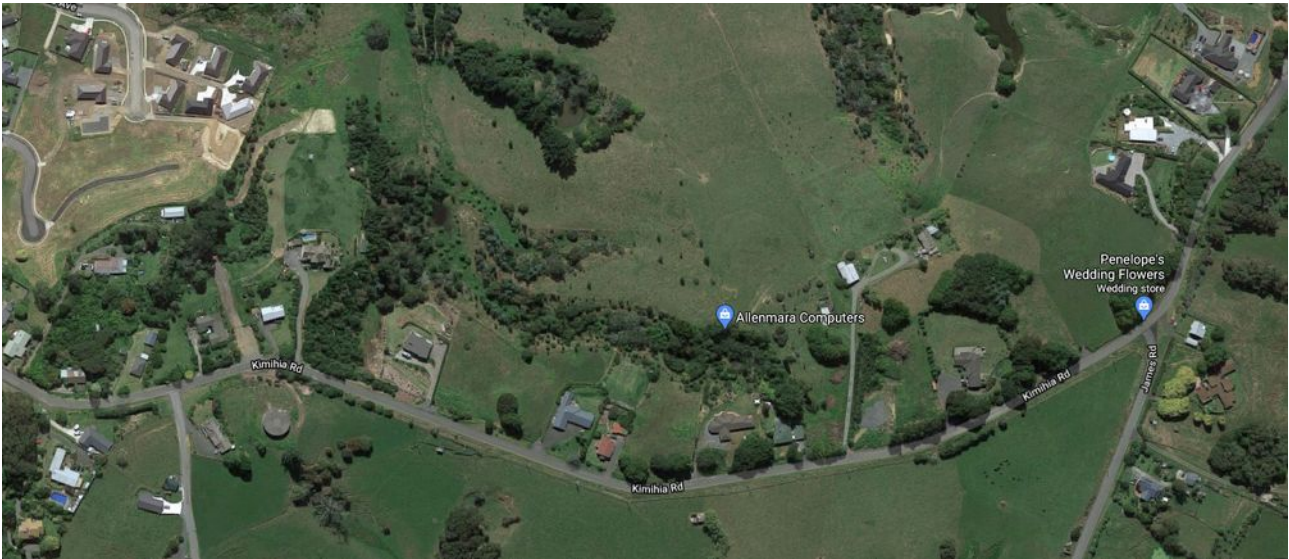
Kimihai Road, East end. Kimihai roads footpath stops at approximately 133 Kimihia road, which is on the left of the illustration. In the PDP this east section will be zoned residential and it already has and increasing density of homes and this looks like it will continue. Thus in the near future a footpath will be required to service this area.

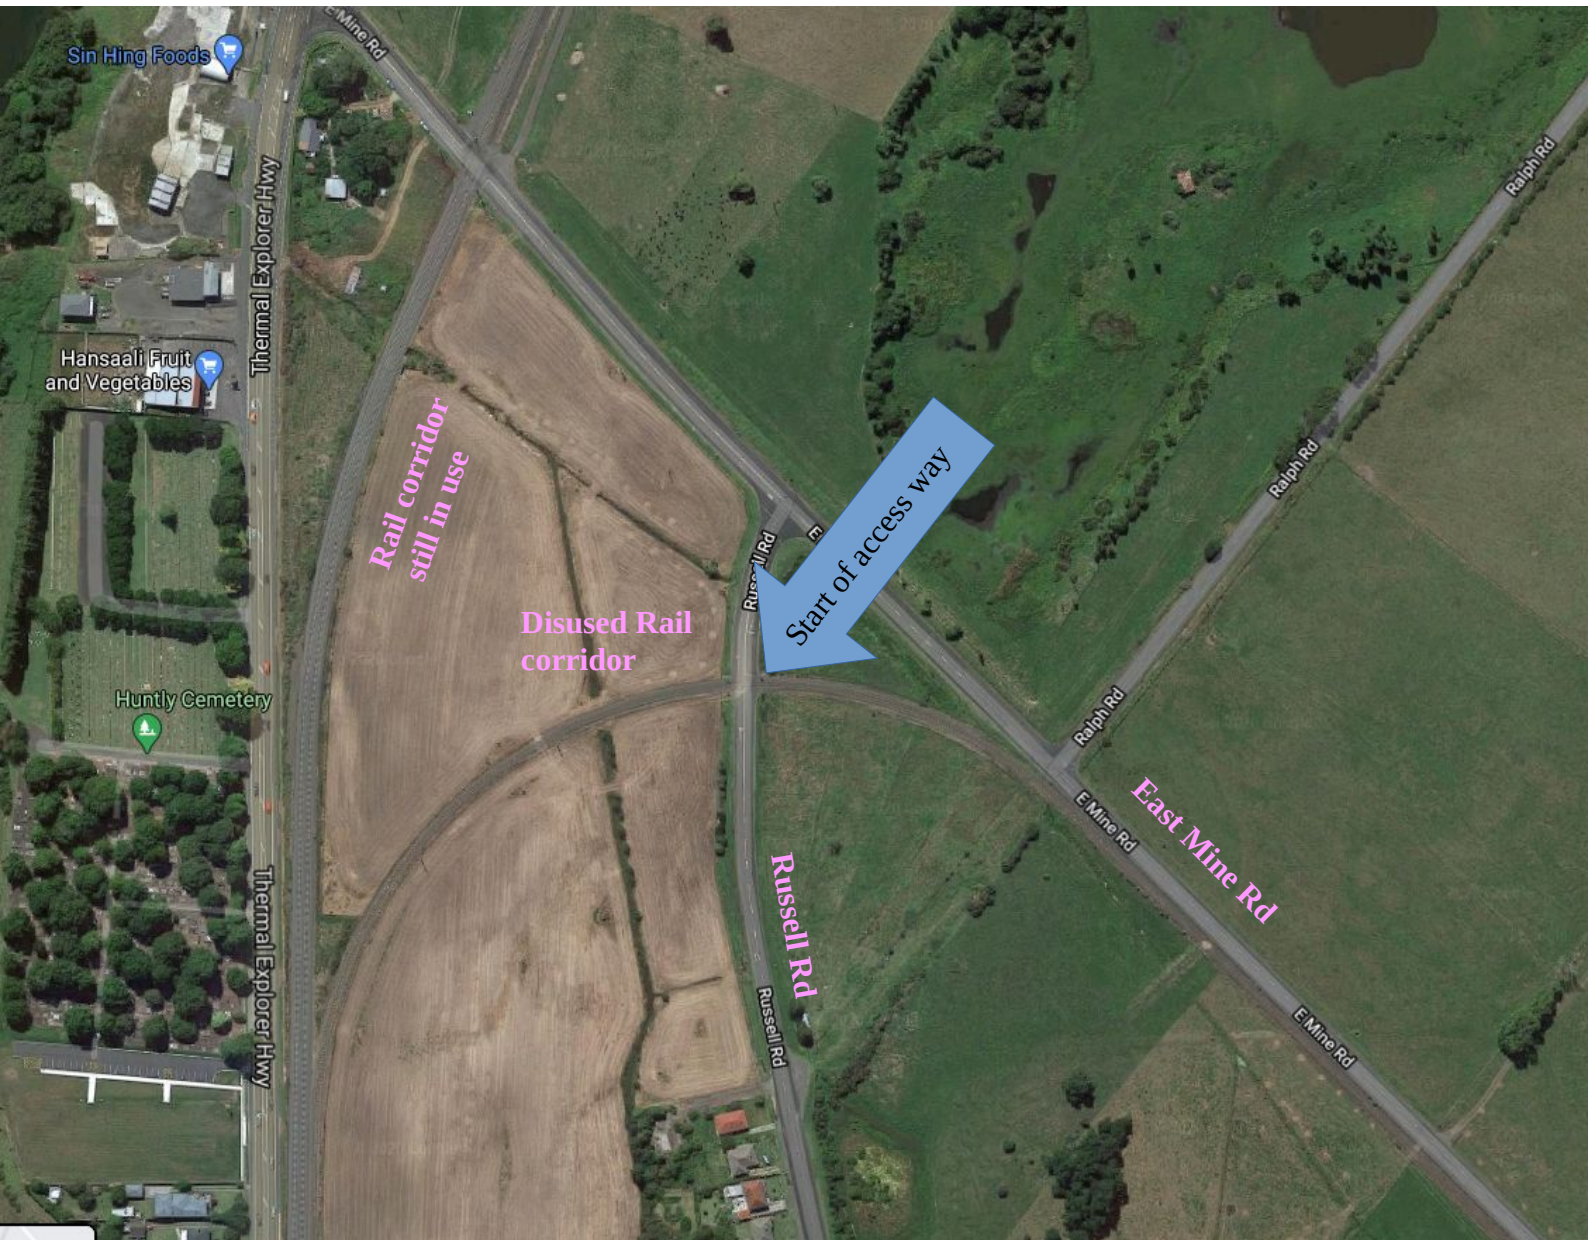
C & D – Kimihia lakes project. As this project moves ahead, pedestrian access for residents will become more important. Fortunately there are two logical routes already in position to service this development. These are the old railway corridor and the park on Hartis Ave.

The disused rail corridor comes from the main trunk line which is still in use. It then turns through Russell Road coming in parallel to East Mine Road, and on into the Kimihia lakes site. It makes sense to turn this into a pedestrian system as it is already separated from the traffic on East Mine road. Given the Russell Road footpath ends with the last home on Russell Road, this would need to be extended.

Also thought should be given to pedestrian access along the Great South Road – East Mine road. Opening up access from this direction as well.

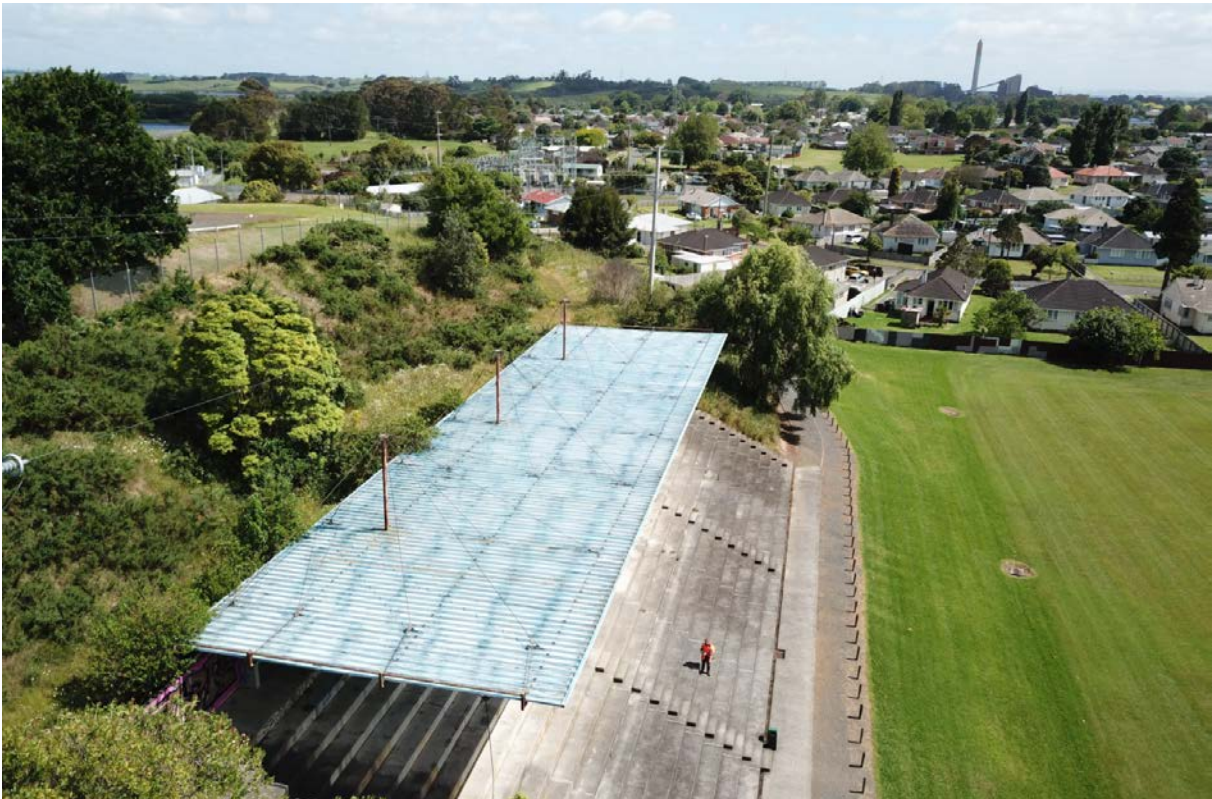
Huntly Grandstand Roof Replacement

Huntly Granstand – Transpower transmission cables span the park above the grandstand roof

Transpower has been made aware of the urgency and the impacts caused from the transmission lines. Transpower have indicated a response plan will be provided by late November.
