Agenda for a meeting of the Huntly Community Board to be held in the Huntly West Community Hub, Harris Street, Huntly on **TUESDAY, 8 DECEMBER 2020** commencing at **6.00pm**.

MINUTES of a meeting of the Huntly Community Board held in the Riverside Room, Civic Centre, Main Street, Huntly on **TUESDAY, 27 OCTOBER 2020** commencing at **6.00pm**.

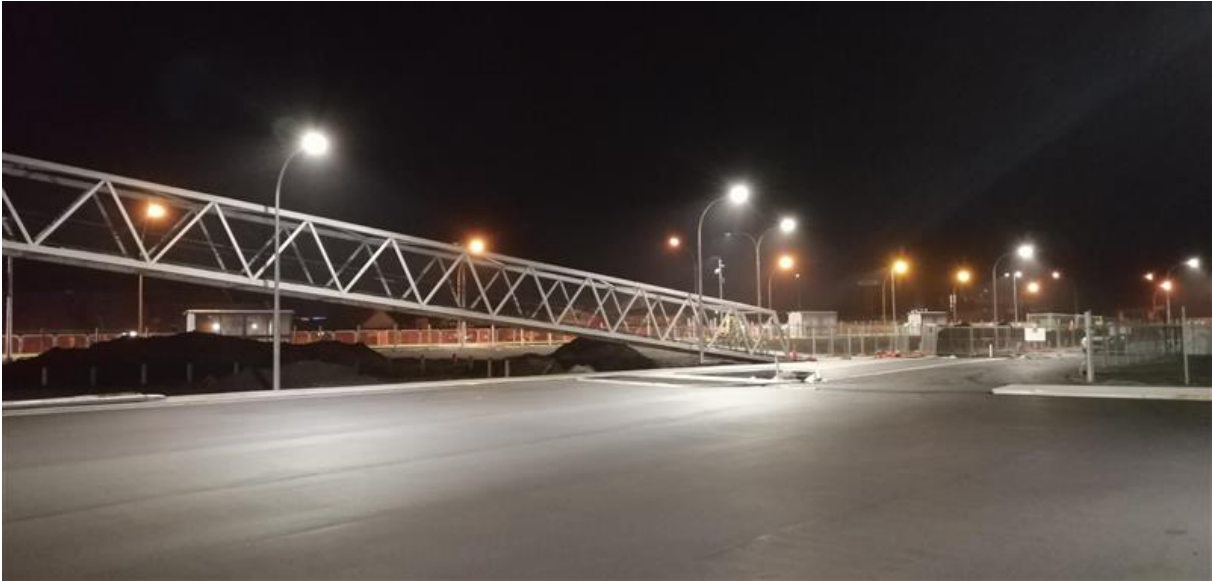
Lighting complete in the Park and Ride

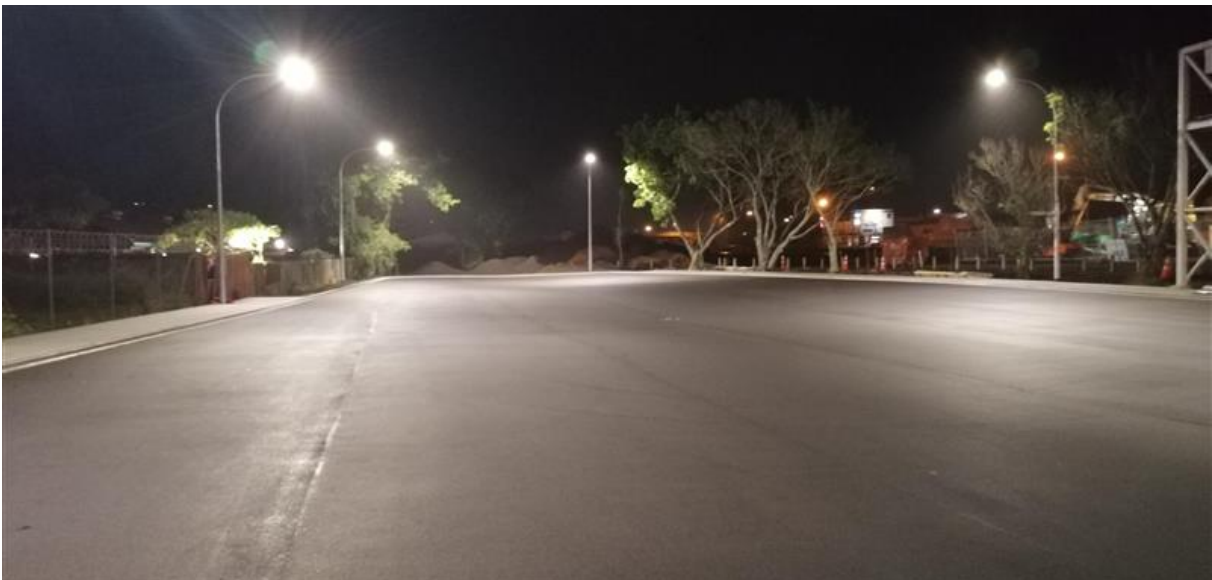
Asphalt surfacing in the car park well underway

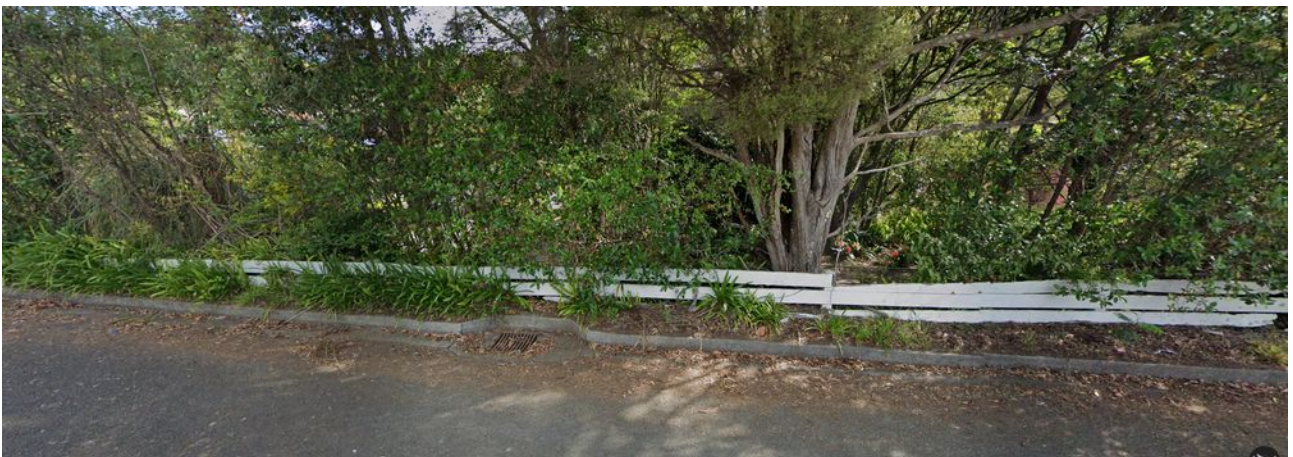
Possible council fence, but could be land owners fence. Hard to determine. In good nick and doesn't have typical council look. Runs along boundary of 23 Upland Road.

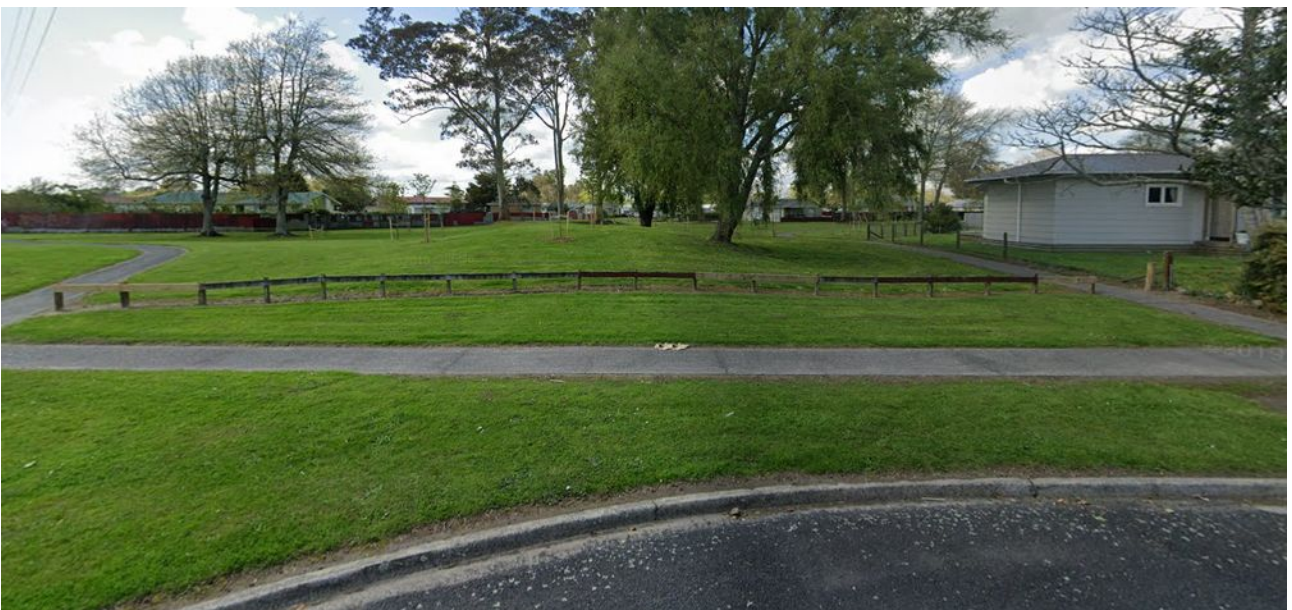
Meyer Street end some sections are white (but covered so badly by mould and algae they look black). These likely would do well to be painted brown like other section of this barrier.

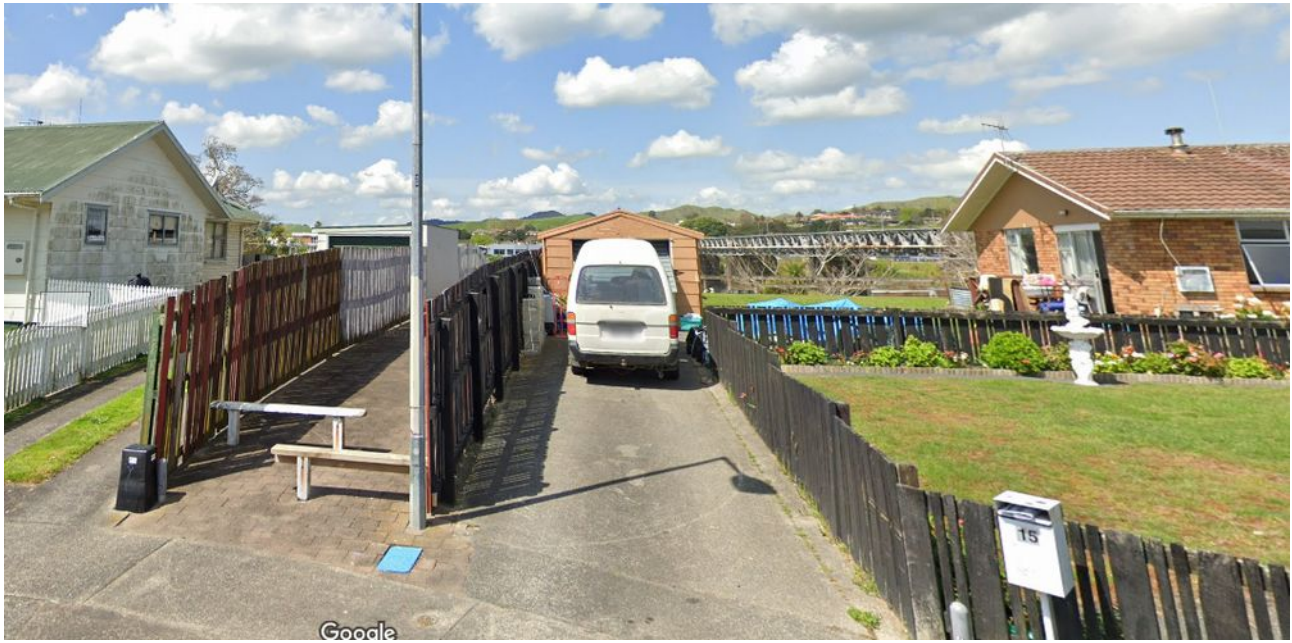
George Clay Place, at the cul-de-sac, barriers to walkway painted white.

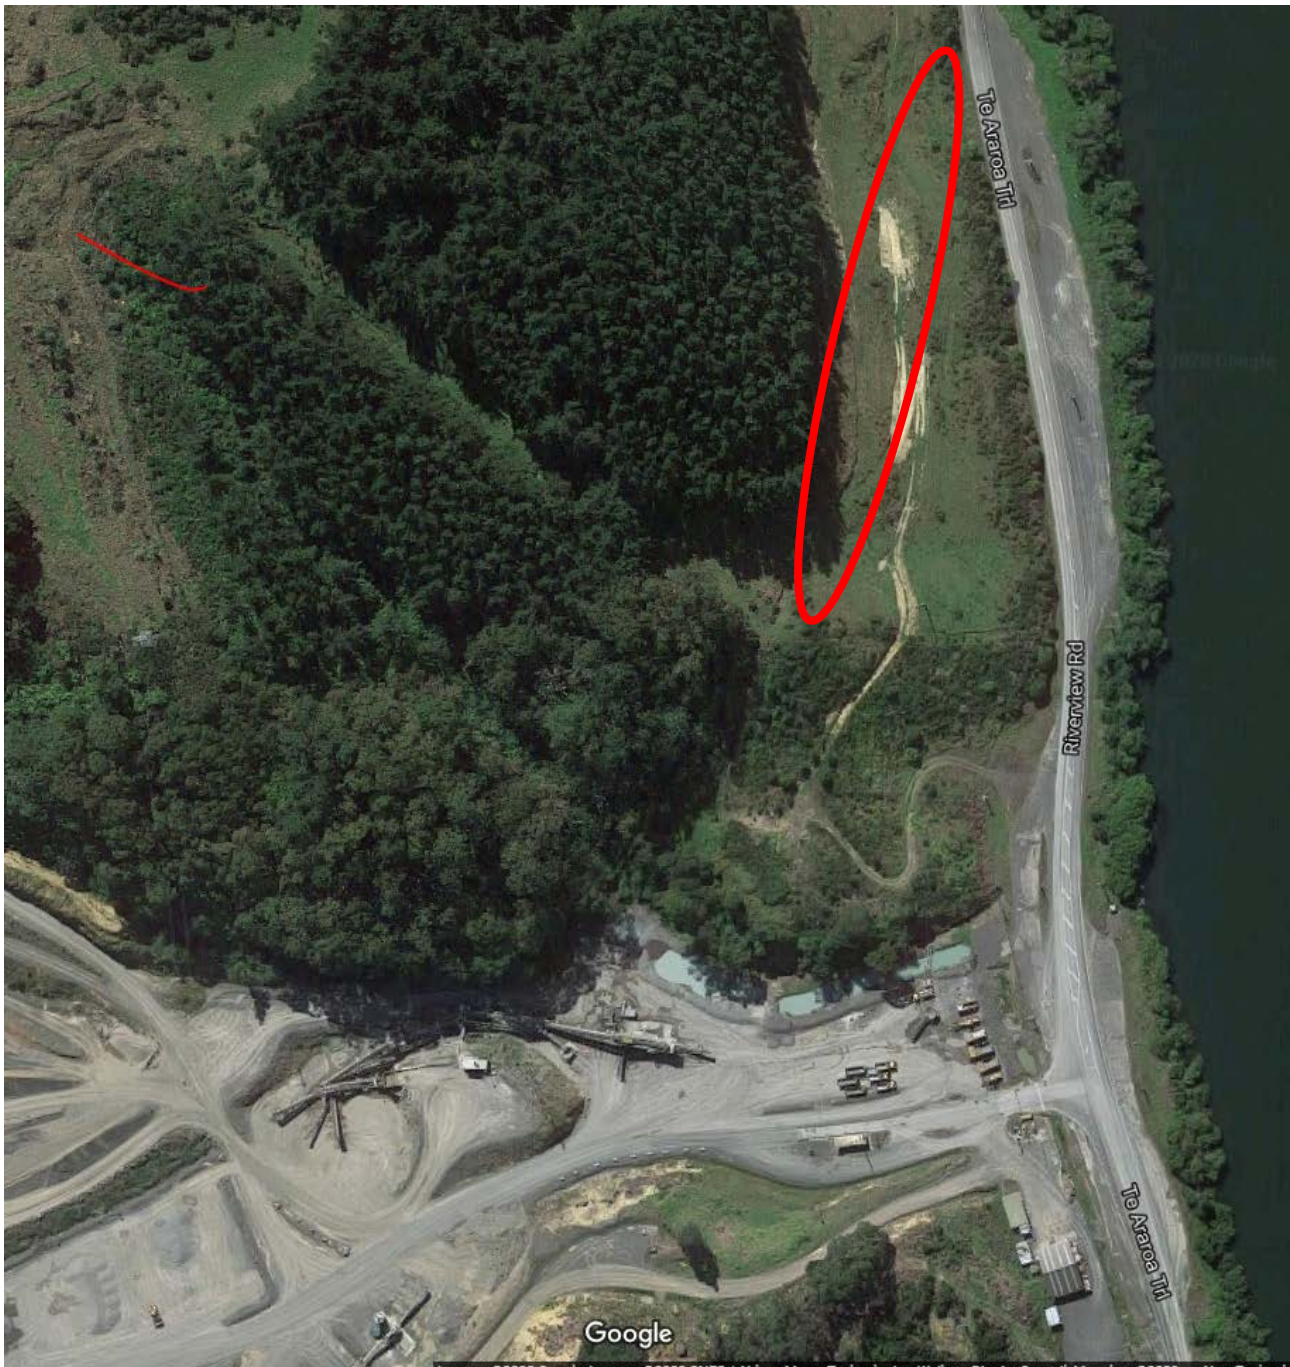
The word on the street is that the dust is caused by trucks using the road side gravel areas outside of the quarry operational area. These are highlighted in the figure below.

What I observed was a systemic use of these gravel areas as part of the quarry operation, and they were treated as though they were owned by the quarry. And the locals were correct, these were sources of significant dust movement.

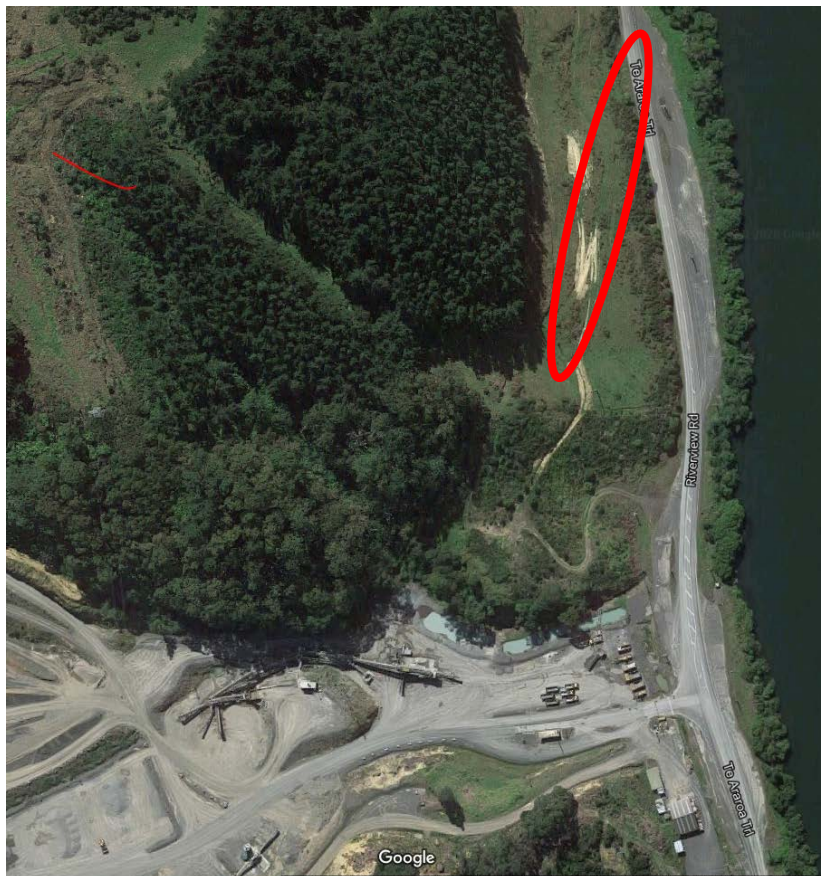
This screen shot shows the south bound gravel area where the trucks were pulling off.

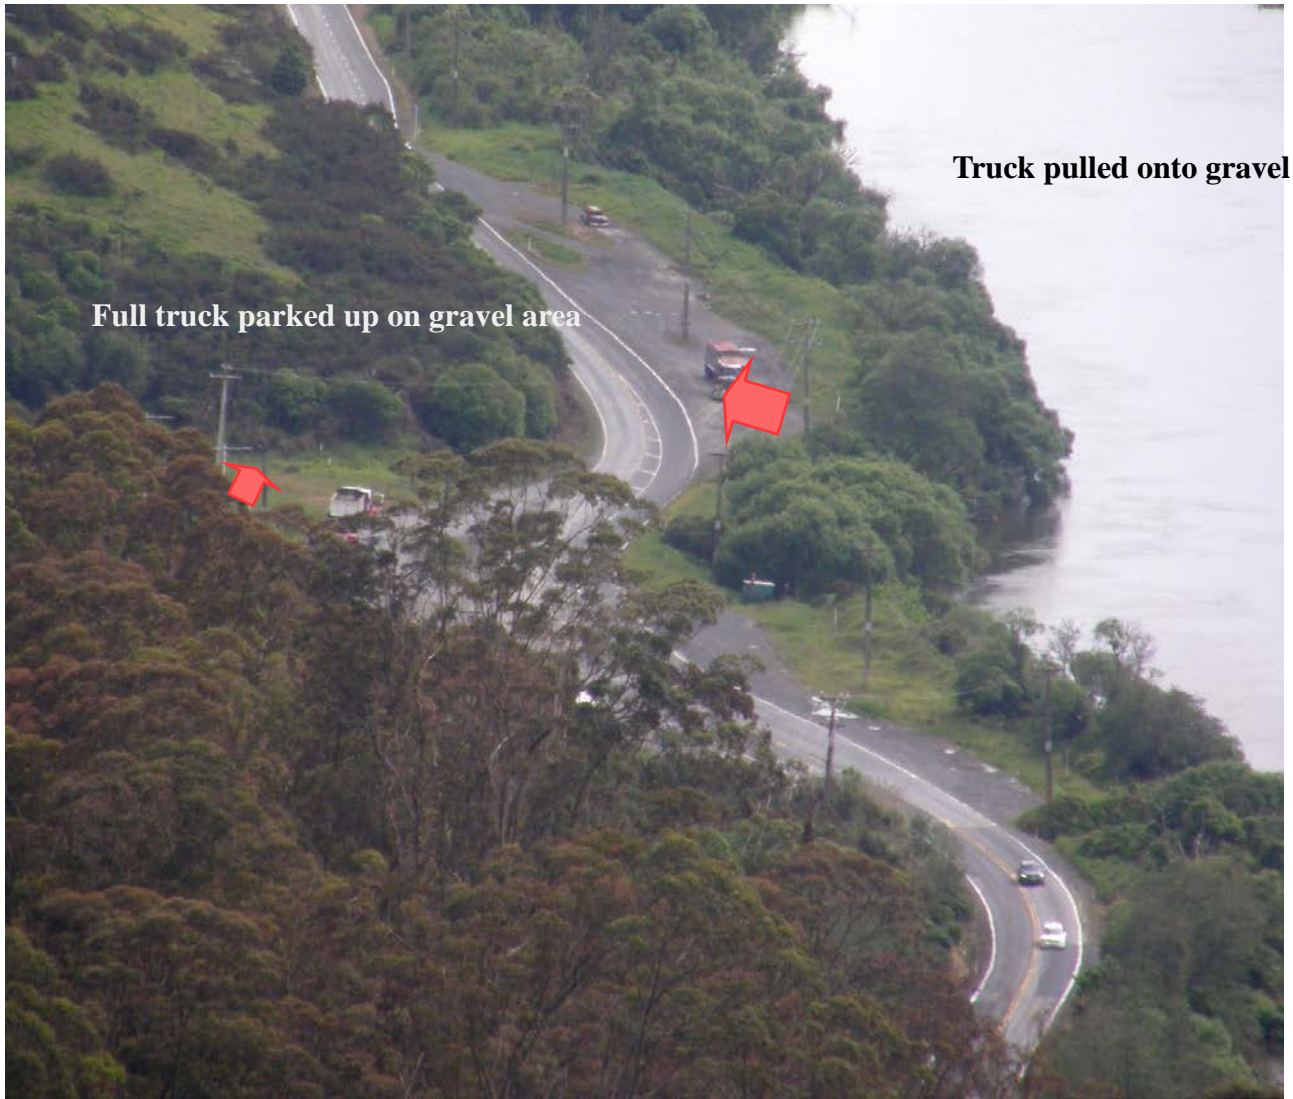
An example of a truck pulled off the road, onto the gravel area to remove its cover is shown below. Also note another truck parked up on gravel on the other side of the road. This will be discussed later. Also obvious is the change in colour of the road surface due to dust. The quarry traffic has transported enough dust to cause a major colour difference

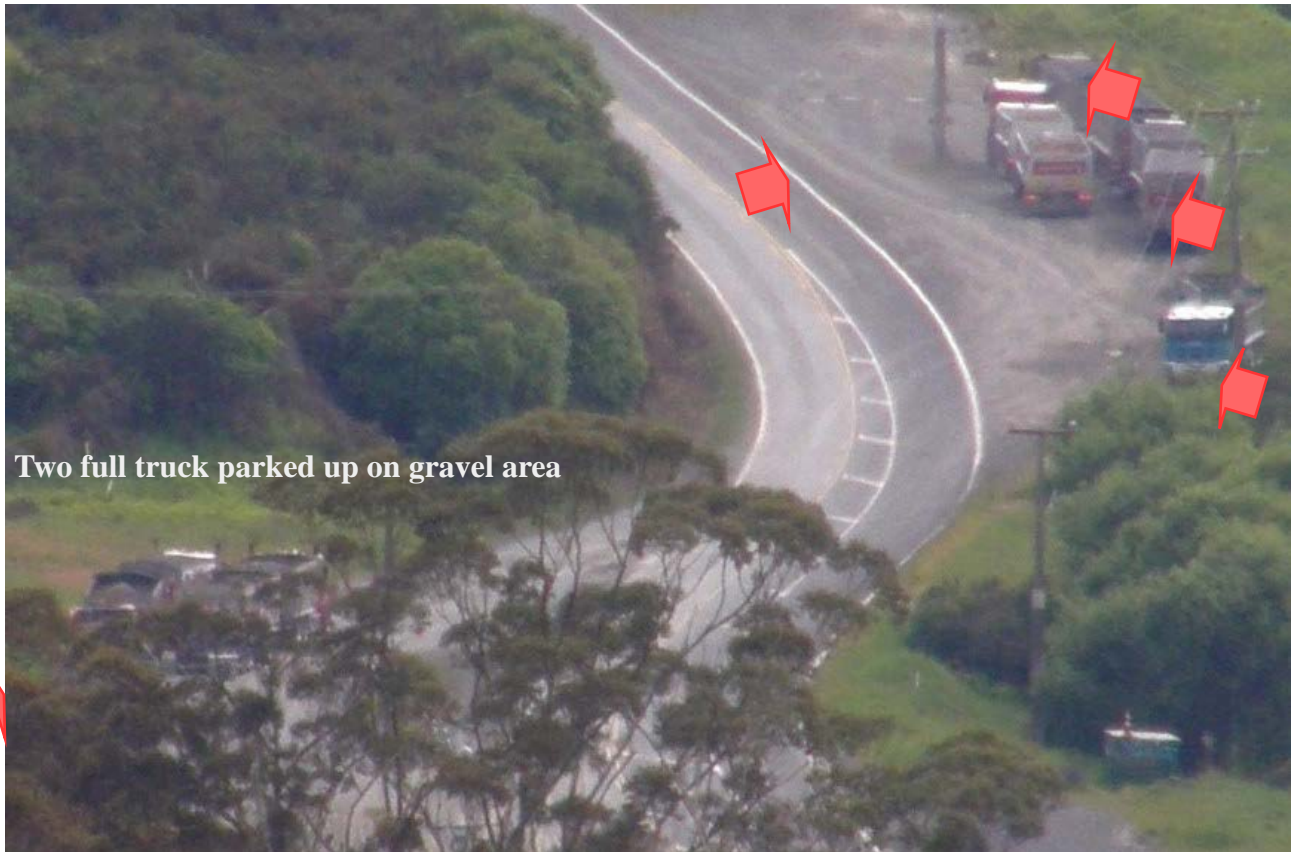
Another example is shown over the page. In this case there are four trucks parked up on the southern direction pull off area. Also there are two trucks in the northern direction pull off area.

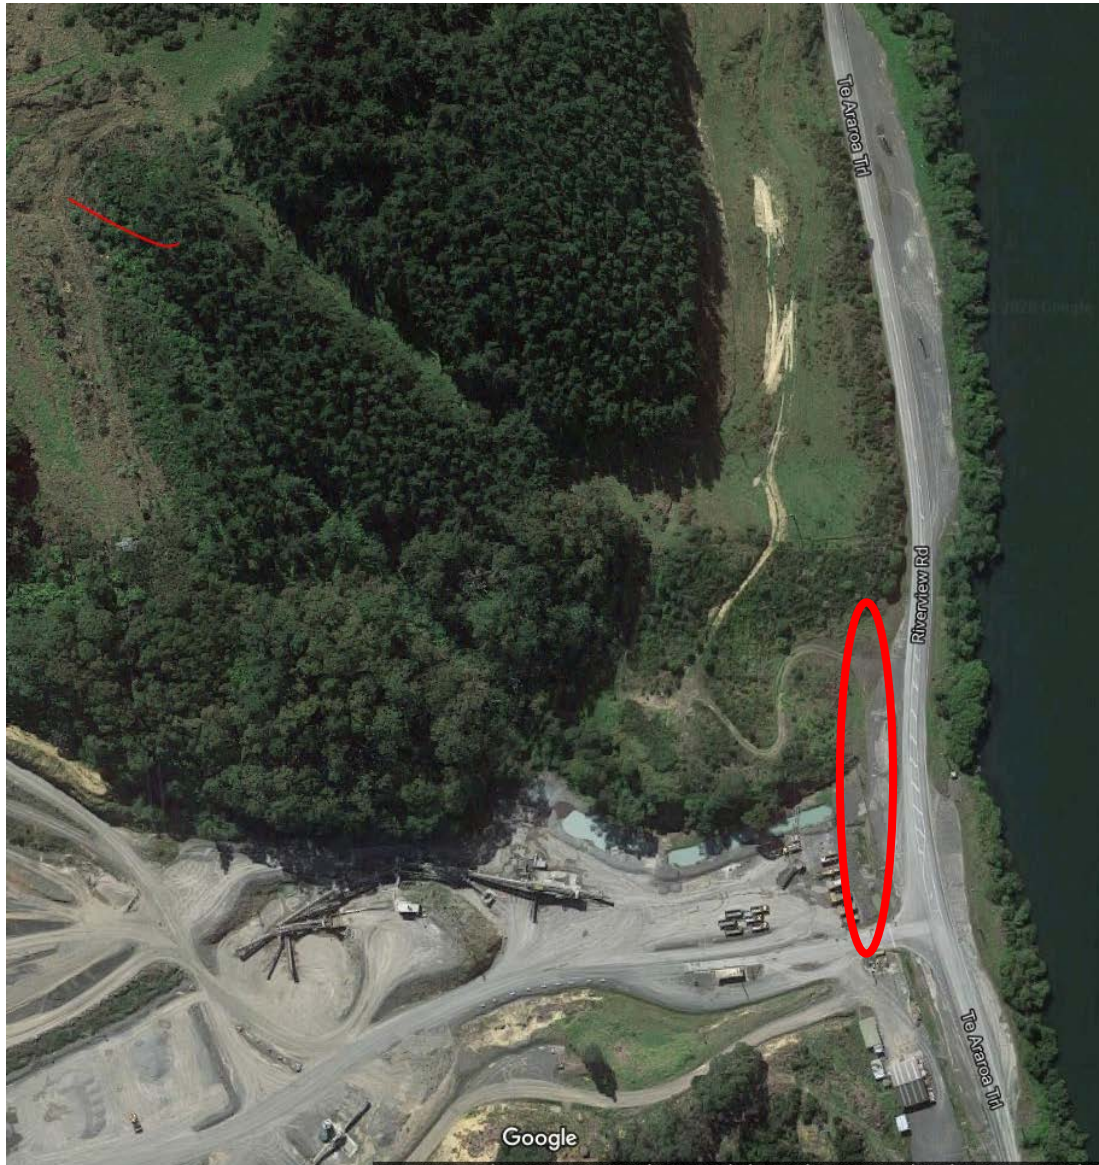
The unsealed gravel area outside the quarry gates is shown in the screen shot below.

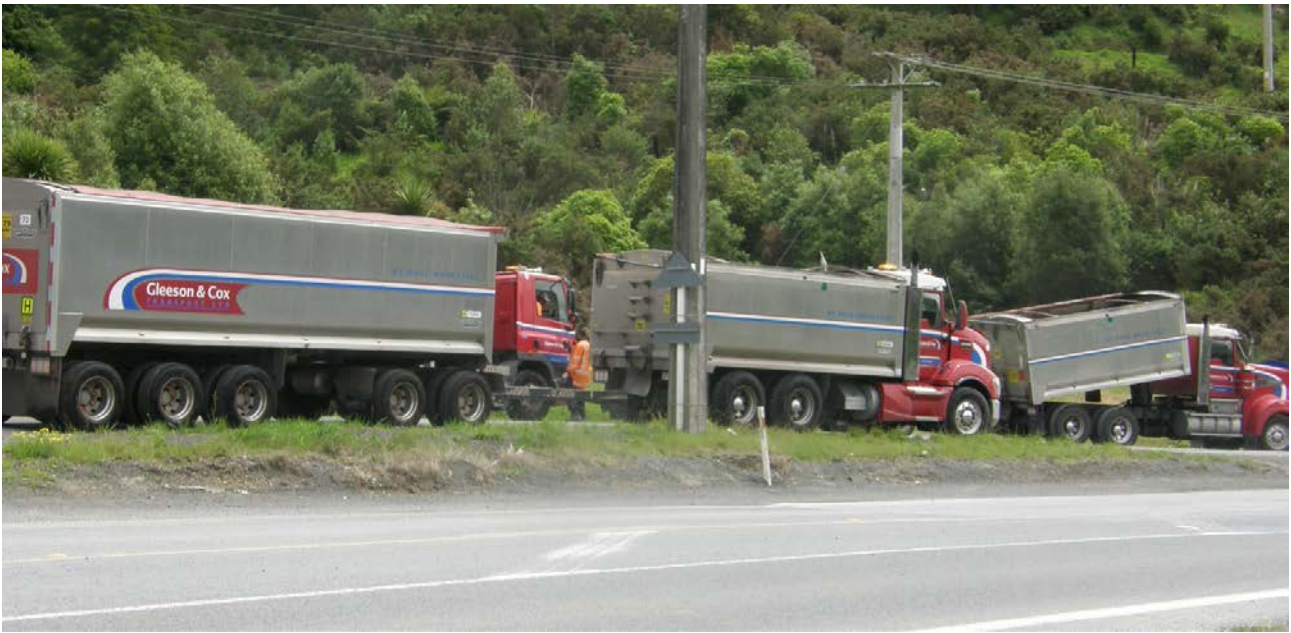
Thus it appears that there is no parking on the quarry site where these important functions can be undertaken. An example of the trucks lined up in this area is shown below. This photo shows three trucks parked up, a fourth was also present at this time but is not in the photograph.

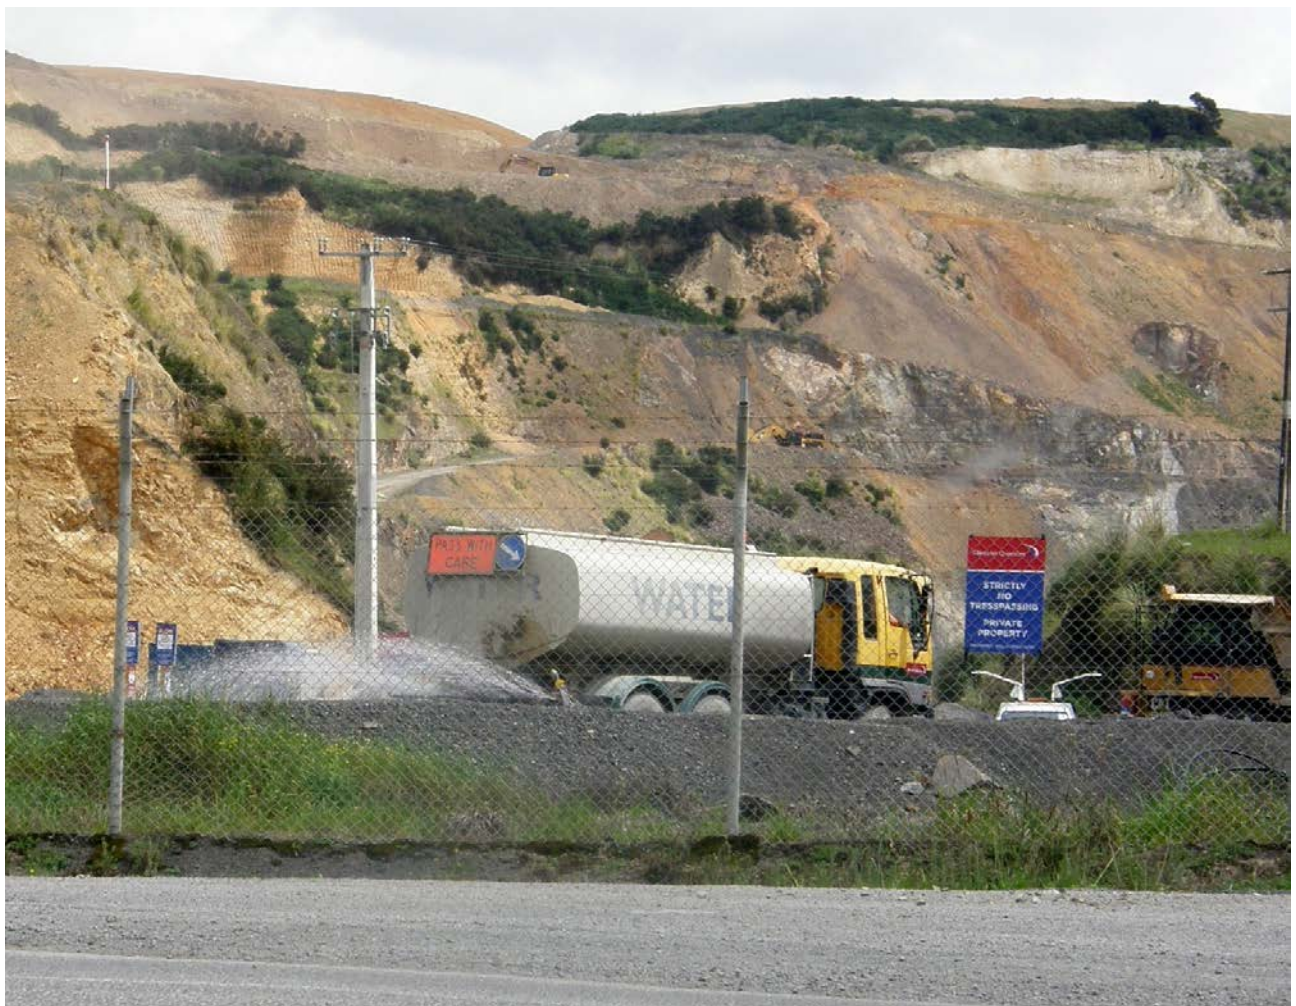
It was noted that a water truck was spraying water over the quarry roadways during time spent observing the quarry entrance. A photo of this is shown below. It was noted that the truck came up from the back of the quarry, through the front road ways before heading back into the quarry. Thus clearly the water truck does not come out of the quarry and apply water to the pull off areas next to the road that are being used as part of the quarry operation
