# Preliminary Site Investigation and Detailed Site Investigation

## Proposed Huntly Managed Fill – Fill Area 3

Prepared For: Paua Planning Limited

Date: 31 August 2021

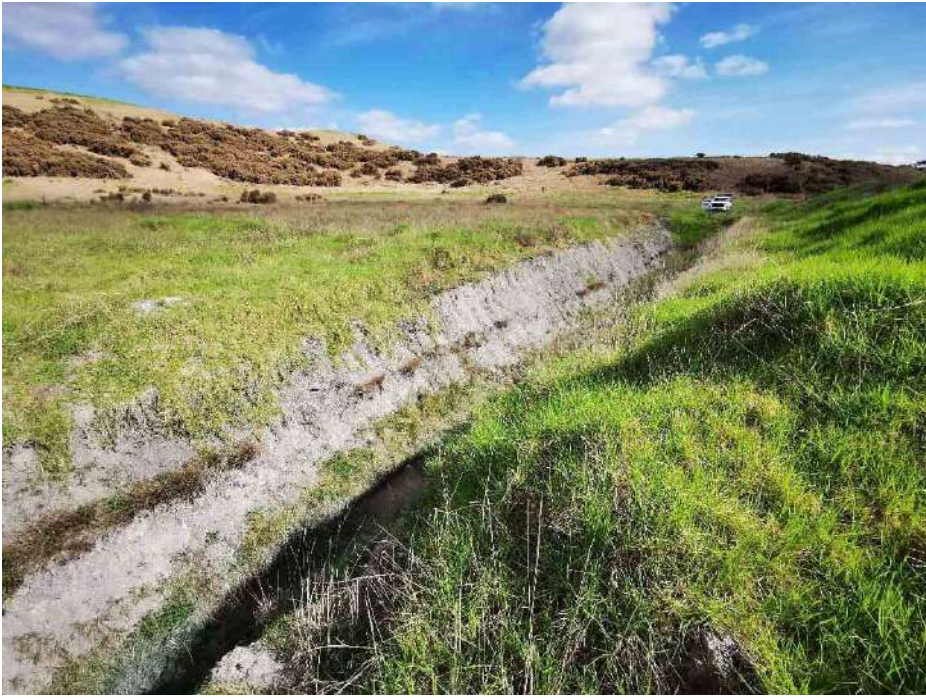
Client Name: Paua Planning Limited		Site Location: 310 River View Road, Huntly	Date: 7 April 2021
<b>Photo No.</b>	<b>1.</b>

Direction Photo Taken: West			
Description: One of the open drainage trenches noted near the centre of the site.			
<b>Photo No.</b>	<b>2.</b>

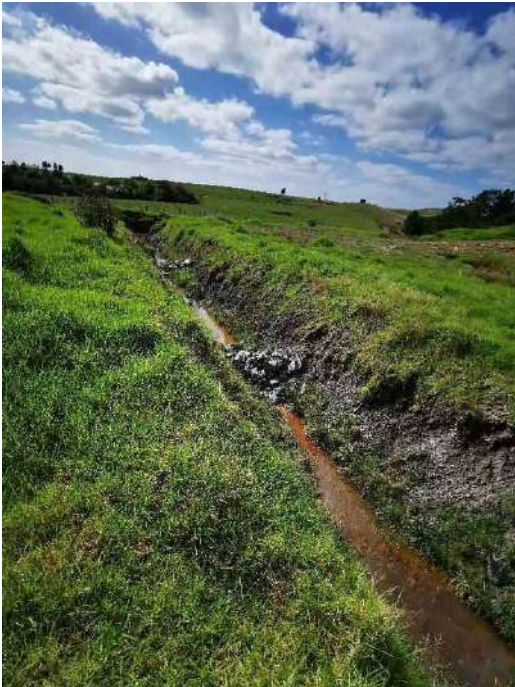
Direction Photo Taken: North			
Description: Open drainage trench running towards the northern site boundary.

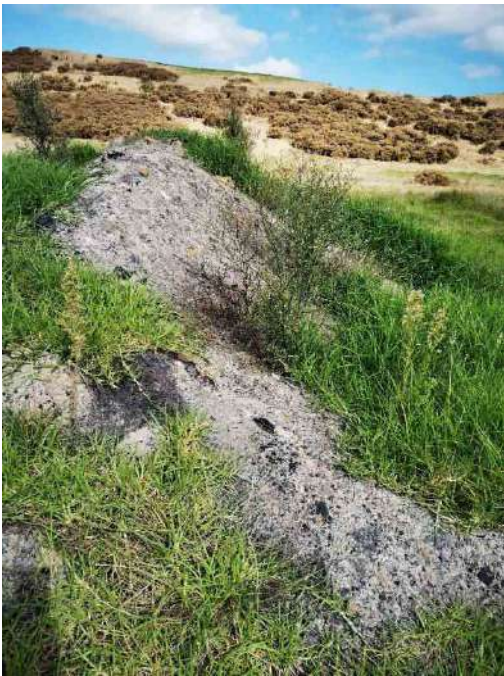
<b>Photo No.</b>	<b>3.</b>

Direction Photo Taken: NA			
Description Coal fragments note in excavated material placed next to open drainage trench.			
<b>Photo No.</b>	<b>4.</b>

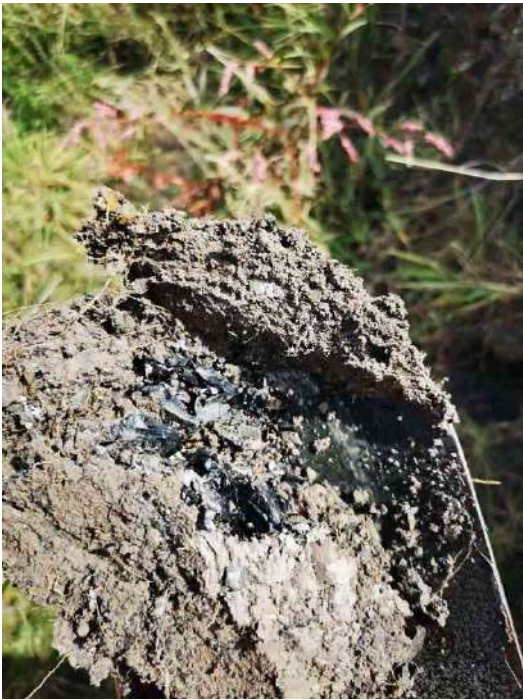
Direction NA			
Description: Coal fragments embedded in soil obtained from the side wall of open drainage trench.

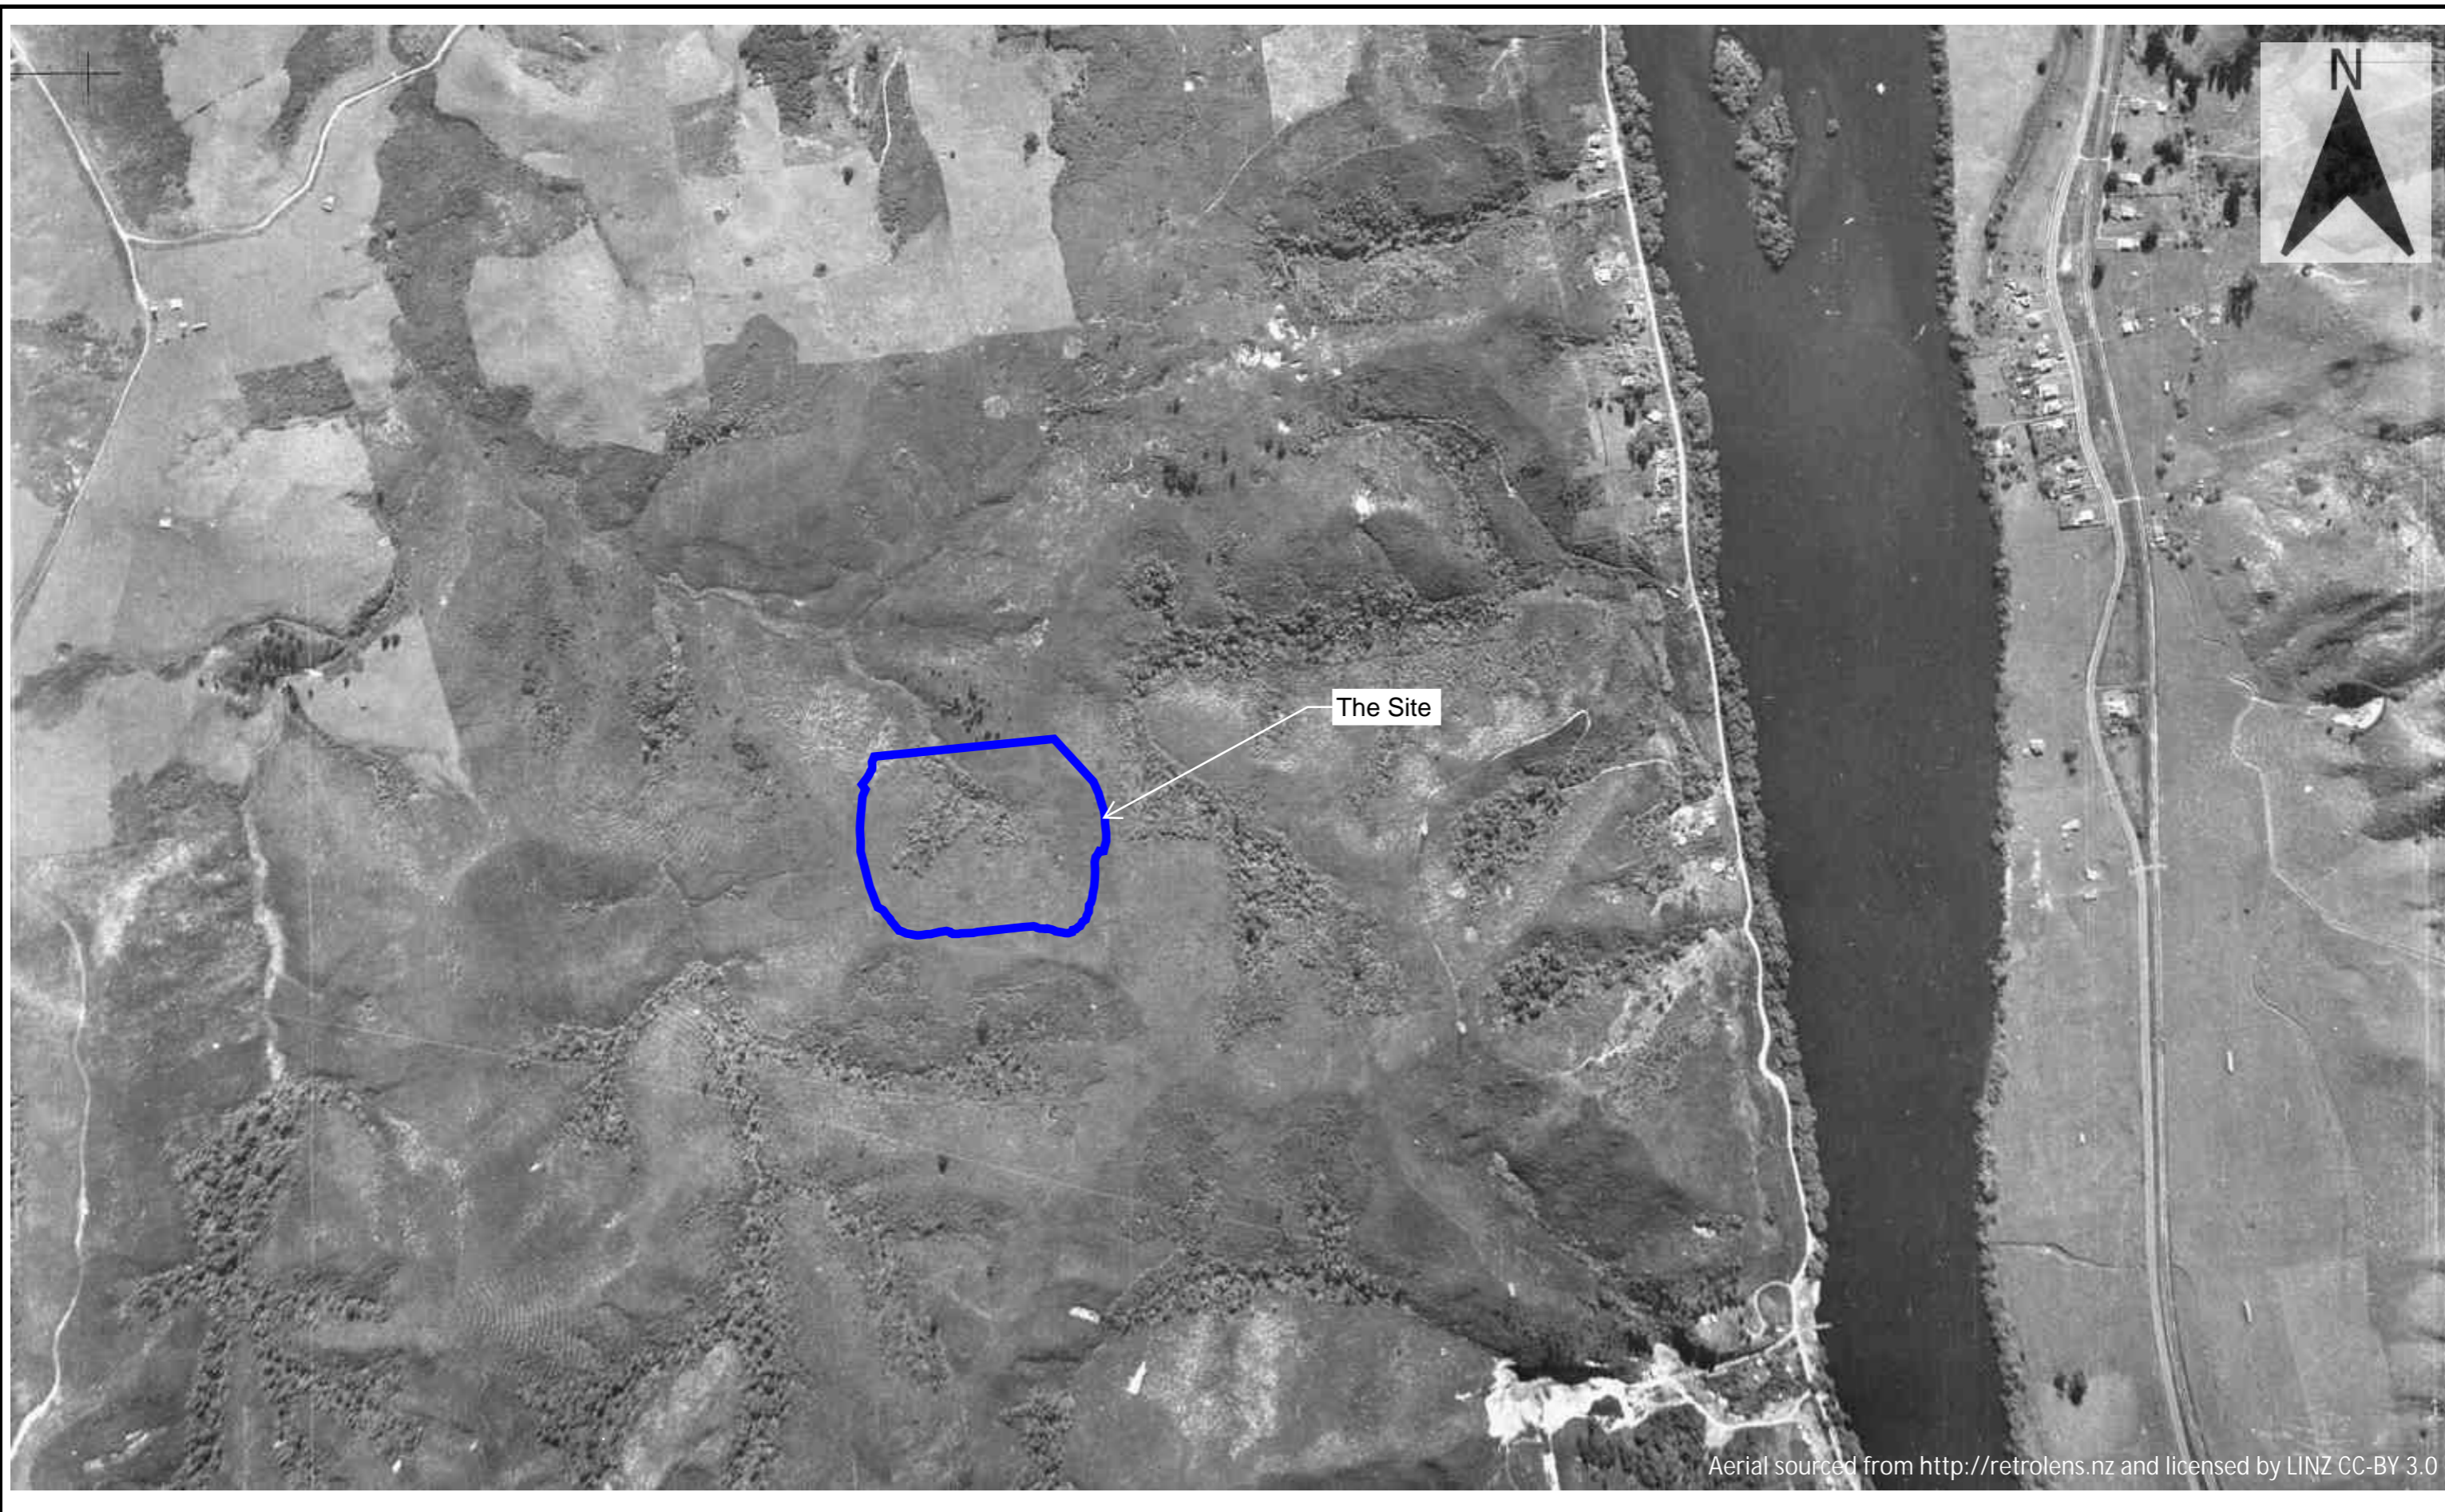
Project Fill Area 3 - Proposed Huntly Managed Fill  
 Title Historical Aerial Photograph - 1941

Year	Site	Surrounding Land Use
1941	The site and the immediate surrounding areas appear	The Waikato River and Riverview Road are located approximately 850 m to the east of the site.

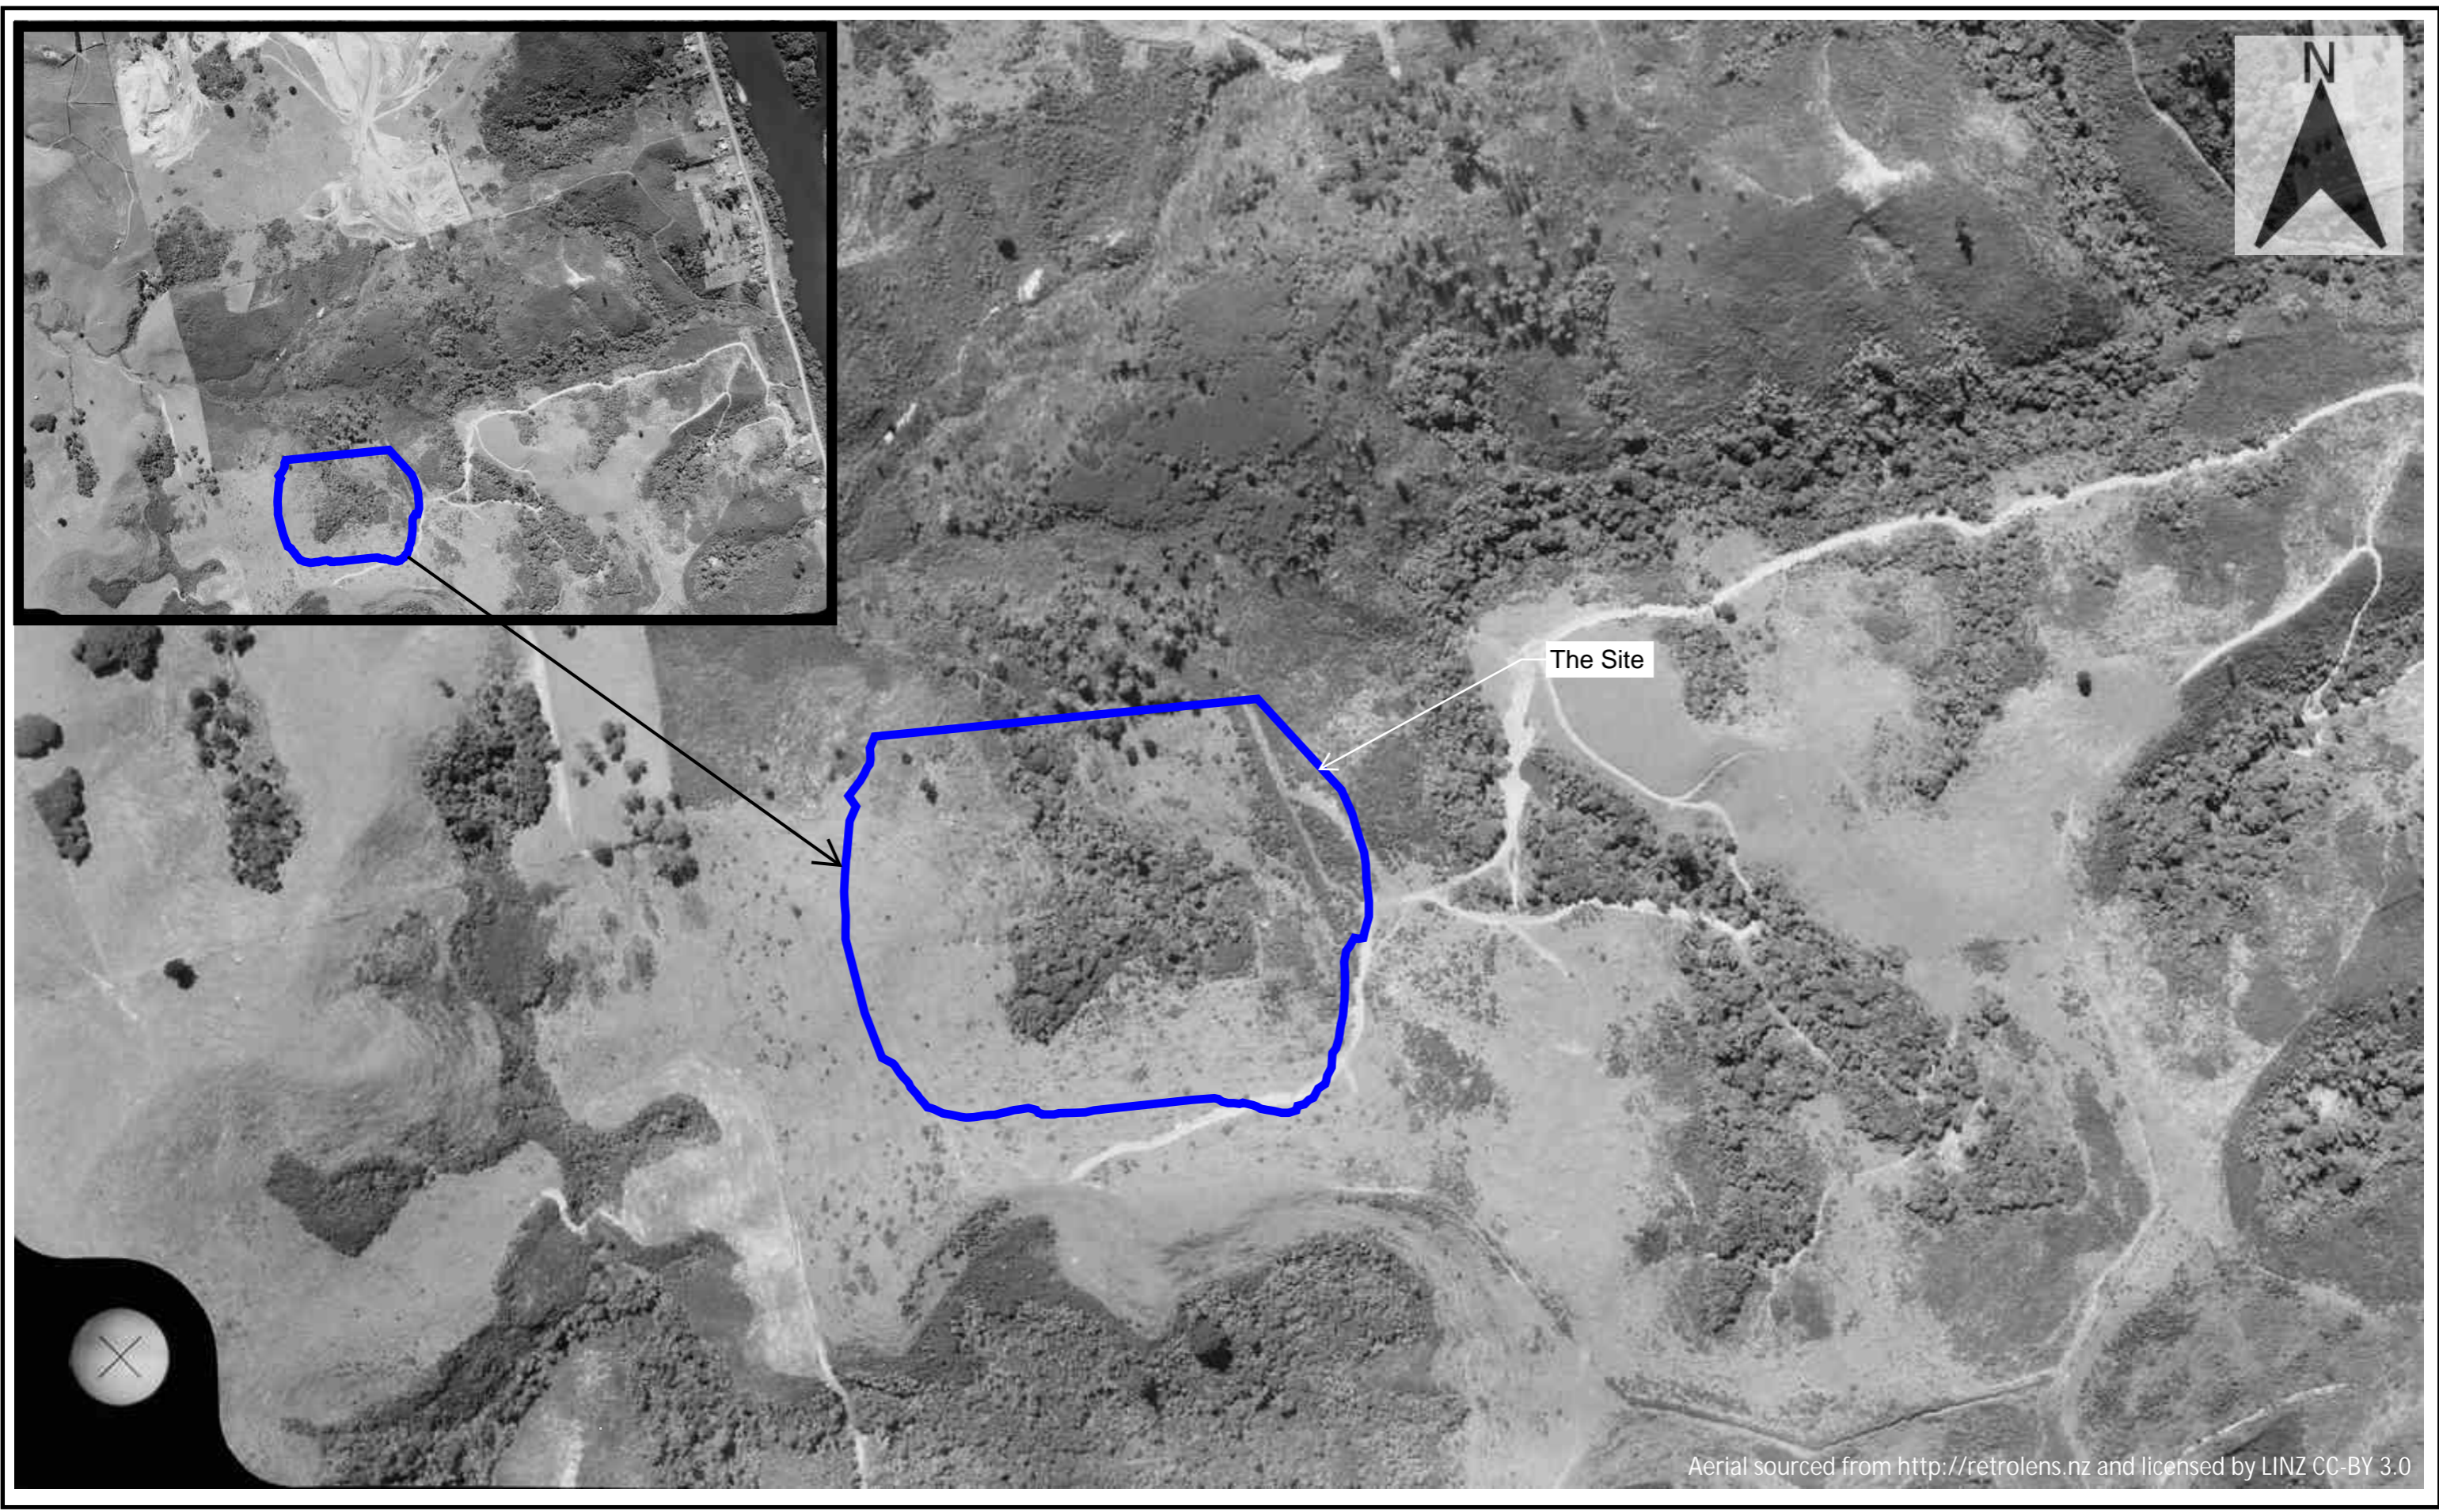
Project Fill Area 3 - Proposed Huntly Managed Fill  
 Title Historical Aerial Photograph - 1957

Year	Site	Surrounding Land Use
	to be vacant and covered by vegetation.	Pastoral farmlands are visible some 500 m to the north and west of the site. The Huntly Quarry operation appears to have started but in a rather small scale.
1957	No significant changes apparent at the site. However, unpaved access tracks off Riverview Road have been established to provide access to the site.	Large scale earthworks believe to be in association with the O'Reilly's opencast coal mine are being undertaken at a property some 600 m to the north of the site. Additionally, more properties to the west of the site have been converted to pastoral farmland.
1966	No significant changes apparent at the site. An unpaved access track is connecting the site and the quarry pit to the north.	A small-scale quarry pit is located approximately 100 m to the north-east of the site. Three additional mine pits are visible to the further north. The Huntly Quarry operation has expanded significantly comparing to the 1941 image.

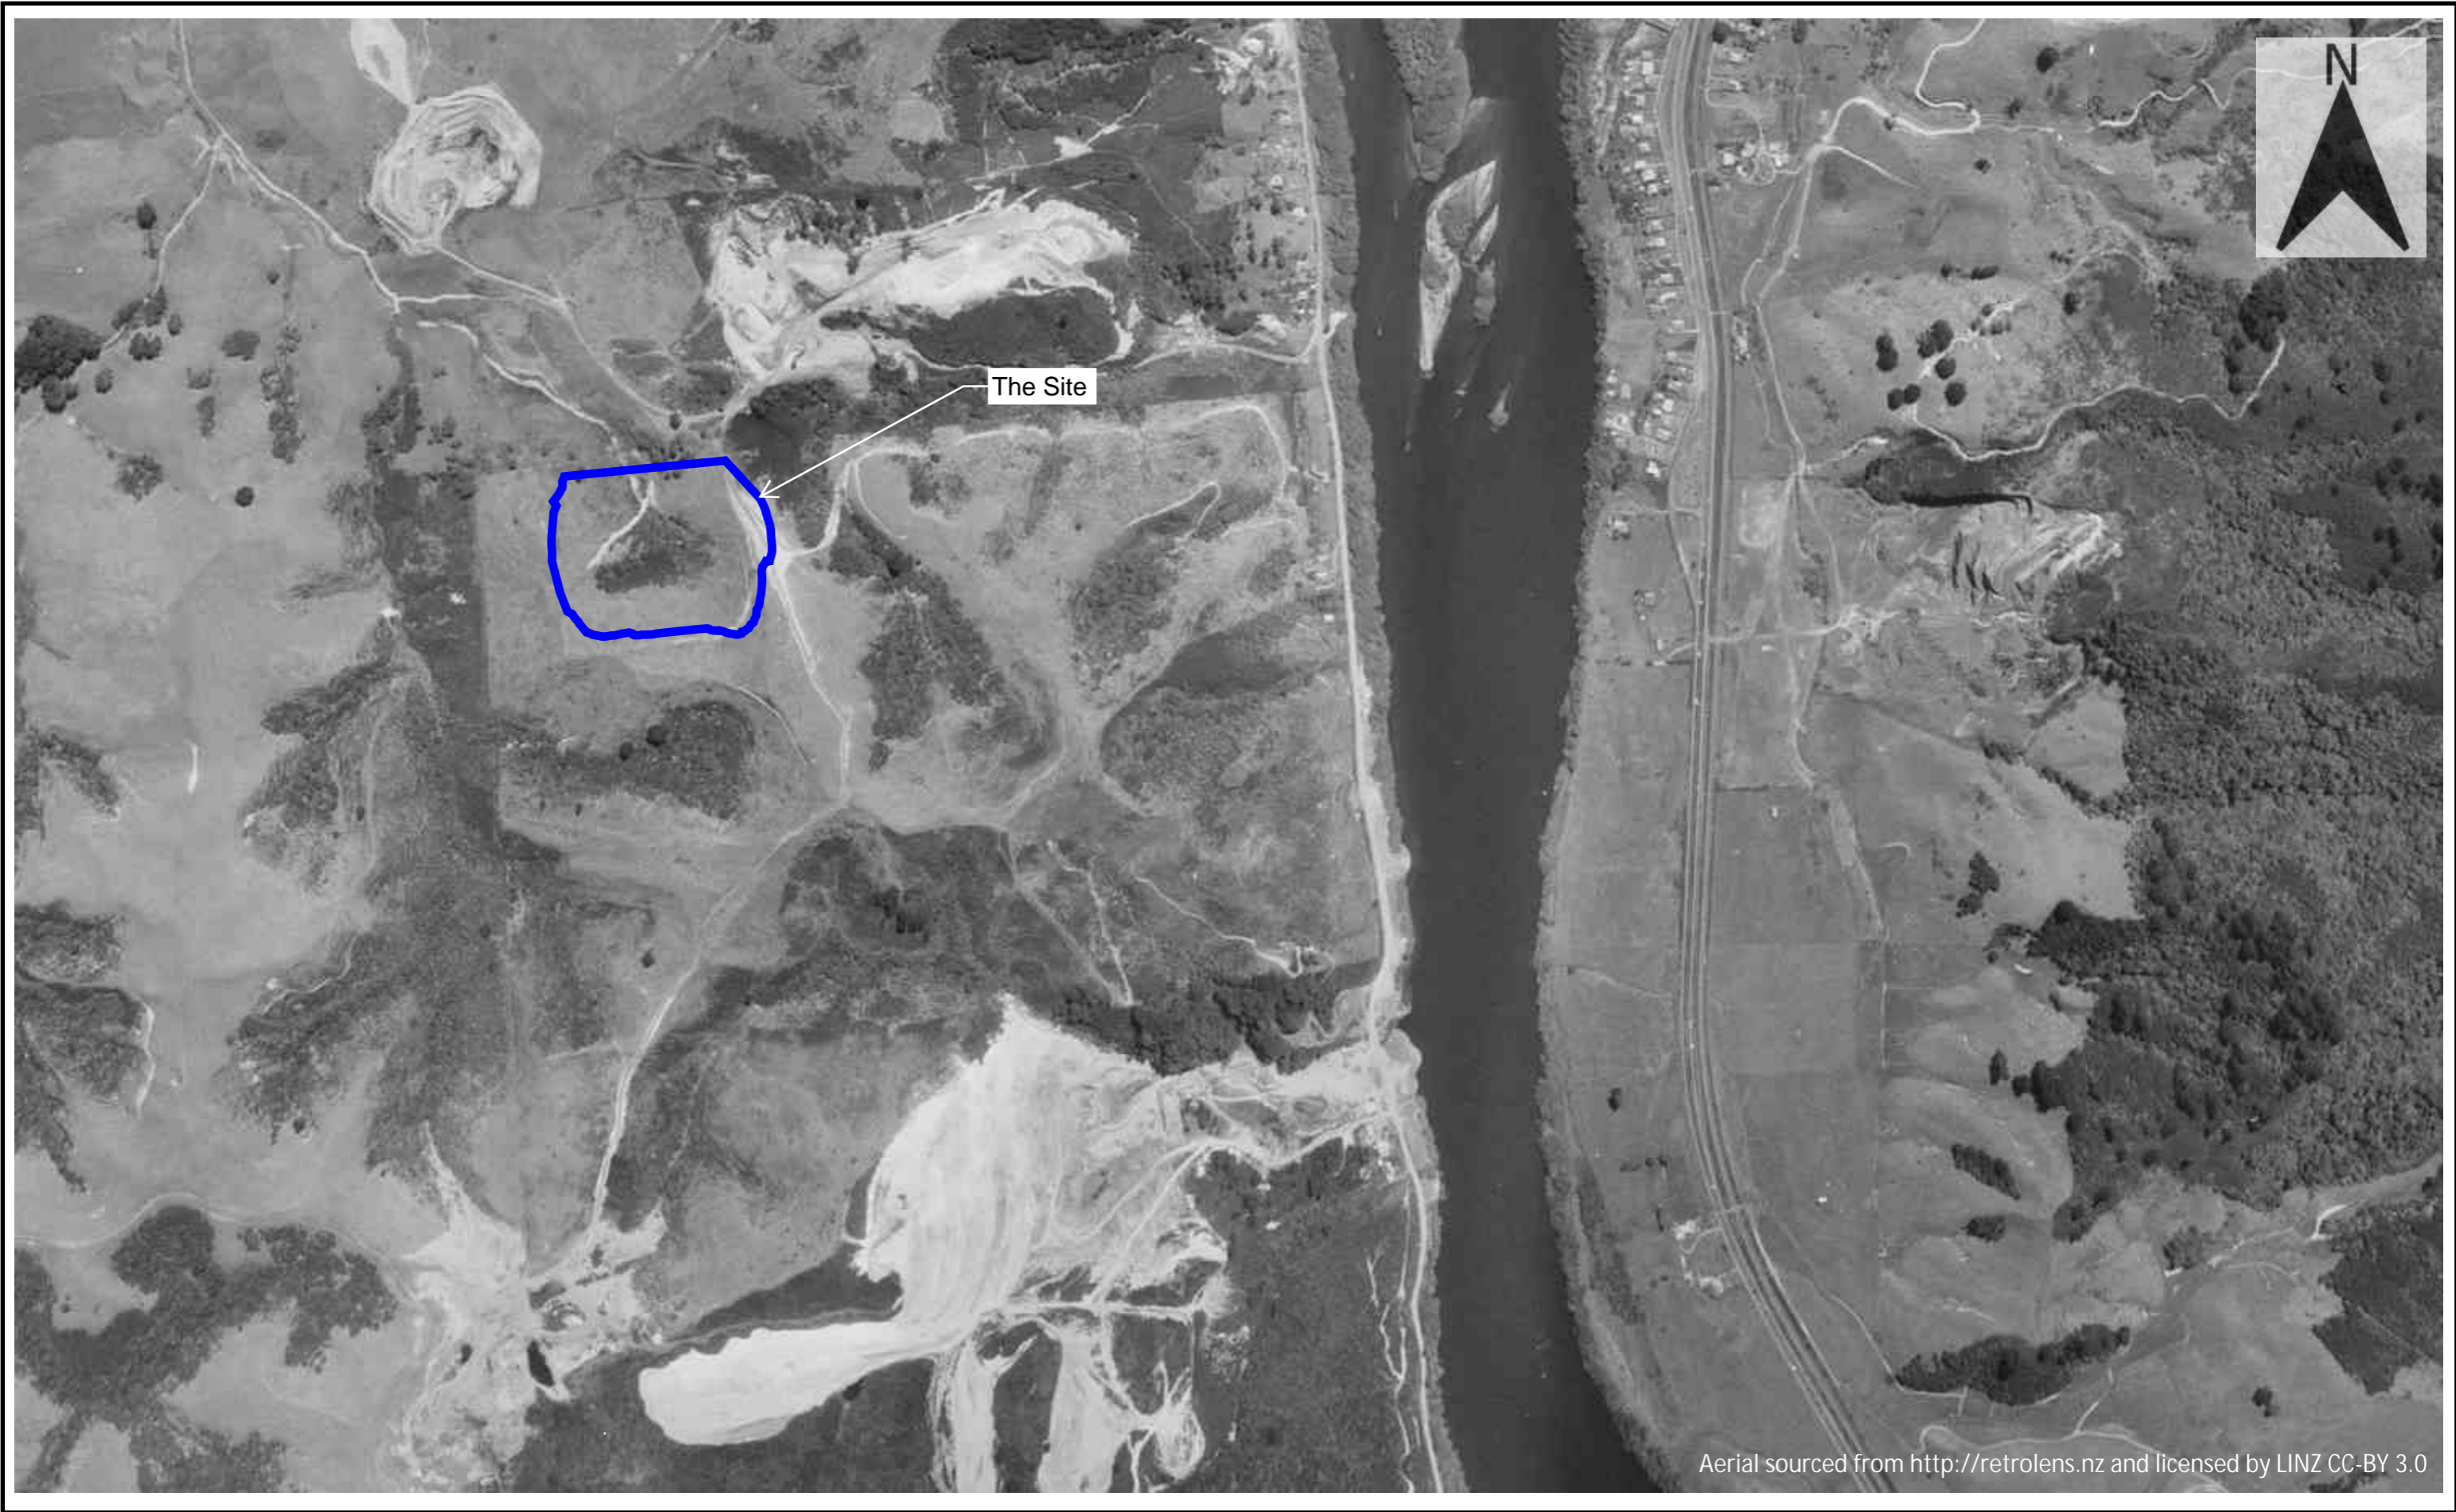
Project Fill Area 3 - Proposed Huntly Managed Fill  
Title Historical Aerial Photograph - 1973

1973	No significant changes apparent at the site but more unpaved access tracks have been established to the north of the site.	The quarry pit to the north-east has doubled in size and a new open pit is visible to the north-west of the site. The Huntly Quarry has been further expanded towards the west.
1979	Vegetation near the centre of the site has been cleared and a small pond is present.	The adjacent quarry pit has been further expanded, however, the mine pit to the north-west of the site had been backfilled.
1995	No significant changes apparent at the site.	The quarry pit to the north-east has been partially backfilled and some of the surrounding areas have been re-vegetated.
2002	No significant changes apparent at the site.	Filling of the adjacent quarry pit continues.
2010	No significant changes apparent at the site.	A new quarry pit has been established to the north of the site. The former quarry area to the north-east had been filled and the area is covered by grass.

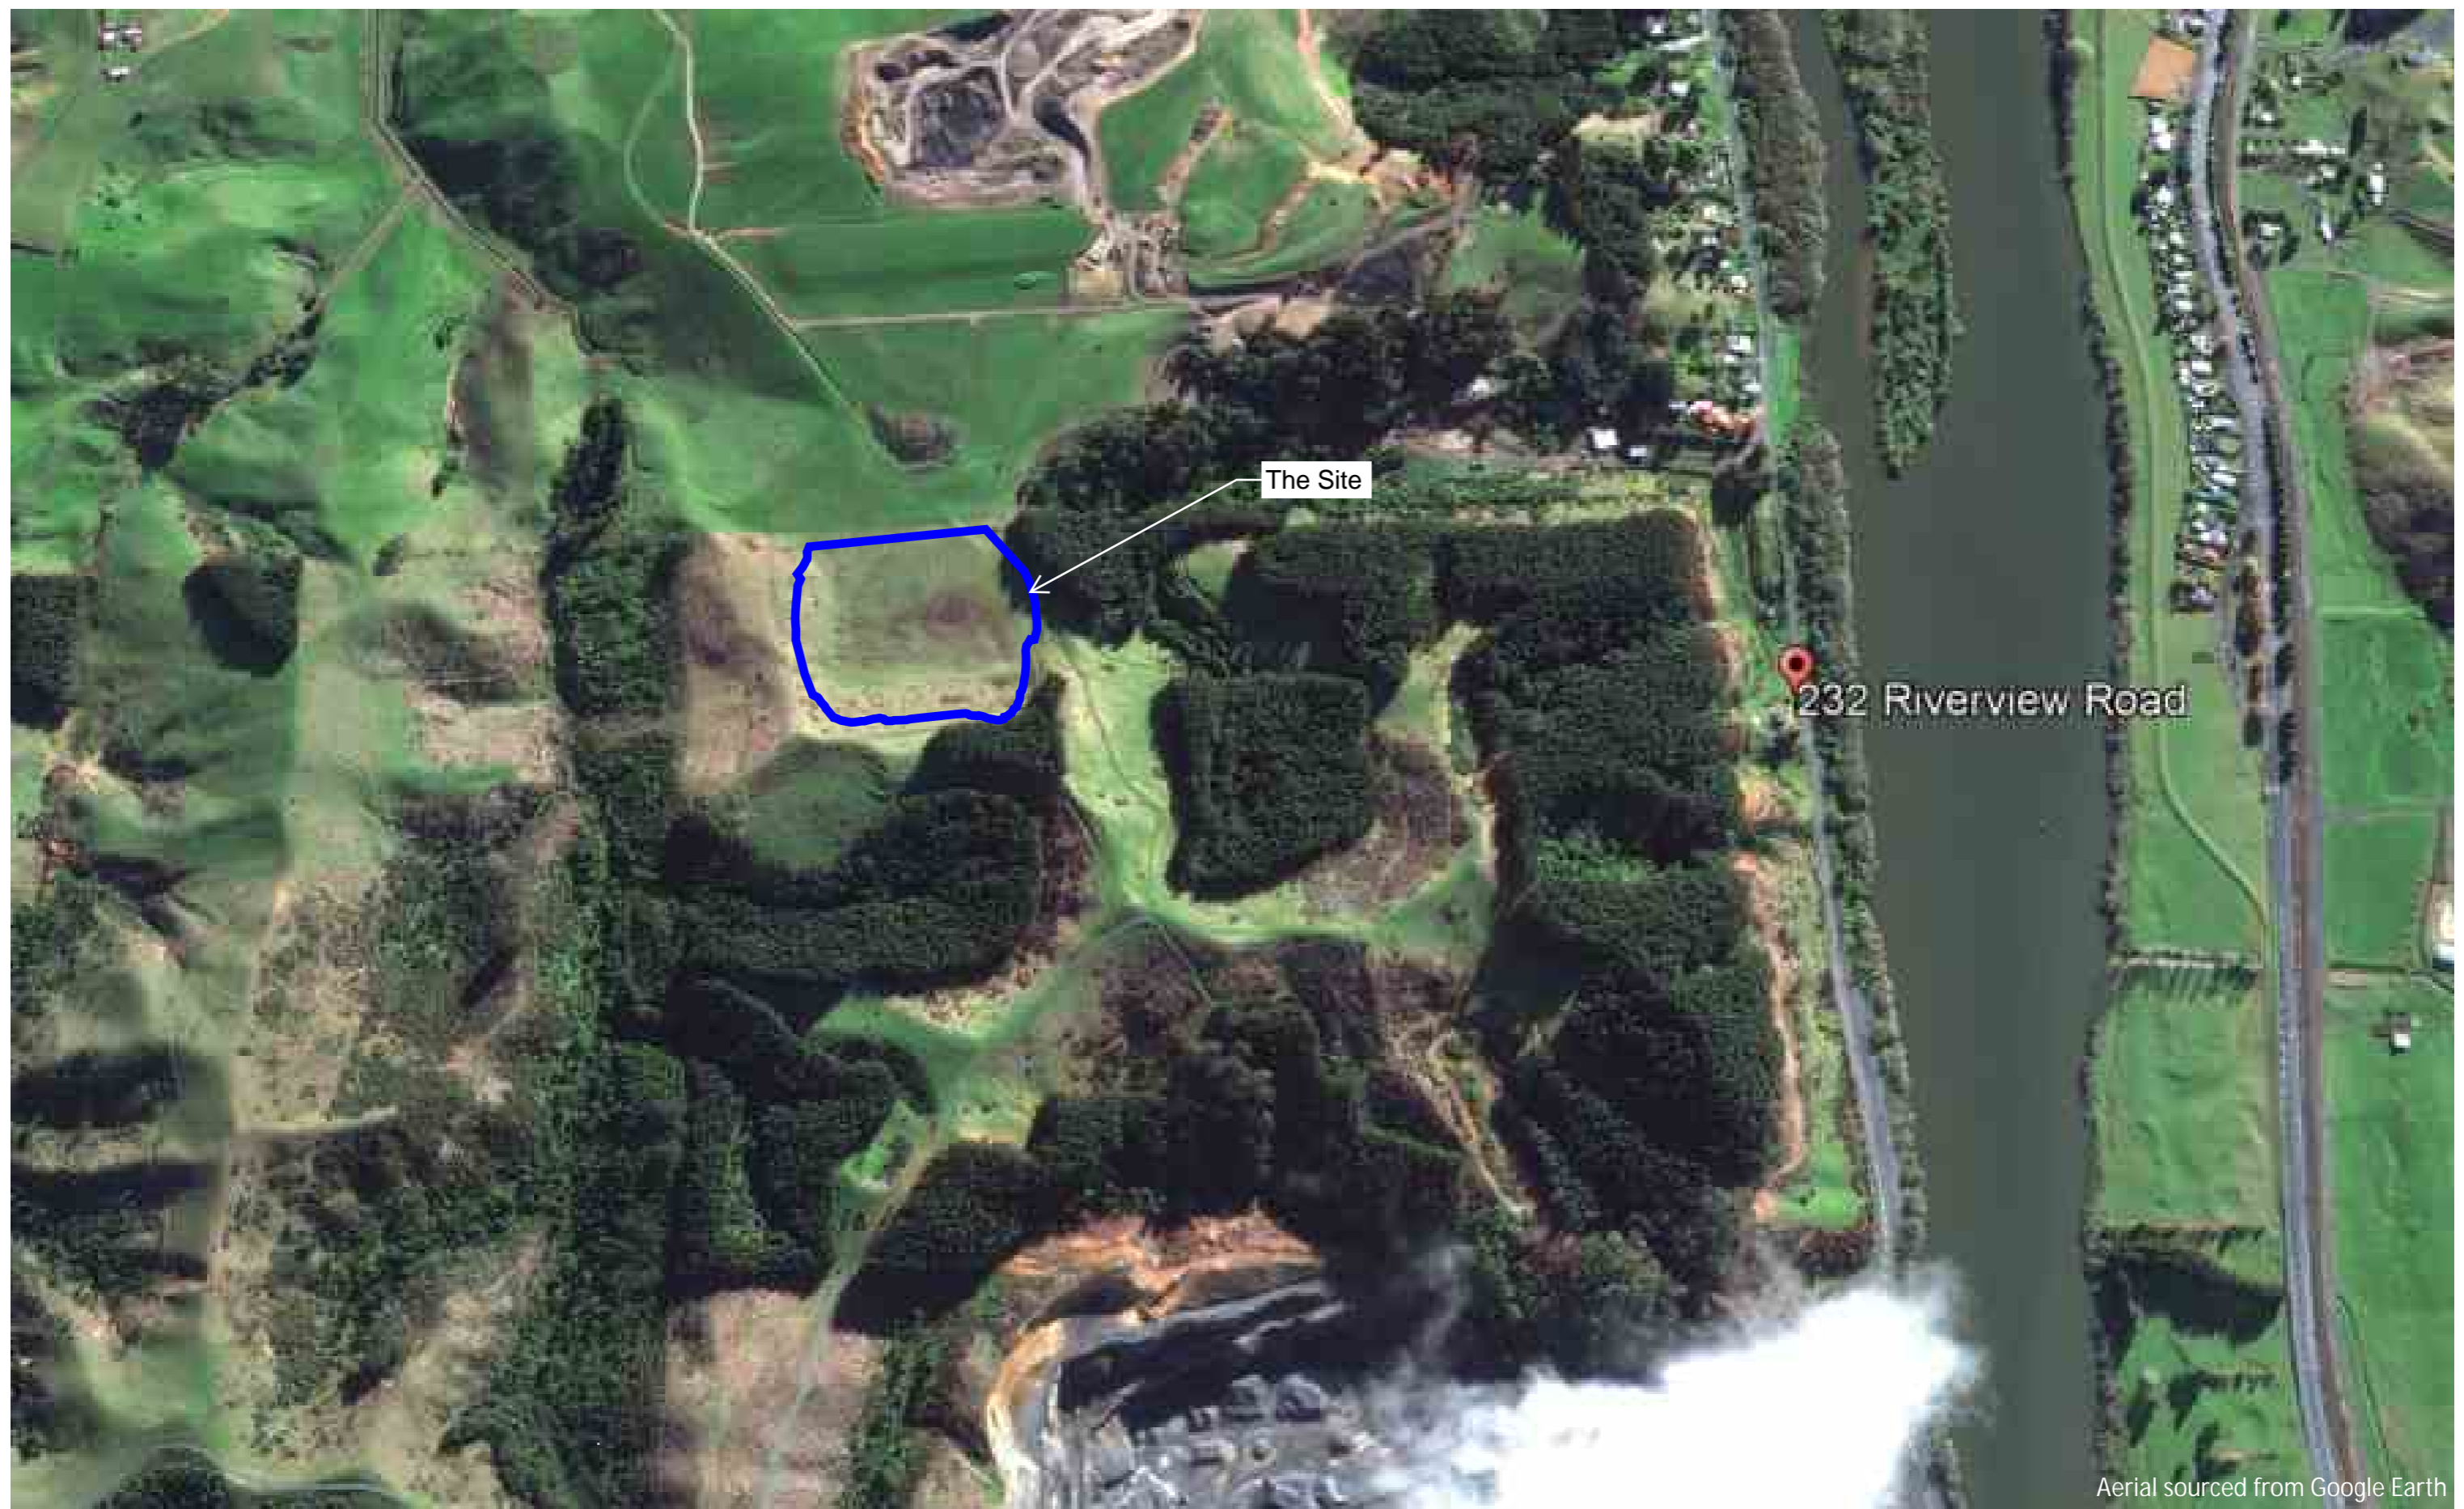
Project Fill Area 3 - Proposed Huntly Managed Fill  
Title Historical Aerial Photograph - 2010

2018	No significant changes apparent at the site.	The new quarry pit visible in the 2010 image had been backfilled.
