# Gleeson Quarries Huntly Limited – District and Regional Resource consents for new fill sites within quarry landholdings

Ecological Impact Assessment  
Prepared for Gleeson and Cox Limited  
14 November 2019

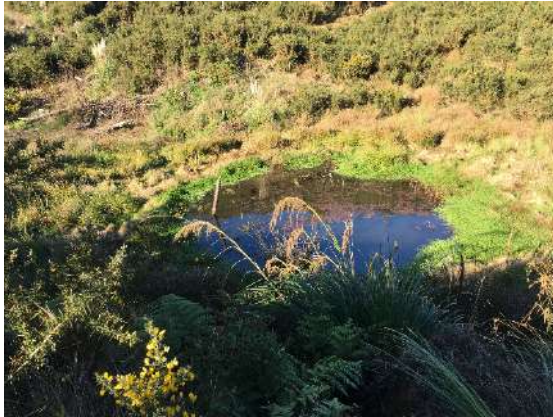
Figure 1: View of wetland located in Fill Area 2 from the true left bank.

A small patch of wetland and open water is situated approximately two thirds up the gully (Figure 1). Forestry tracks abut the wetland immediately upstream and downstream and have probably modified its size and depth. Vegetation is a mosaic of native and exotic sedges and

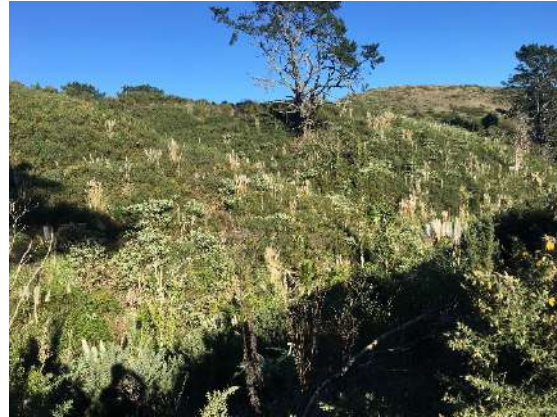
Figure 2: View across the Fill Area 2 gully bottom from the mid slope of the true right bank. Note the native broadleaf scrub in the gully bottom and the gorse-covered upper slopes.

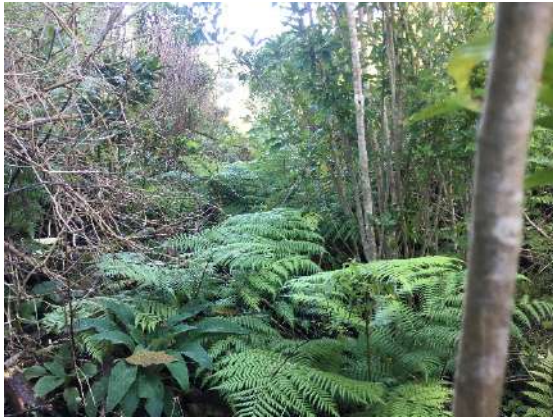
Figure 3: View upstream from under the native scrub canopy in the gully bottom of Fill Area 2. Scrub dominated by māhoe and ponga.

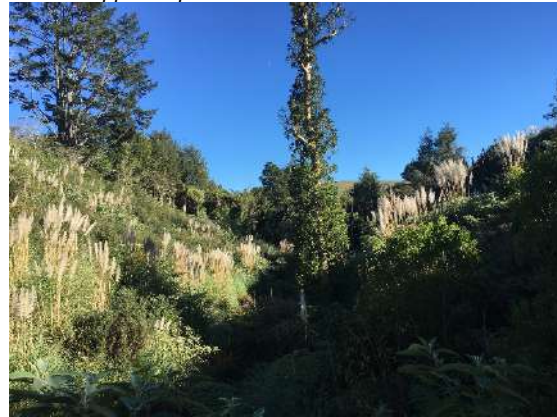
Figure 4: View downstream from the true right bank. One of the more mature pukatea trees is visible in the centre of the photo. The native forest edge in the background delimits the boundary of the site.

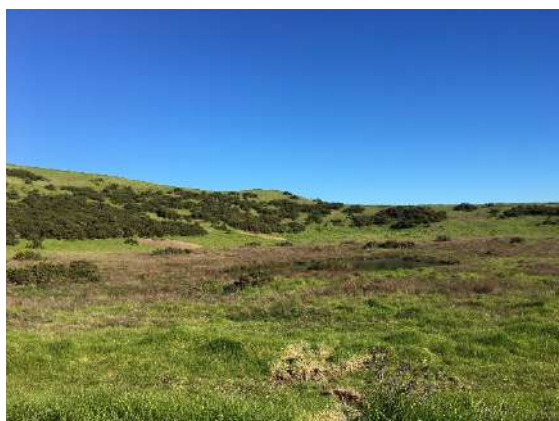
Figure 5: View of the wetland located near the centre of Fill Area 3 surrounded by rank grass and Edgar's rush. Note rank grass and gorse on the dry slopes.

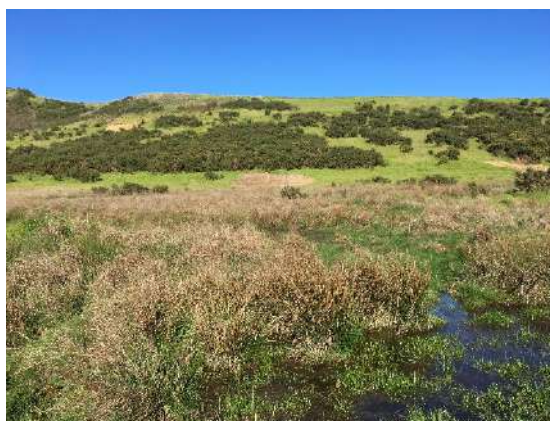
Figure 6: Area of wet paddock to the west of the Fill Area 3 wetland. Flora assemblage includes Edgar's rush, rank grass and a number of other herbaceous exotics including spearwort.

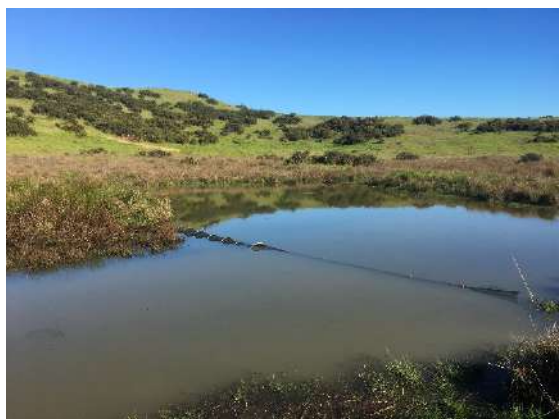
Figure 7: View of the Fill Area 3 wetland.

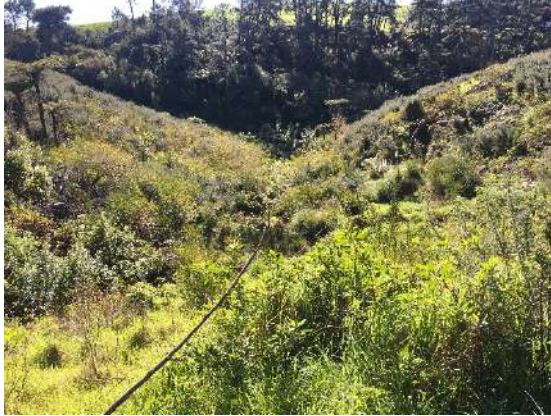
Figure 8: View downstream of the lower reach of Fill Area 4 from the forestry track. Recent regenerating scrub typical of post clear-fell harvest.

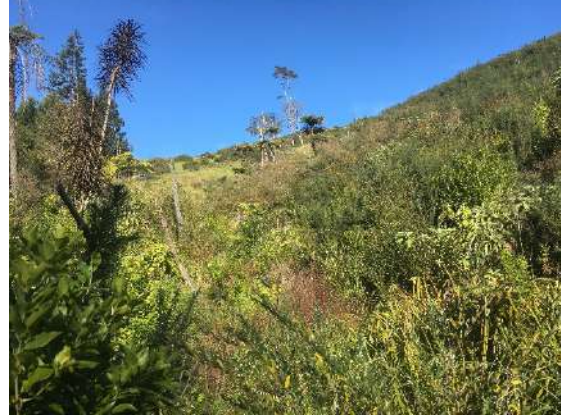
Figure 9: View facing upstream in Fill Area 4 towards the forestry track.

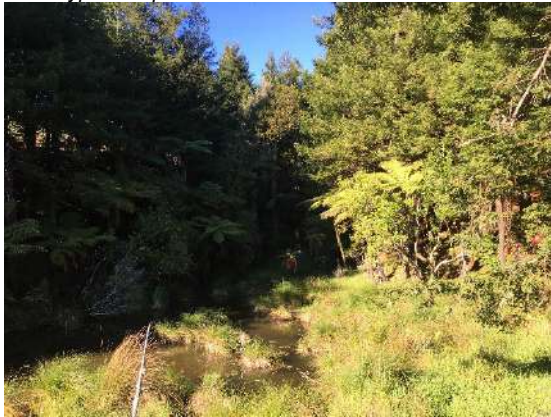
Figure 10: View upstream of the middle reach of Fill Area 4 including the wetland bordered by exotic redwood trees.

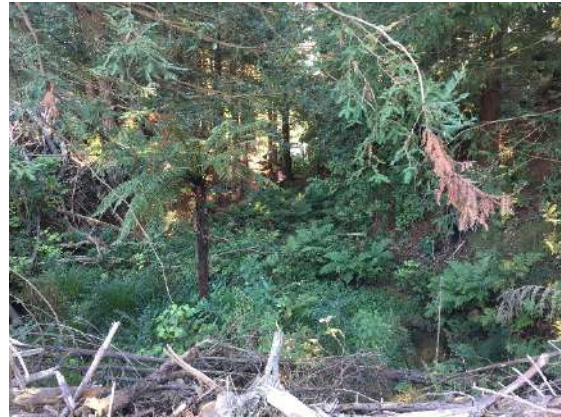
Figure 11: View downstream in the middle reach of Fill Area 4. Regeneration under the redwoods is limited but native regeneration is apparent along the stream corridor.

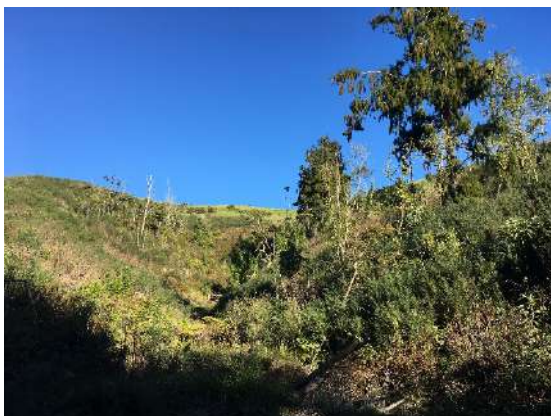
Figure 12: View upstream of the true left branch of the upper reach of Fill Area 4. Recent native regeneration on lower slope with gorse upslope. Note the stand of mature native trees including rimu on the true left bank.

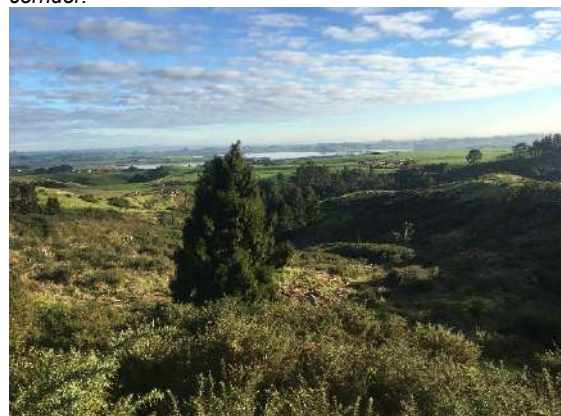
Figure 13: View downstream of the true right branch of the upper reach of Fill Area 4. Single semi-mature rimu in the centre of the image, surrounded by gorse which dominates the reach.

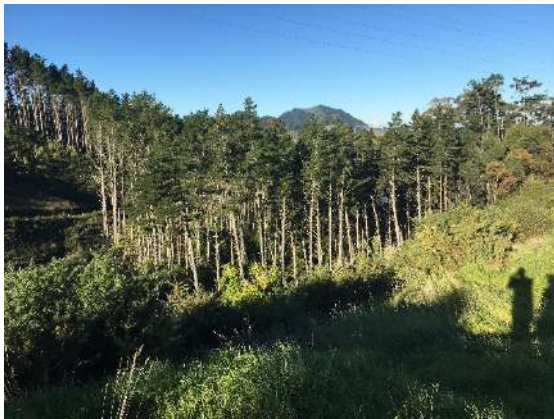
*Figure 14: View downstream of Fill Site 5 from the true right bank. The pine trees approximately delimit the toe of the fill area.*

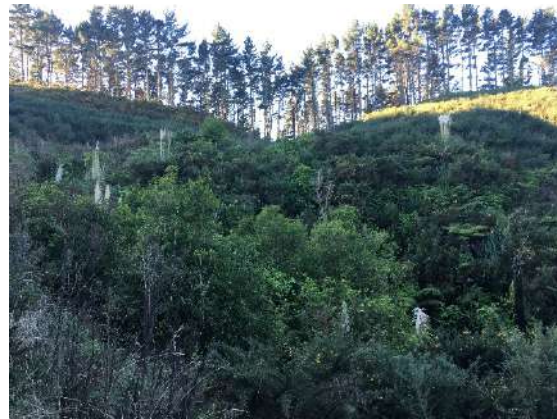
*Figure 15: View upstream of Fill Area 5 from the true right bank. Dense native regeneration is apparent in the fenced area with gorse covering the upper slopes.*

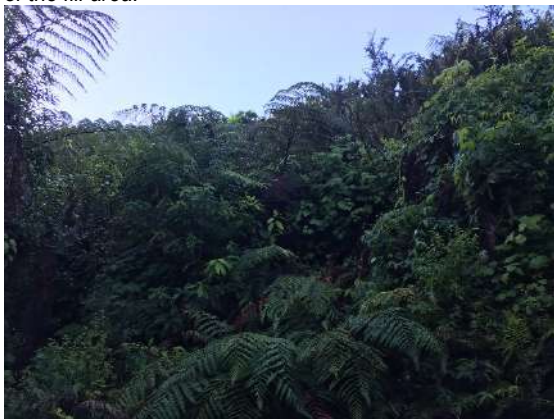
*Figure 16: View upstream from the gully floor. Dense native regeneration with the occasional weed species such as gorse and banana passionfruit.*

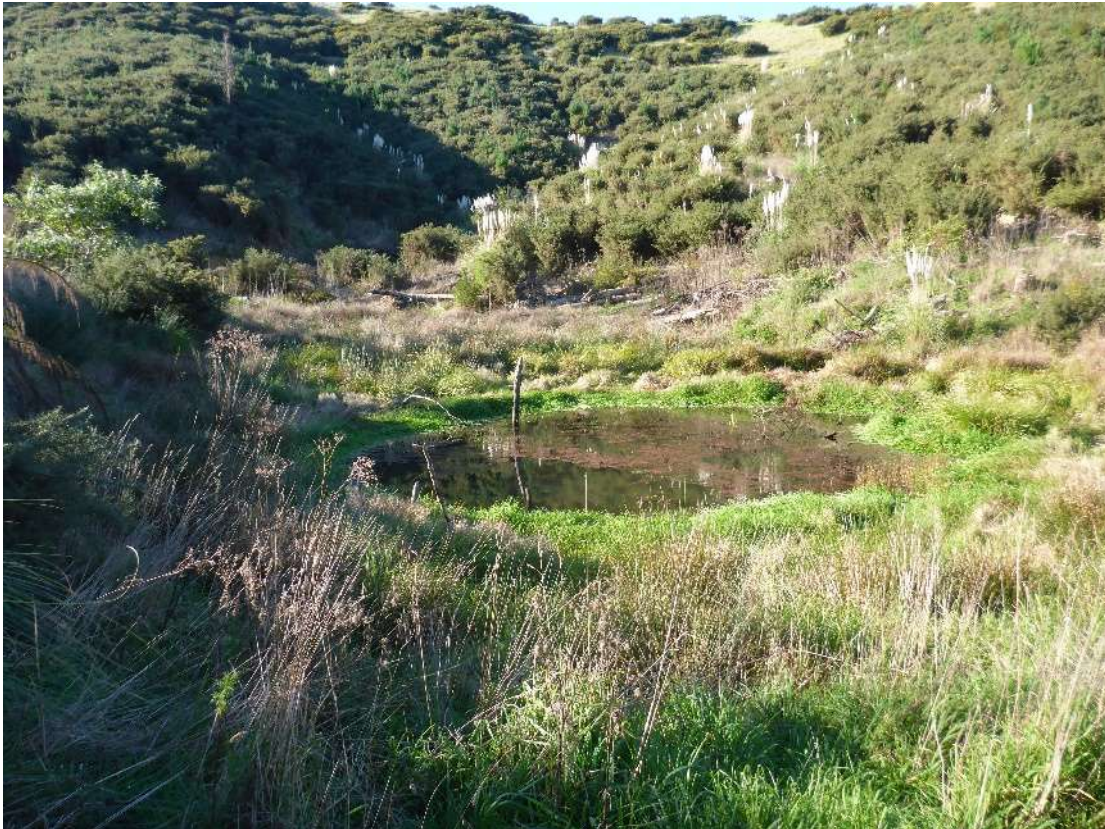
Figure 19. Wetland within fill area 2.

Aquatic habitat features within the wetland are predominantly from macrophytes such as *Carex virgata*, common water milfoil, water pepper, *Gahnia xanthocarpa* and exotic species including soft rush, buttercup, spearwort, kikuyu and various other herbaceous weeds and grasses, as well as woody debris from previous forestry harvest within the catchment.

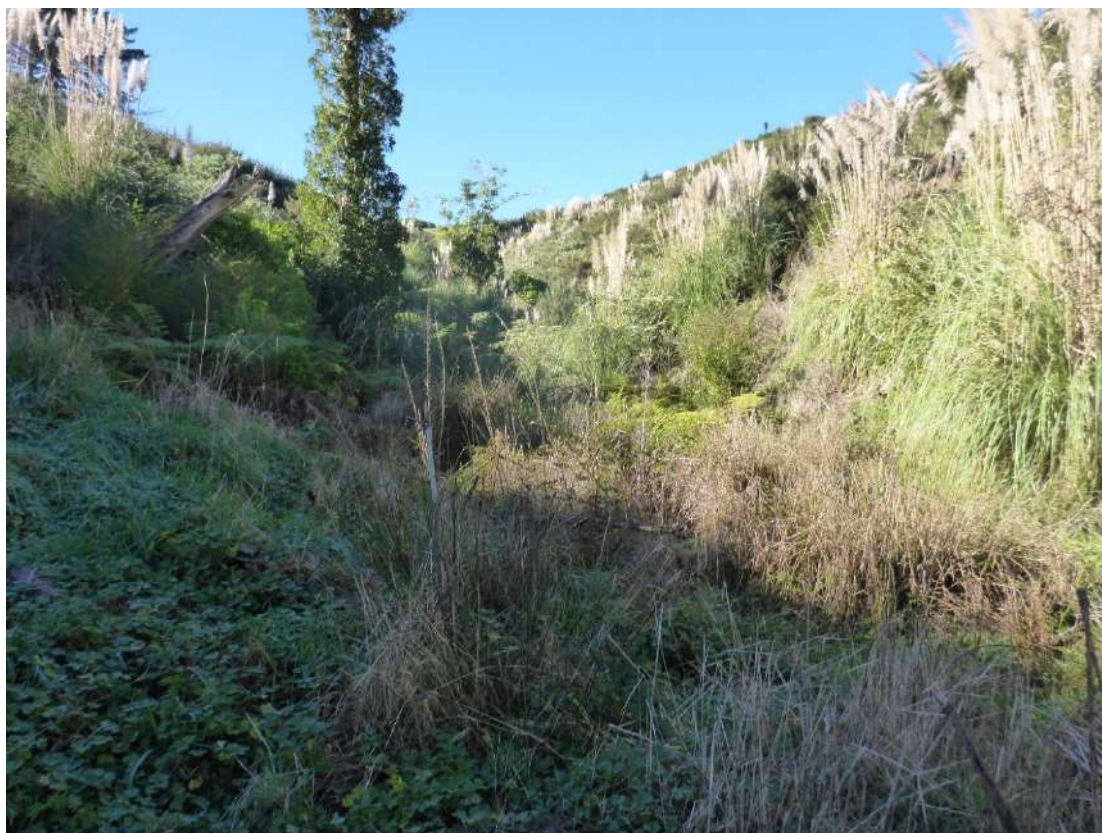
Figure 20. Overgrown ephemeral watercourse downstream of the wetland area within fill area 2.

Immediately below the forestry track at the downstream extent of the wetland is a reach of moderate gradient lacking any instream habitat. Further downstream, an overgrown ephemeral watercourse of approximately 160 m in length was observed without any defined channel and

minimal surface water (of about 2 cm depth) found only in a few areas (Appendix 1, Figure 20). These features are likely a barrier to upstream migration for most native fish species.

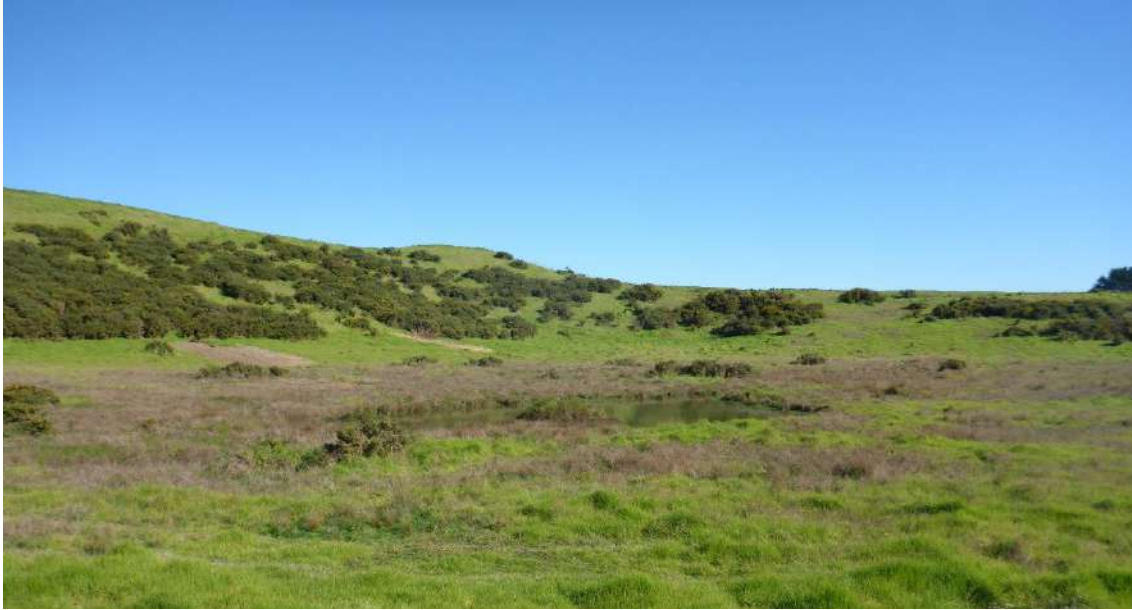
Figure 21. Wetland area within fill area 3.

The main modifications observed within this wetland habitat include:

- Reduced ecosystem intactness due to limited connectivity to downstream habitat;
- Evidence of previous stock damage; and
- Reduced presence of native plants (Appendix 6).

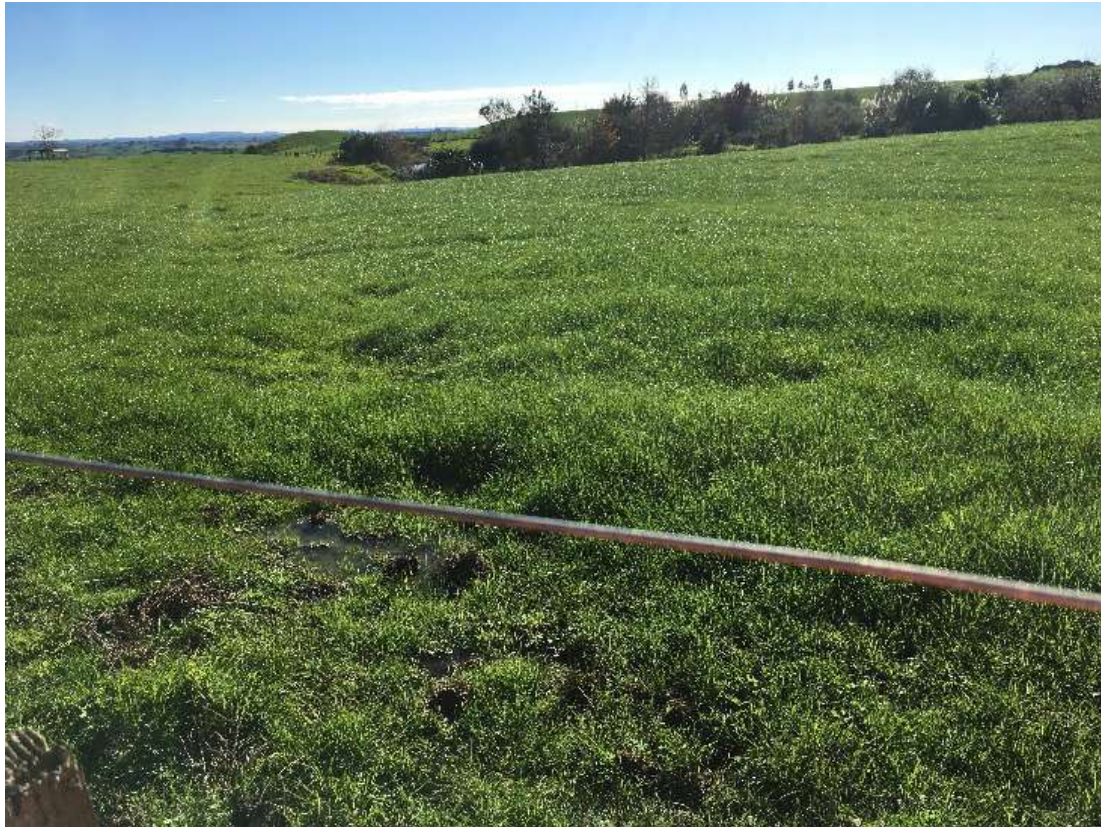
Figure 22. Ephemeral watercourse beyond the quarry boundary.

An unshaded, ephemeral watercourse of approximately 145 m long, was identified downstream of the wetland extent toward the northern property boundary. The ephemeral watercourse was diffuse and had very limited waterflow over muddy/clay substrate. Pasture grass was present throughout the watercourse. This is a barrier to any upstream migration for most native fish species. A more defined, unshaded ephemeral channel lacking any riparian vegetation besides pasture grasses was observed beyond the boundary connecting to ponded areas within the northern landholding (Figure 22).

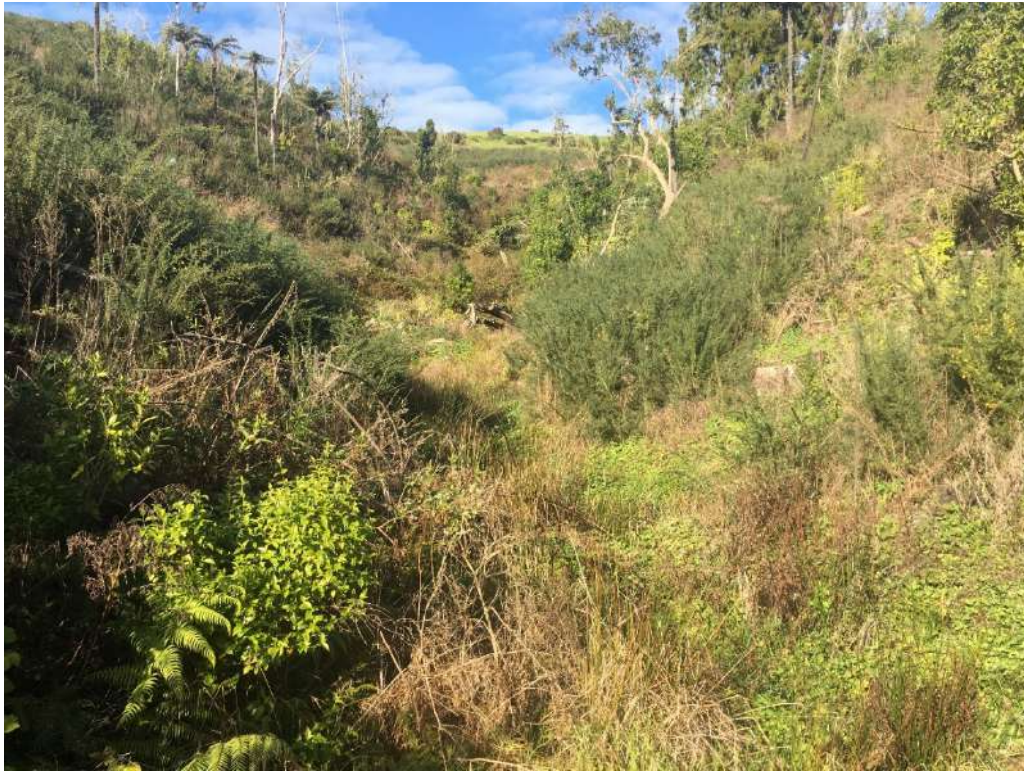
*Figure 23. Ephemeral watercourse within western gully branch at the upstream reach of fill area 4.*

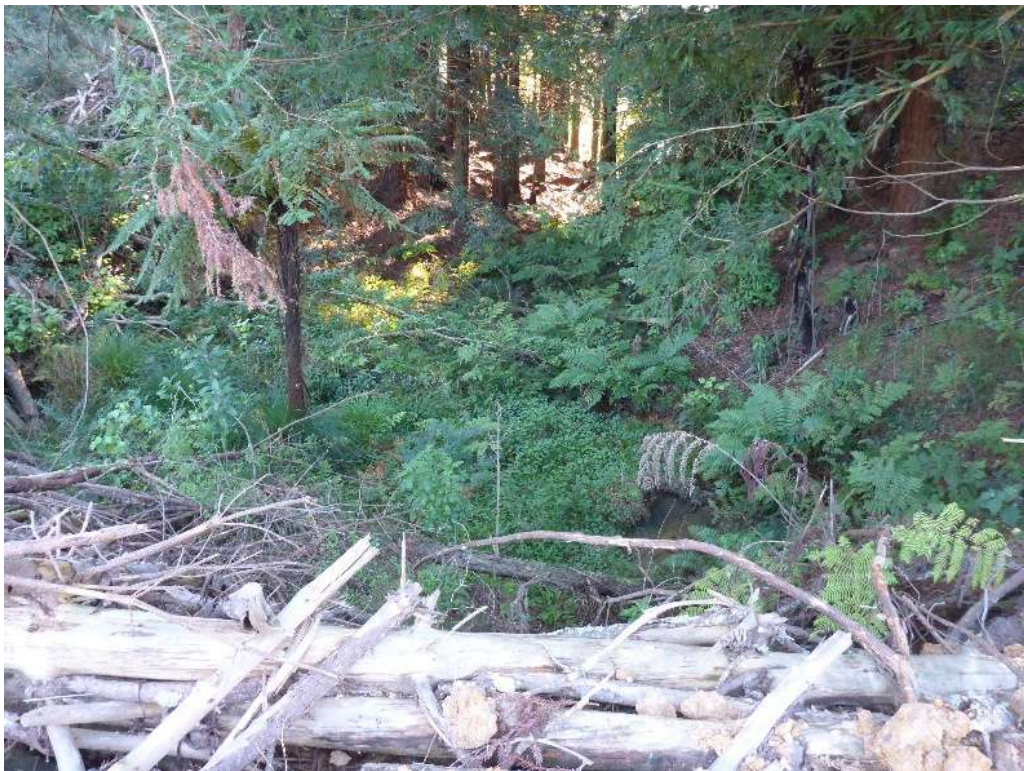
*Figure 24. Stacked tree slash upstream of the intermittent forest stream.*

At the convergence of the two gully branches is a forestry track and stacked tree slash. A small forest stream, approximately 40 m long, was observed downstream of the slash (Figure 24).

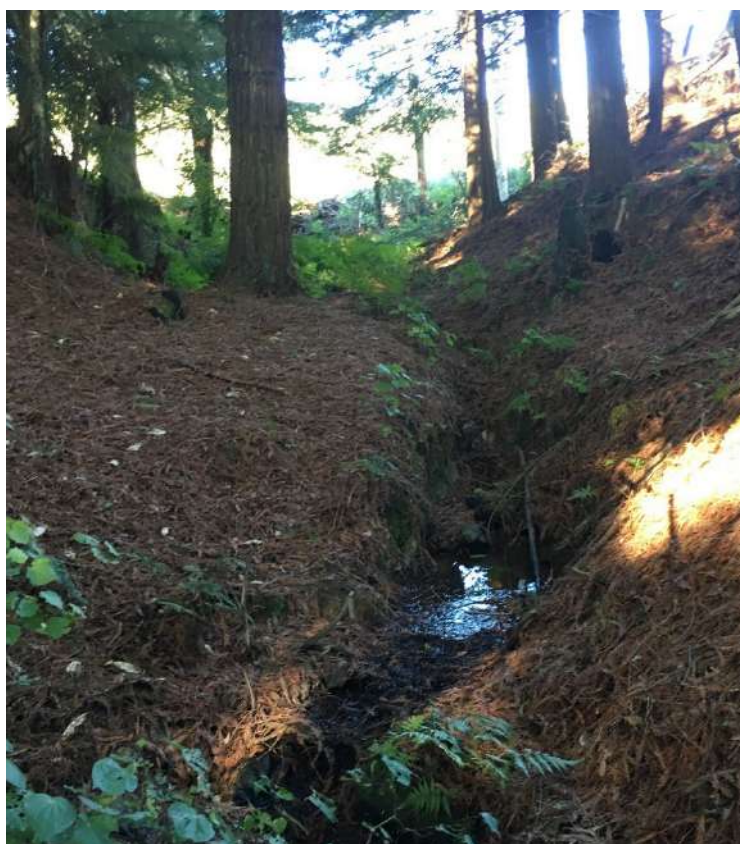
*Figure 25. Highly shaded intermittent forest stream reach within fill area 4.*

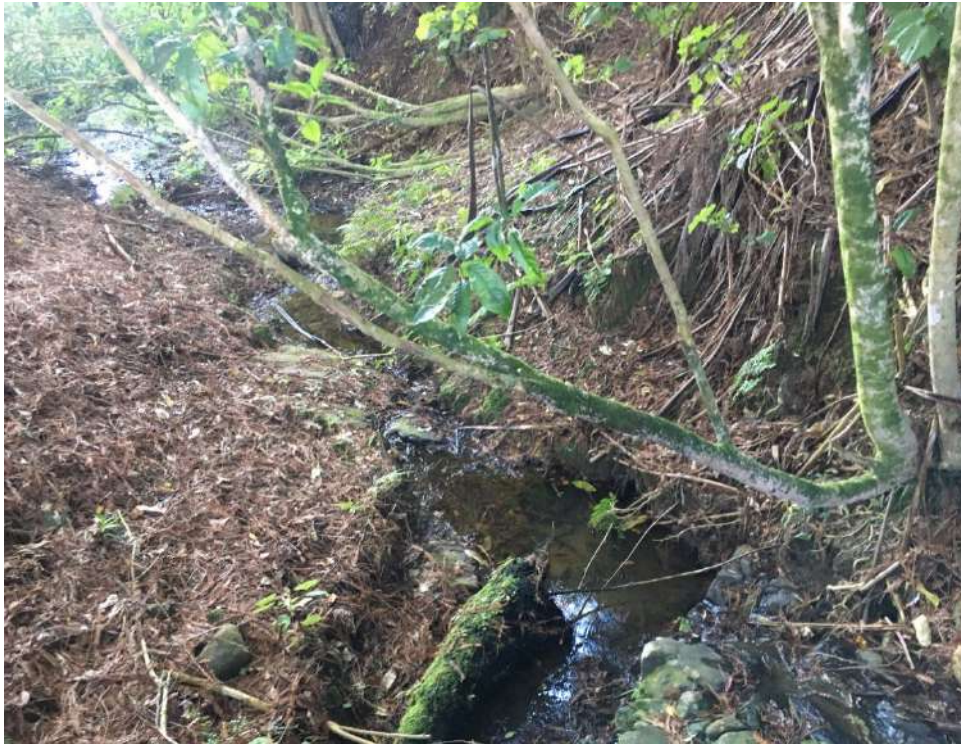
Figure 26. Intermittent stream habitat with localised bedrock, and small pools connected by riffles and runs.

The stream had an average wetted width of 1.2 m and featured mostly pooled slow-flowing sections connected by small runs and riffles (Figure 26). Average water depth ranged from 7 cm to 25 cm, with a maximum water depth of 45 cm within a pool.

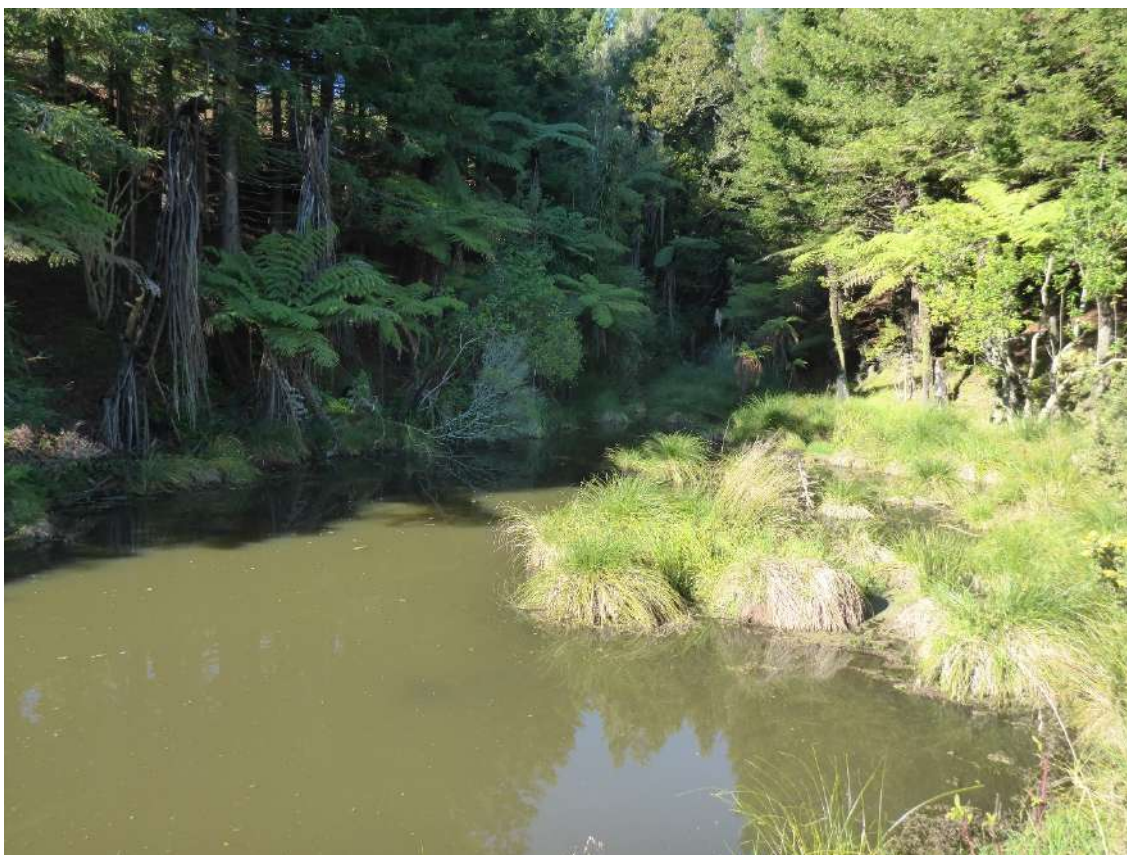
Figure 27. Bunded wetland within fill area 4.

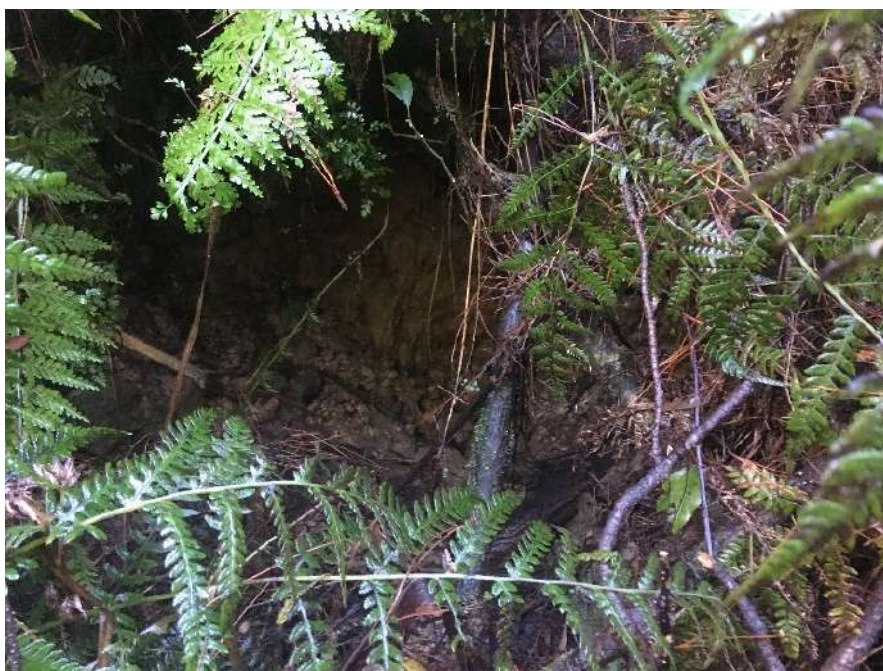
Figure 28. Dry ephemeral channel within fill area 5.

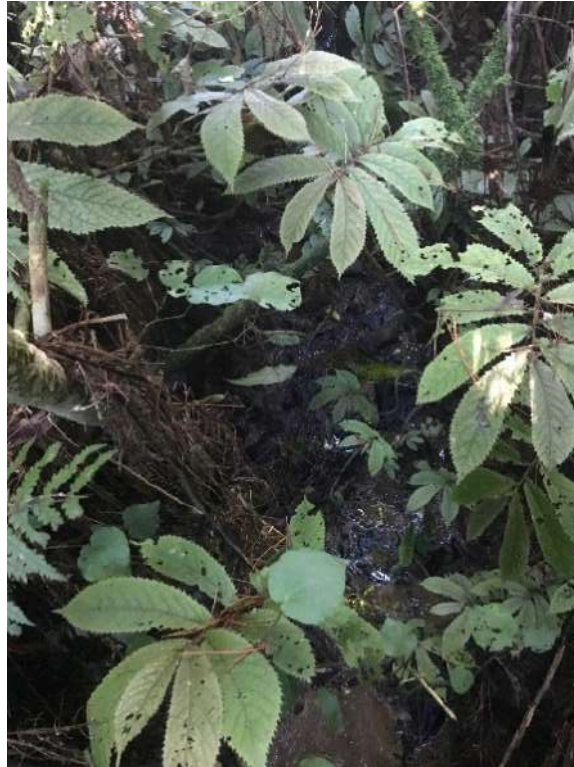
Figure 29. Highly shaded intermittent stream reach within fill area 5.

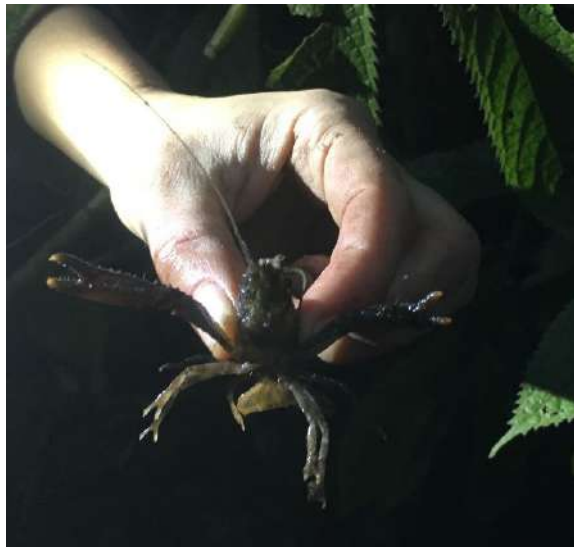
Figure 30. Koura observed within the intermittent stream reach in fill area 5.

No aquatic macrophytes or periphyton was observed. The stream had an average wetted width of 1 m along the assessed reach, while average water depth ranged from 1.6 to 9.6 cm and featured predominantly small pools connected by runs and riffles with limited water flow. One koura (*Paranephrops planifrons*, classified as 'Not Threatened' (Grainger et al., 2018)) was encountered during the stream assessment (Figure 30).

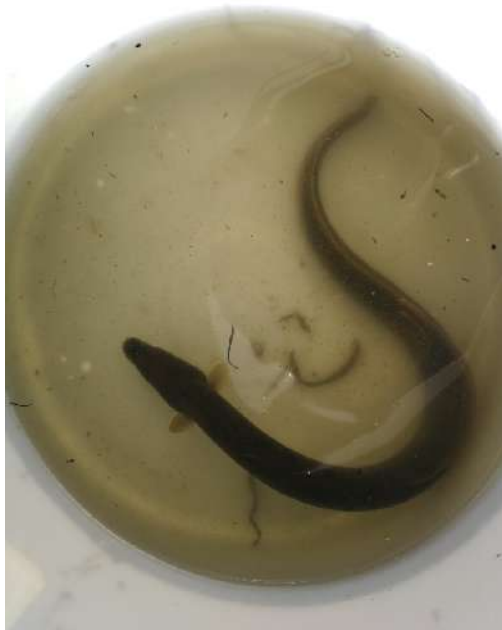
Figure 31. Shortfin eel caught within the bunded wetland at fill site 2.

The only fish species observed was shortfin eel (*Anguilla australis*; Figure 31) with one eel caught in fill sites 2 and 4, and seven eels caught within fill site 3 (350 to 620 mm). Shortfin eels are common throughout New Zealand with a widespread distribution and are classified as 'Not Threatened' (Dunn et al., 2018). They are known to tolerate degraded habitat and water quality parameters. They can migrate into freshwater habitats with limited connectivity due to their remarkable climbing abilities over steep wet surfaces or through wet soil and vegetation.

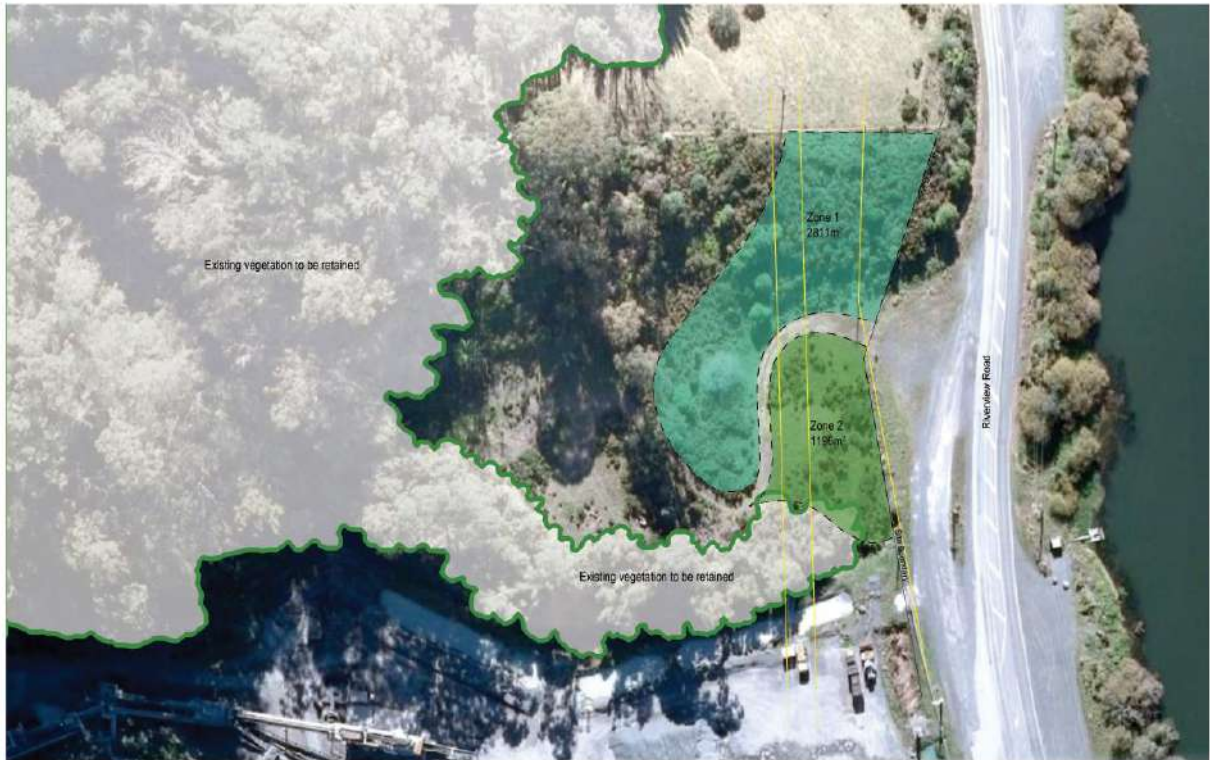
**Map 3: Area of pine and eucalypt to be retained**

In the existing resource consent, there is specific conditions that relates to screen planting and vegetation. The resource consent conditions PC 10 - 12 requires that the areas of pine and eucalypt is retained in perpetuity and enhanced through native vegetation as illustrated in Map 3. It is required that the ecological study assesses the effect of the clearance of sections of these areas due to the location of the fill sites and assist with other/additional management measures.
