## Macroinvertebrate Community Assessment Report Gleeson Huntly Quarry

Prepared for:  
Gleeson Quarries Huntly Ltd  
Gleeson Managed Fill Ltd

April 2022

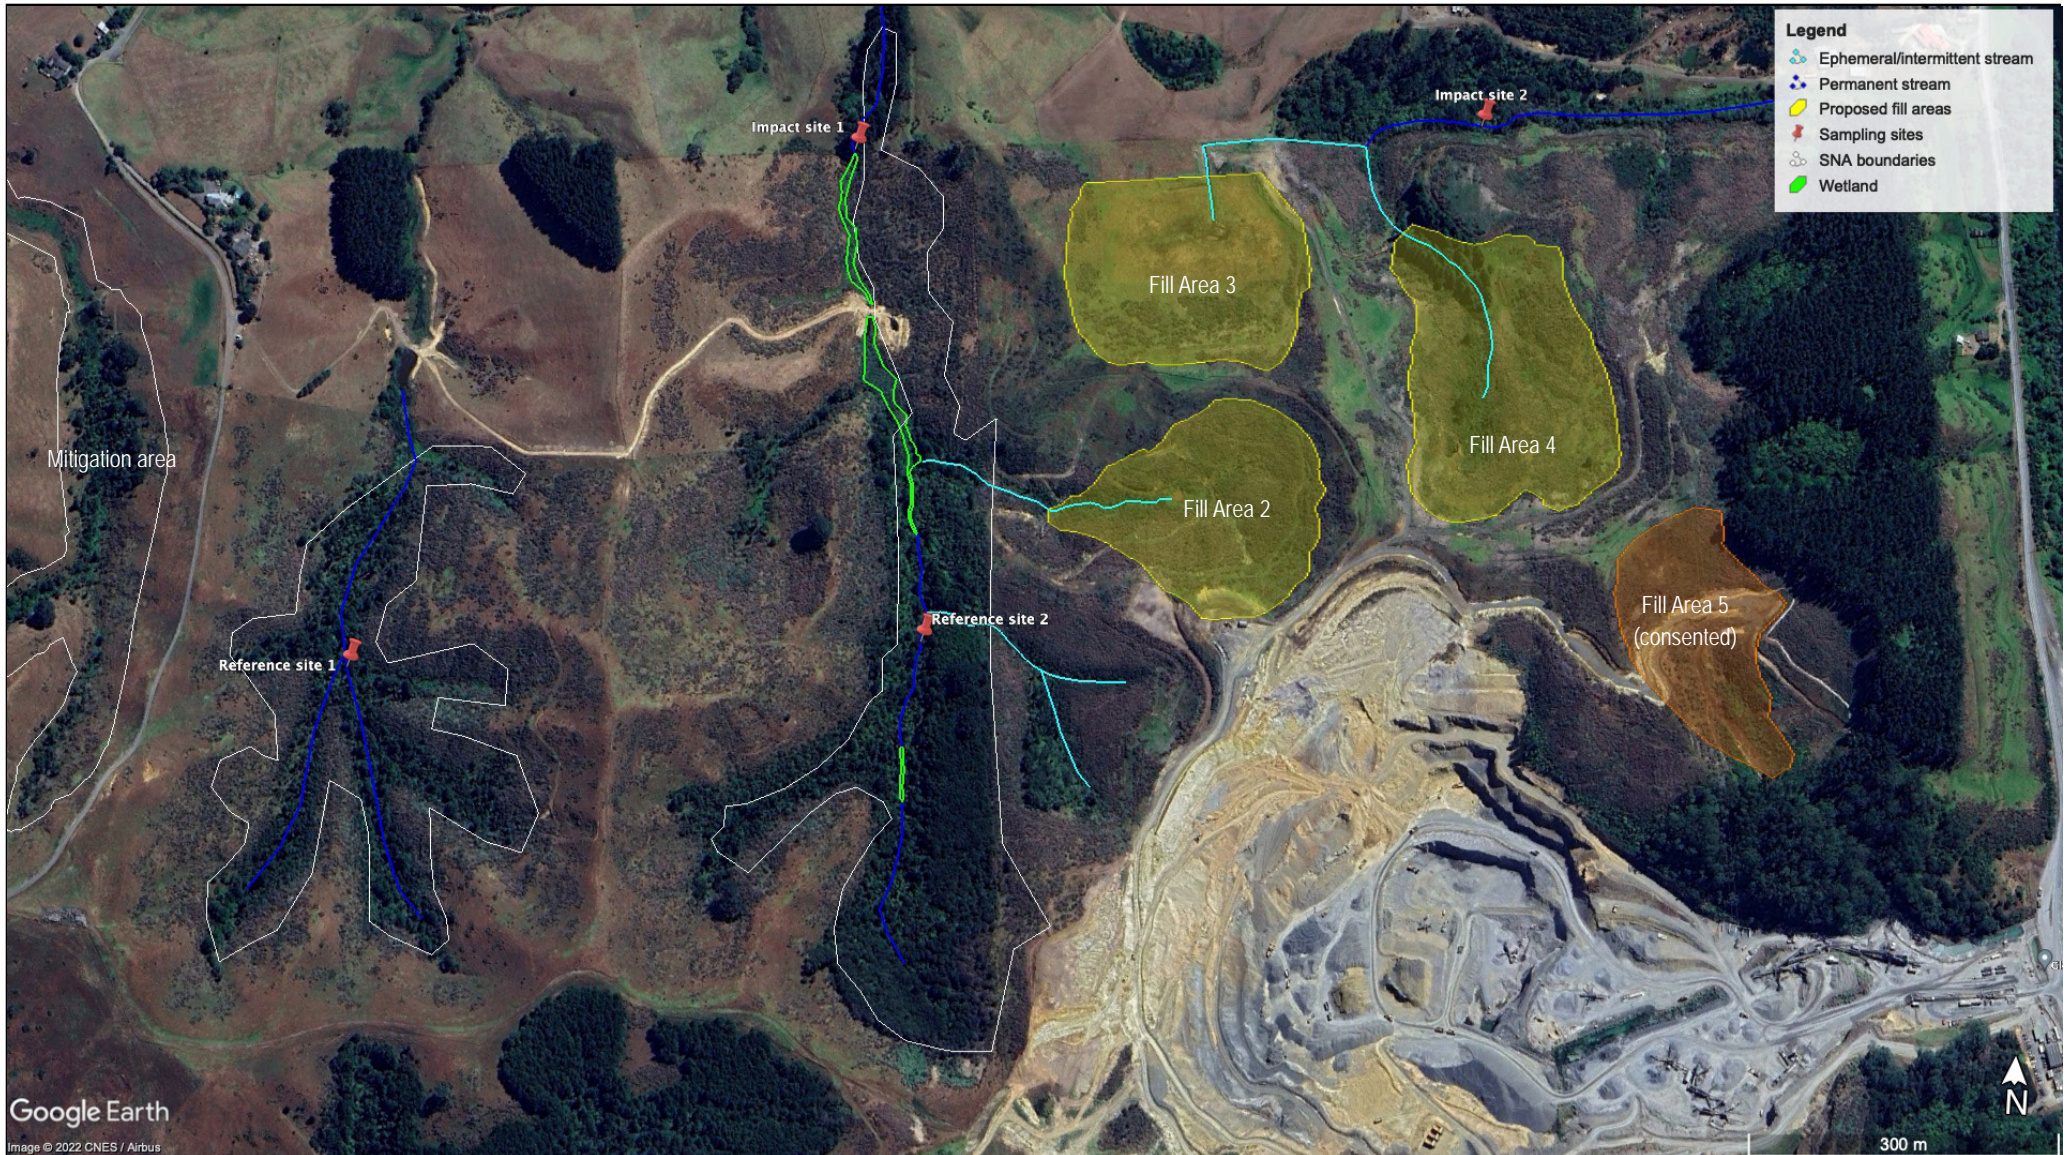
Gleeson Huntly Quarry showing macroinvertebrate sampling sites, proposed fill areas and locations of SNA's.

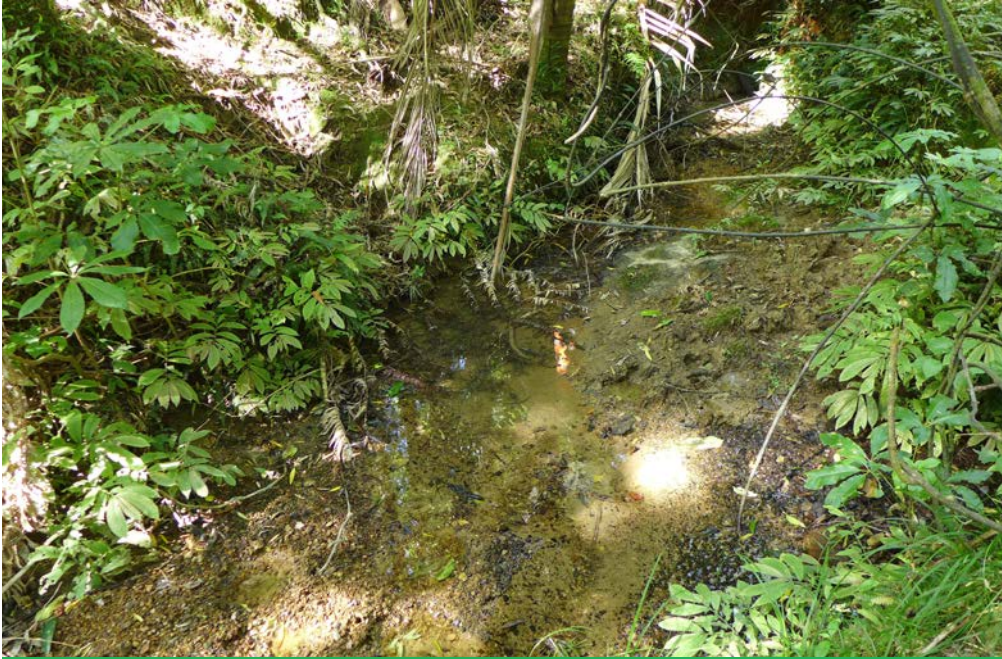
The first reference site is located in a catchment to the west of the quarry and fill areas, and is characterised by secondary podocarp-broadleaf gully forest and small permanent hard-bottomed streams fed by springs. The site is impacted by the effects of pest mammals and livestock, aerial herbicide damage and edge effects caused by lack of continuity with similar habitat. The stream appeared to be in baseline flow conditions and had a variety of habitat types within the channel suited for macroinvertebrate colonisation, such as runs and riffles with high amounts of organic matter and varying sizes of gravel.

Figure 1: Section of stream in reference site 1 that was sampled.

Reference site 1 was located in a gully adjacent to the impact sites and was sampled in order to assess the condition of the impact stream relative to local stream conditions and communities within a similar ecosystem type. Sections of riffle and run habitat in the hard-bottomed stream were sampled, with an MCI score of 125 and QMCI score of 5.66 obtained for the site. According to the National Policy Statement for Freshwater Management (MfE, 2020), these scores reflect mild organic pollution or nutrient enrichment. Water quality classes outlined in 'Table 2. Interpretation of MCI-type biotic indices' (Stark & Maxted, 2007) place this site in the 'excellent/clean water' category based on the MCI score and 'good/doubtful quality or possible mild pollution' based on the QMCI score. The percentage of EPT taxa was 50%, indicating relatively diverse habitat and healthy ecosystem within the stream. A *Paranephrops planifrons* (northern koura/freshwater crayfish) was captured during sampling at this site and was returned to the stream. This species has an MCI score of 5, meaning it is moderately tolerant to pollution/nutrient enrichment.

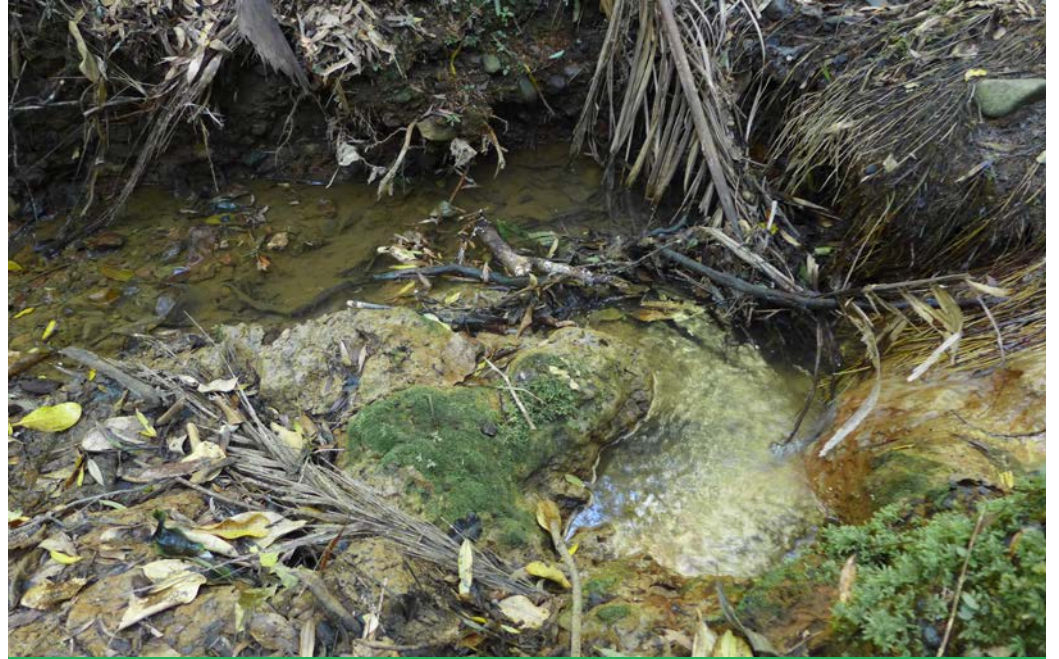
The second reference site is located in a forested gully directly west of the quarry and fill areas, and is also characterised by secondary podocarp-broadleaf gully forest. The site contains a watercourse running south to north, containing sections of permanent hard-bottomed stream and sedge-dominated wetland. Much of the site, particularly the periphery, is impacted by pest mammals, livestock and wild goats. The sample site was located approximately 175m upstream of the discharge point of Fill Area 2, meaning water chemistry and macroinvertebrate communities will remain largely unaffected by potential impacts of the fill. The stream was similar to the first reference site, appearing to be in baseline flow conditions and containing a variety of habitat types.

Figure 2: Reference site 2 showing section of riffle habitat which was sampled.

Reference site 2 was located upstream of the impact sites and was sampled in order to assess the condition of the stream above the impact site within the same catchment. Sections of riffle and run habitat in the hard-bottomed stream were sampled, and obtained similar scores to the first reference site with an MCI of 122.86 and QMCI of 6.89. These scores also fall within the 'mild organic pollution or nutrient enrichment' category of the NPS-FW and 'excellent/clean water' category in Stark and Maxted (2007). The lower MCI and higher QMCI relative to the first reference site is reflective of the higher proportion of EPT taxa (57%) in a smaller sample size with fewer taxa overall. These results also indicate that the stream contains relatively diverse habitat and a healthy intact ecosystem.

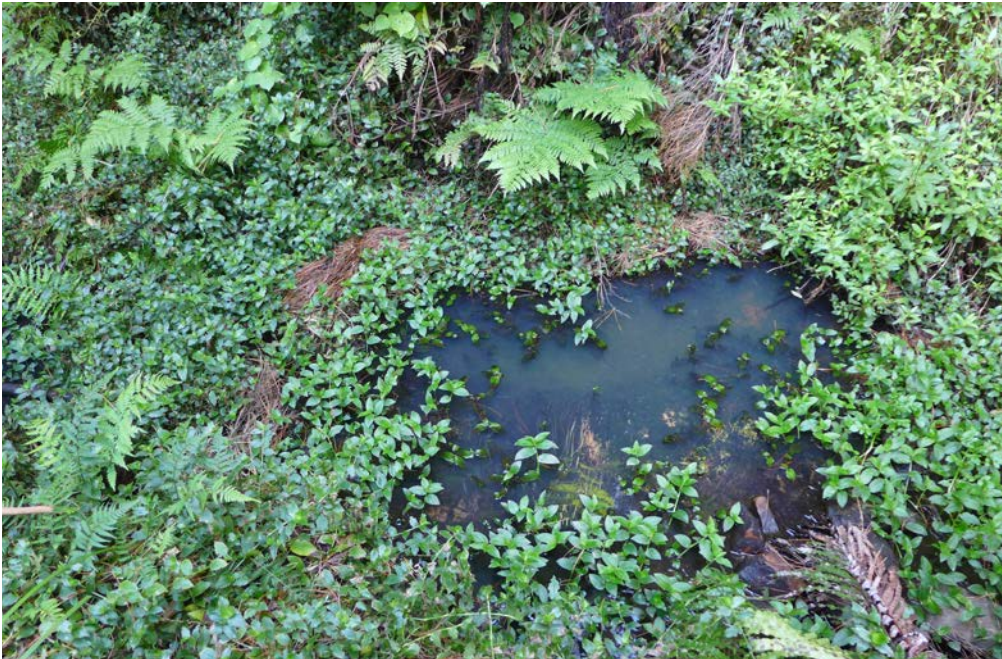
The first impact site is located underneath a pine plantation with a sparse naturally regenerating native understorey. Much of the watercourse below the fill discharge point is wetland, making it unsuitable for macroinvertebrate sampling. The sample site was located below the wetland area in the stream channel approximately 315m downstream of the discharge point of fill area 2, meaning water chemistry and macroinvertebrate communities may be affected by potential impacts of the fill. The stream and surrounding environment is heavily modified, with the channel substrate dominated by concrete, rock rubble and submerged macrophytes. There is a high dominance of exotic vegetation within and surrounding the channel, particularly *Tradescantia fluminensis* (wandering jew). The stream was also in baseline flow conditions, however the habitat was relatively homogenous with little area available for sampling.

Figure 3: Impact site 1 showing open area of channel where sample was taken.

Impact site 1 was located downstream of the discharge point of Fill Area 2 and was sampled to assess the baseline condition of the stream prior to any works. Due to the heavily modified environment it was difficult to find a sampling point containing high quality macroinvertebrate habitat (ie. riffles and runs), so the stream bed, margins, submerged macrophytes and debris were also sampled. This section obtained an MCI score of 85 and a QMCI score of 4.33, falling below the national bottom line defined in the NPS-FW as 'indicative of severe organic pollution or nutrient enrichment', and within the 'fair/probable moderate pollution' category in Stark & Maxted (2007). These results are reflective of the lack of EPT taxa and the small sample size, which is likely caused by the surrounding modified environment. Upstream of the site is a long stretch of wetland within retired farmland heavily impacted by aerial herbicide spraying and past livestock grazing. The wetland and stream channel appeared to contain a high amount of sediment, which would explain the low MCI scores.

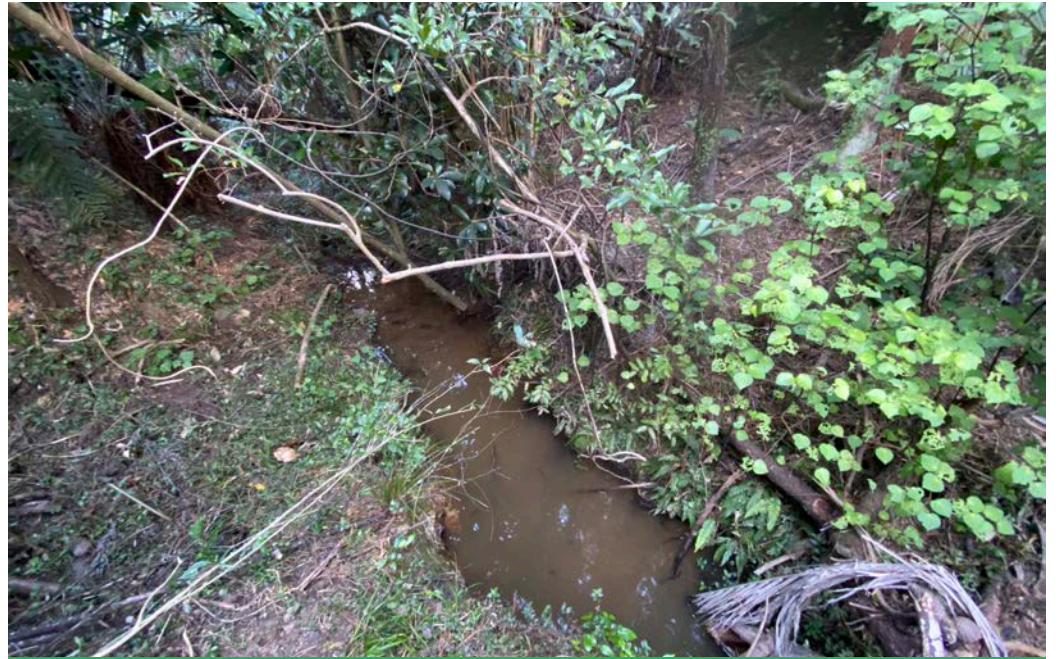
The second impact site is located in a fragment of early successional native forest to the north of the quarry and fill areas and is also impacted by pest mammals, wild goats and exotic pest plants. The stream is characterised by a narrow, slow-flowing channel with mainly hard-bottomed substrate (small gravels along with organic matter). The sample site is located downstream of fill areas 3 and 4, so any impacts resulting from fill works may potentially show up in the macroinvertebrate community. The stream appeared to be in baseline flow conditions and was relatively homogenous, containing narrow and shallow sections of run as well as small pools.

Figure 4: Impact site 2 showing run and pool habitat which was sampled.

Impact site 2 was located downstream of the discharge points of Fill Area 3 and 4 and was also sampled to assess the baseline condition of the stream prior to any works. This site lacked riffle habitat so run and pool habitat containing some submerged leaf litter and woody debris was sampled. This section obtained a MCI score of 82 and a QMCI value of 3.40. Being lower than the first impact site, these scores also fall below the national bottom line defined in the NPS-FW as 'indicative of severe organic pollution or nutrient enrichment', and are within the 'poor/probable severe pollution' category in Stark & Maxted (2007). The site did however contain 20% EPT taxa (made up of mayflies *Tepakia* and *Zephlebia*), but due to high abundances of low-scoring taxa the MCI score remained low. The low MCI scores can be attributed to the lack of high quality macroinvertebrate habitat and historical land-use within the catchment (ie. farming, pine forestry, aerial herbicide

spraying and the use of Fill Area 3 as an overburden disposal site in the past). Although the scores reflect severe pollution when compared with interpretations in the literature, the presence of EPT taxa indicates there are still areas of habitat diverse and intact enough to support populations of macroinvertebrates sensitive to pollution, modification and disturbance.

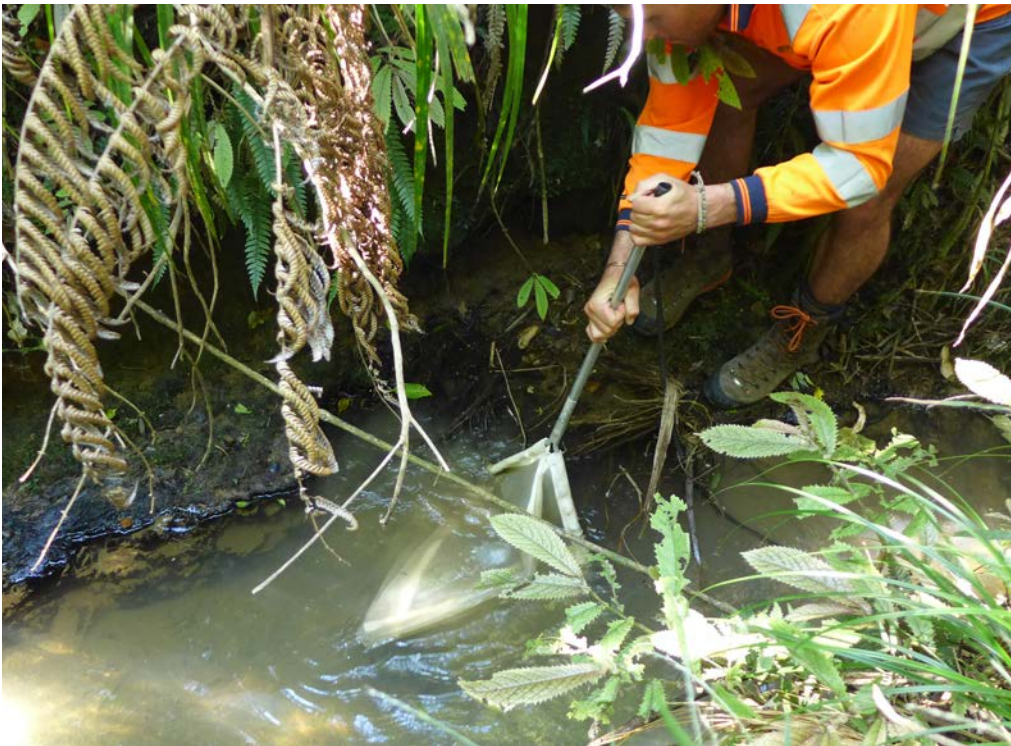
A fine-mesh (0.5mm) D net was used for to sample in suitable macroinvertebrate habitat in the four sampling sites. Approximately 1m<sup>2</sup> of stream habitat was sampled in each site, focussing on riffle habitat where possible. Protocol C1 (hard-bottomed semi-quantitative) sampling method was used for the reference sites and protocol C2 (soft-bottomed semi-quantitative) sampling method was used for the impact sites, following methods outlined in 'Protocols for sampling macroinvertebrates in wadeable streams' (Stark et al. 2001). There were some difficulties with finding suitable riffle habitat to sample particularly in the impact sites due to access and hydrological conditions of the stream (ie. low flow). Other suitable habitat, such as bank margins, aquatic macrophytes, submerged leaf litter and woody debris within the stream channel were sampled to help achieve a representative sample of the macroinvertebrate community. Macroinvertebrate samples were transferred from the net to 300ml containers with 70% preservative (ethanol), and were sent to a lab for identification and analyses from a taxonomist. Protocol P3 (full count with subsampling option) was used for sample processing, following methods outlined in Stark et al. 2001. This protocol method produces a QMCI value (Quantitative Macroinvertebrate Community Index), which uses the same tolerance scores as the MCI but uses relative abundances of taxa to produce a score that is more sensitive to subtle changes in water quality, rather than solely using presence/absence data as with the MCI.

Figure 5: Sampling a section of stream in reference site 1.

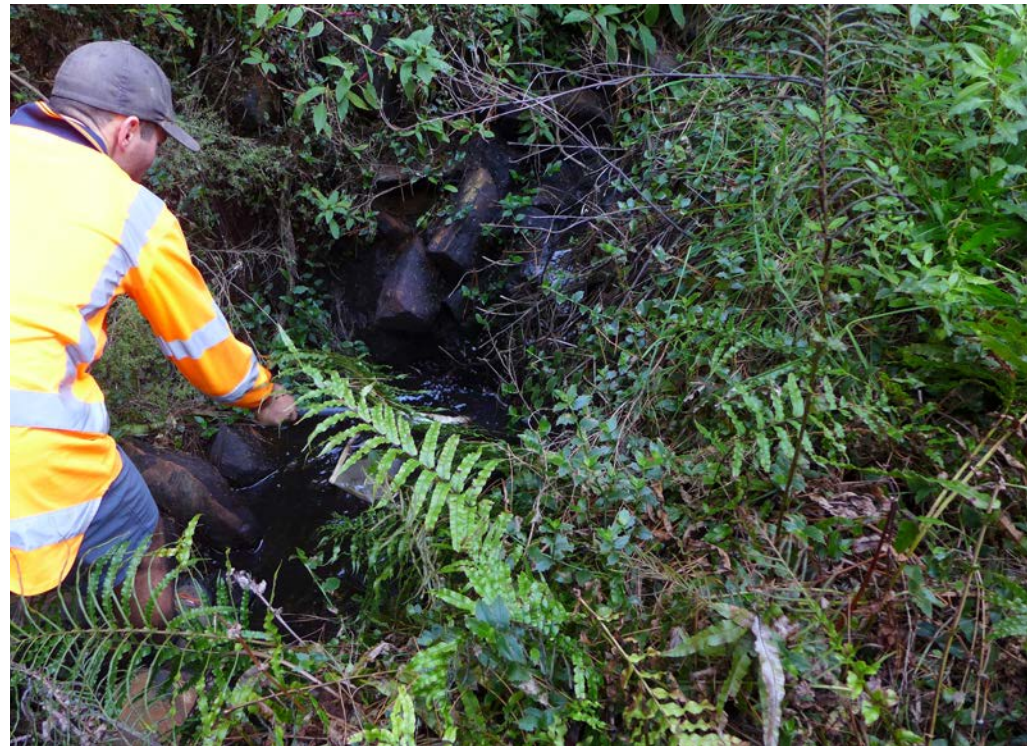
Figure 6: Sampling a section of stream in impact site 1.

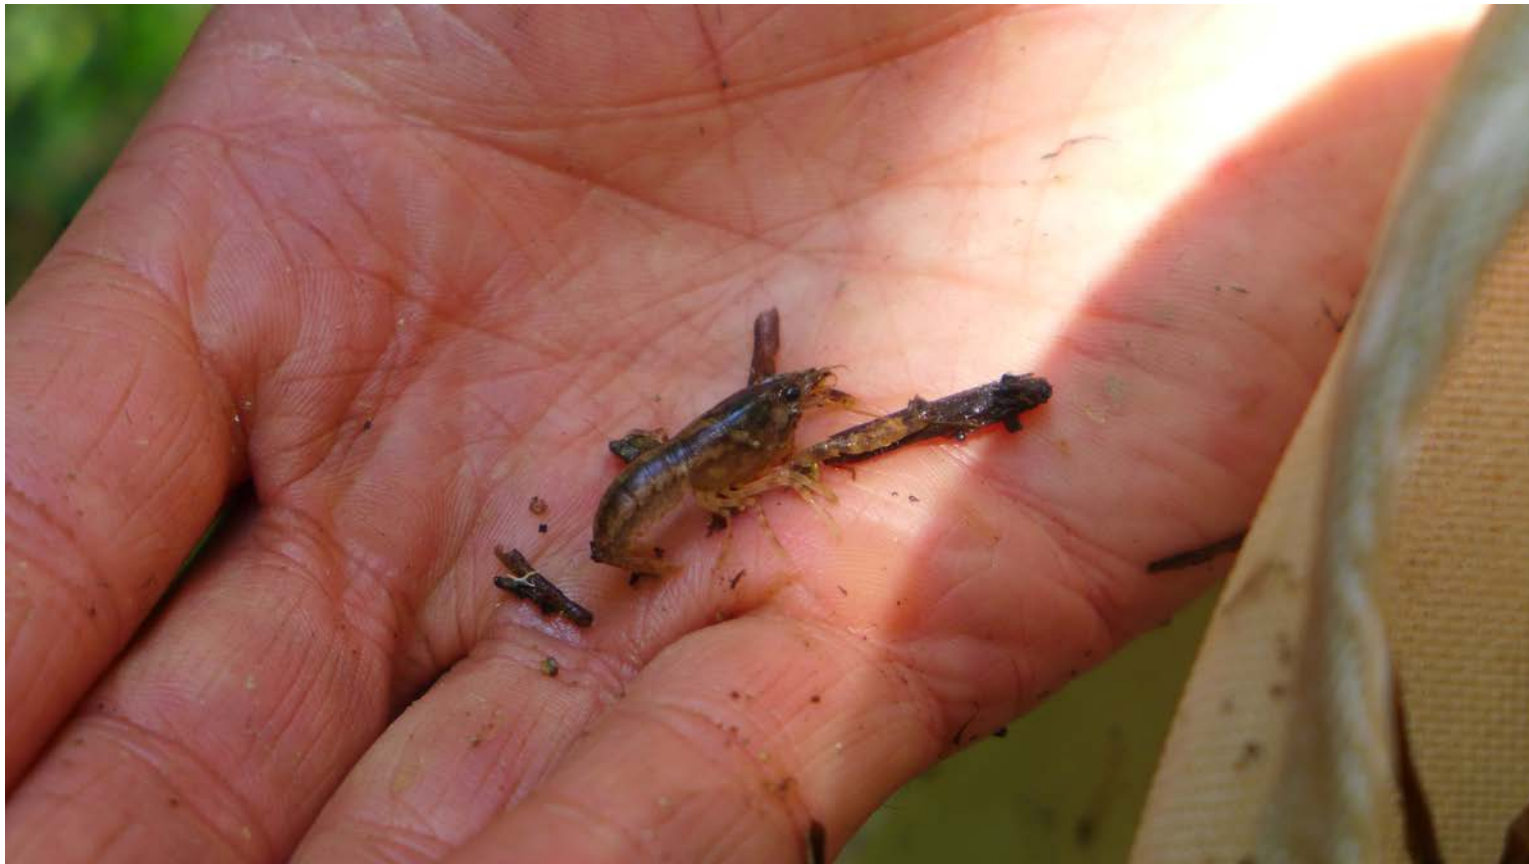
Figure 7: *Paranephrops planifrons* (northern koura/freshwater crayfish) found during macroinvertebrate sampling at the first reference site.
