Macroinvertebrate Community Assessment Report Gleeson Huntly Quarry

Prepared for:
Gleeson Quarries Huntly Ltd
Gleeson Managed Fill Ltd

April 2022

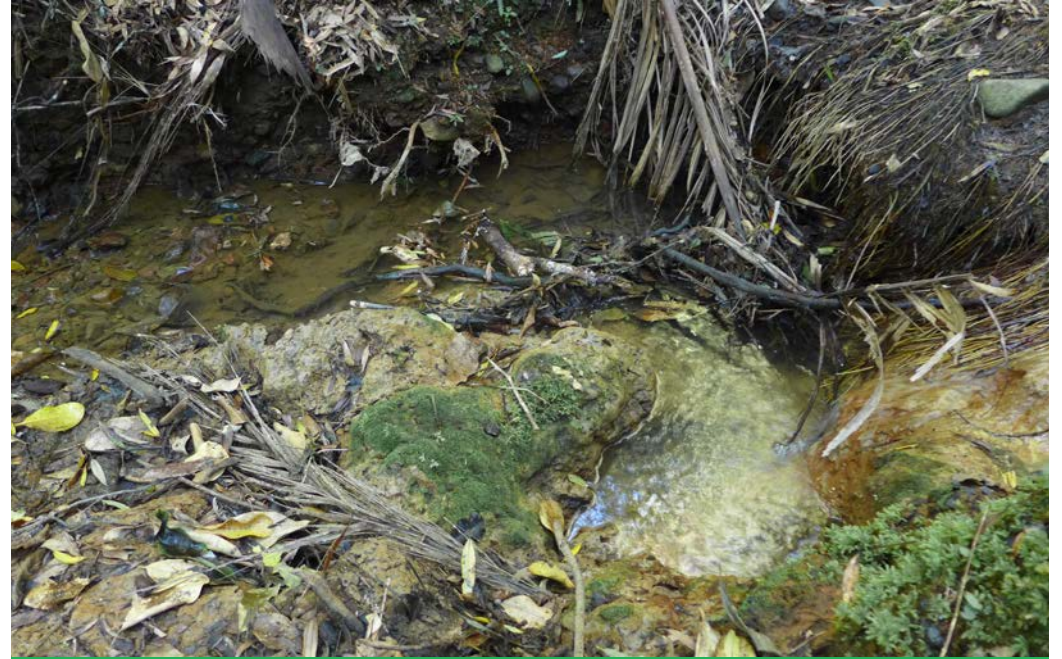
Figure 2: Reference site 2 showing section of riffle habitat which was sampled.

The second reference site is located in a forested gully directly west of the quarry and fill areas, and is also characterised by secondary podocarp-broadleaf gully forest. The site contains a watercourse running south to north, containing sections of permanent hard-bottomed stream and sedge-dominated wetland. Much of the site, particularly the periphery, is impacted by pest mammals, livestock and wild goats. The sample site was located approximately 175m upstream of the discharge point of Fill Area 2, meaning water chemistry and macroinvertebrate communities will remain largely unaffected by potential impacts of the fill. The stream was similar to the first reference site, appearing to be in baseline flow conditions and containing a variety of habitat types.

Reference site 2 was located upstream of the impact sites and was sampled in order to assess the condition of the stream above the impact site within the same catchment. Sections of riffle and run habitat in the hard-bottomed stream were sampled, and obtained similar scores to the first reference site with an MCI of 122.86 and QMCI of 6.89. These scores also fall within the 'mild organic pollution or nutrient enrichment' category of the NPS-FW and 'excellent/clean water' category in Stark and Maxted (2007). The lower MCI and higher QMCI relative to the first reference site is reflective of the higher proportion of EPT taxa (57%) in a smaller sample size with fewer taxa overall. These results also indicate that the stream contains relatively diverse habitat and a healthy intact ecosystem.

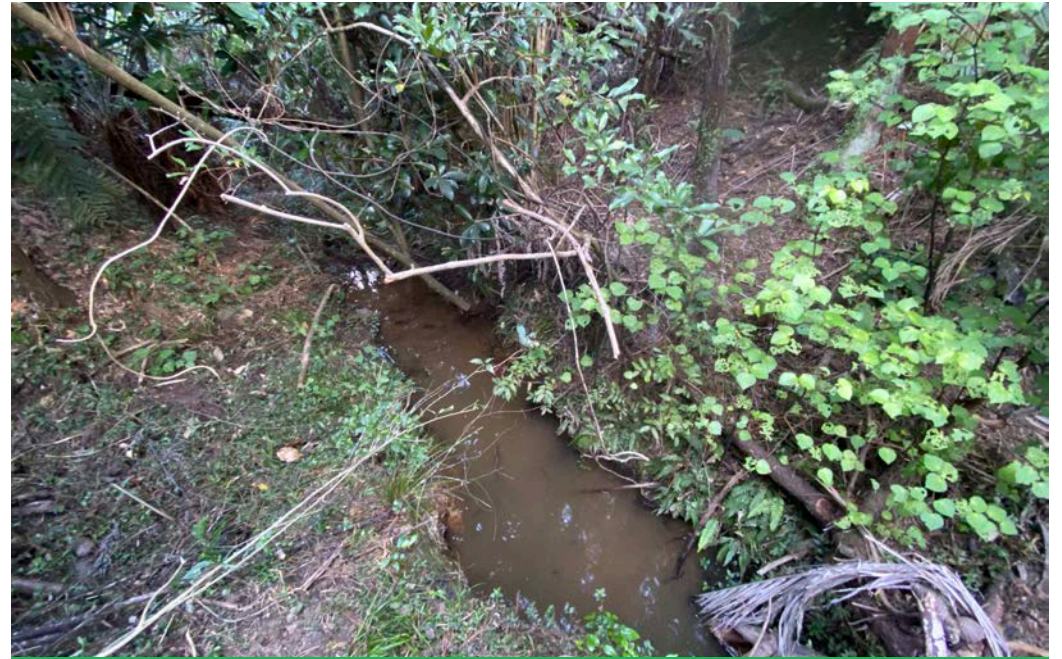
Figure 4: Impact site 2 showing run and pool habitat which was sampled.

The second impact site is located in a fragment of early successional native forest to the north of the quarry and fill areas and is also impacted by pest mammals, wild goats and exotic pest plants. The stream is characterised by a narrow, slow-flowing channel with mainly hard-bottomed substrate (small gravels along with organic matter). The sample site is located downstream of fill areas 3 and 4, so any impacts resulting from fill works may potentially show up in the macroinvertebrate community. The stream appeared to be in baseline flow conditions and was relatively homogenous, containing narrow and shallow sections of run as well as small pools.

Impact site 2 was located downstream of the discharge points of Fill Area 3 and 4 and was also sampled to assess the baseline condition of the stream prior to any works. This site lacked riffle habitat so run and pool habitat containing some submerged leaf litter and woody debris was sampled. This section obtained a MCI score of 82 and a QMCI value of 3.40. Being lower than the first impact site, these scores also fall below the national bottom line defined in the NPS-FW as 'indicative of severe organic pollution or nutrient enrichment', and are within the 'poor/probable severe pollution' category in Stark & Maxted (2007). The site did however contain 20% EPT taxa (made up of mayflies *Tepakia* and *Zephlebia*), but due to high abundances of low-scoring taxa the MCI score remained low. The low MCI scores can be attributed to the lack of high quality macroinvertebrate habitat and historical land-use within the catchment (ie. farming, pine forestry, aerial herbicide

spraying and the use of Fill Area 3 as an overburden disposal site in the past). Although the scores reflect severe pollution when compared with interpretations in the literature, the presence of EPT taxa indicates there are still areas of habitat diverse and intact enough to support populations of macroinvertebrates sensitive to pollution, modification and disturbance.
