Ecological assesment of wetlands north of Fill Area 3 at Gleeson Huntly Quarry.

Prepared for Paua Planning Ltd / Gleeson Quarries
Huntly Ltd

July 2022

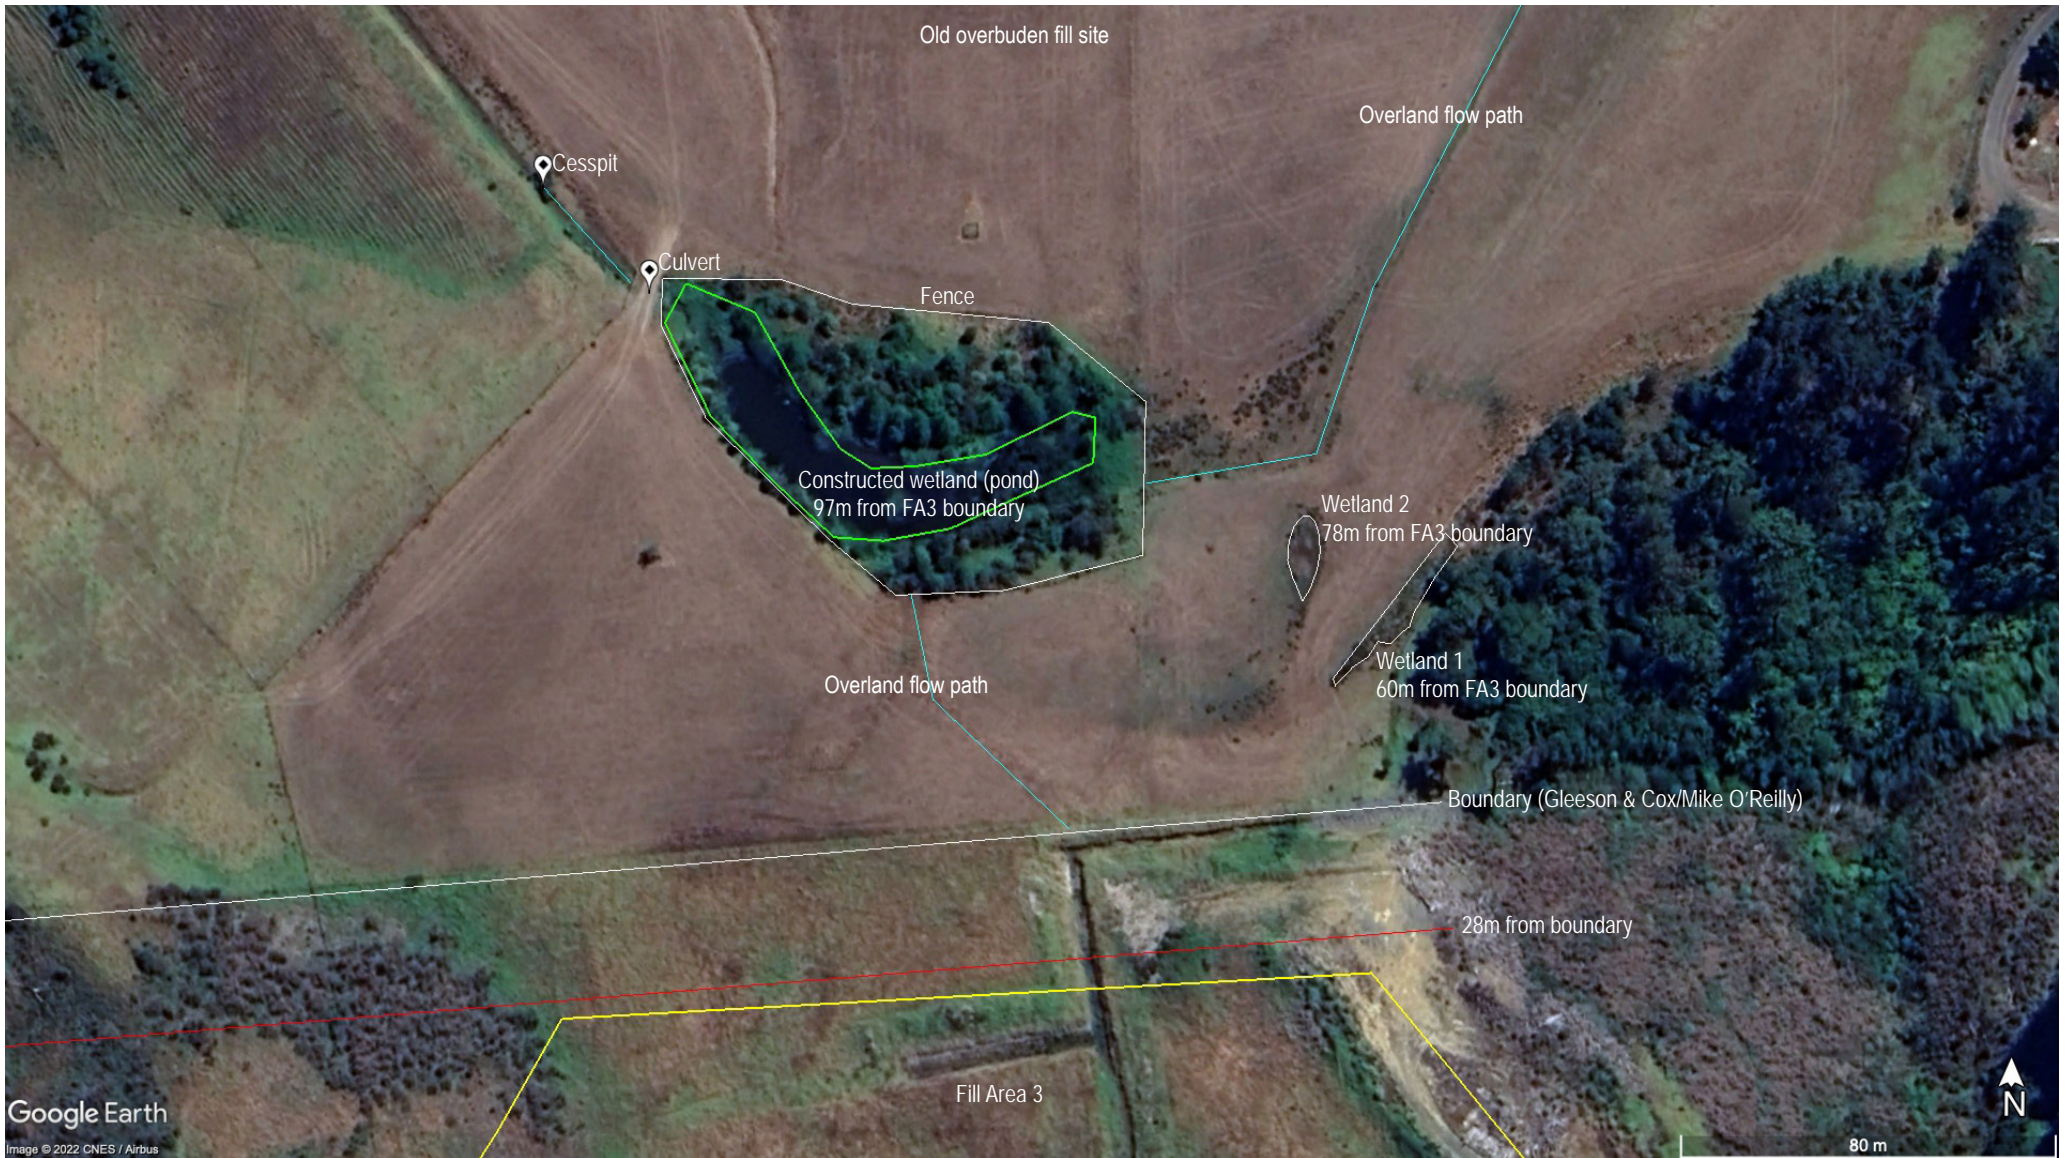
Figure 1: Map of hydrological features and boundaries associated with Fill Area 3, Gleeson Huntly Quarry. Google Earth (February 2019).

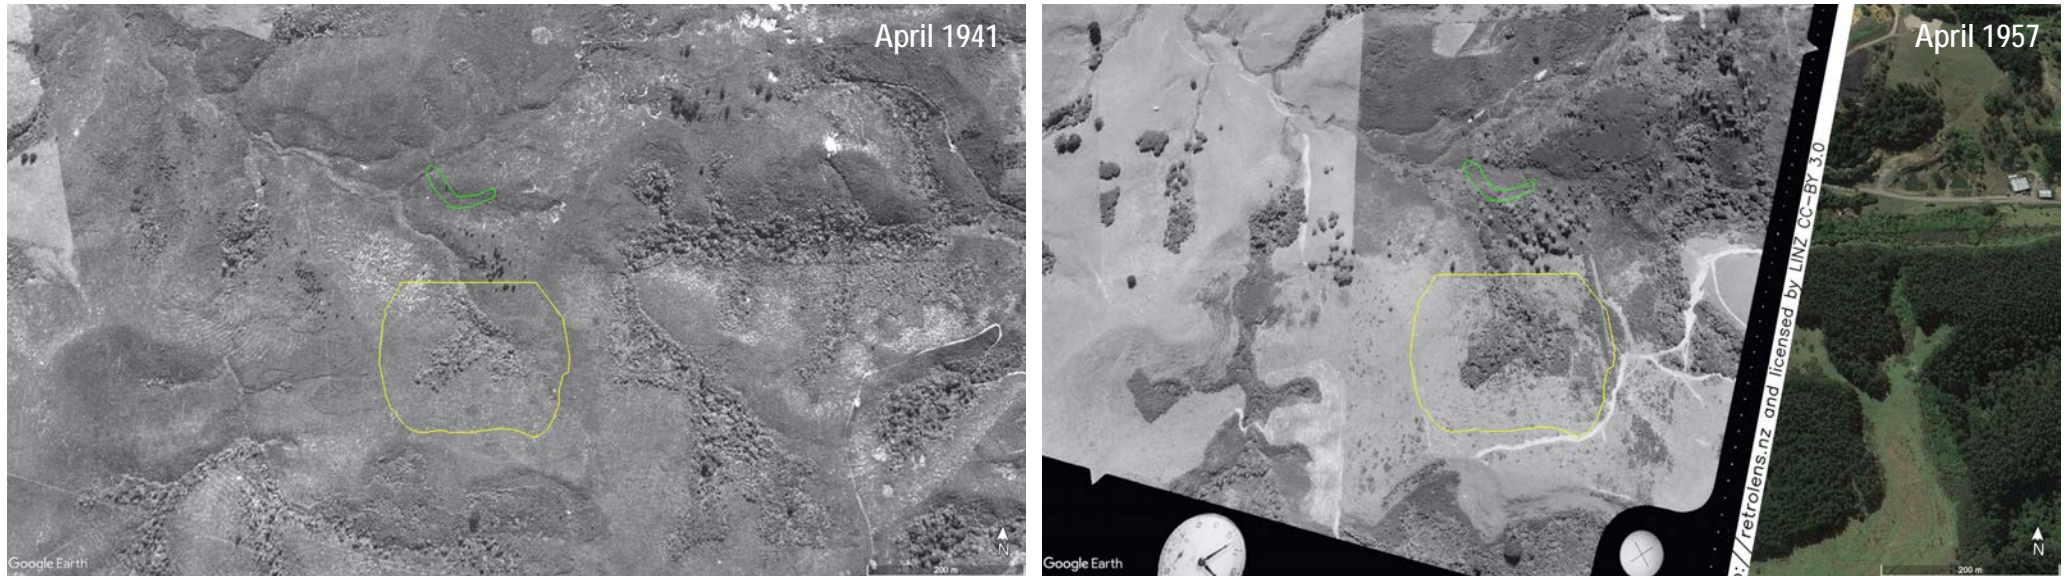
Fill Area 3 and the existing wetland to the north were present within gully systems typical of the local landscape between 1941 and 1957. The appearance of the topography indicates there were watercourses, possibly palustrine wetland systems (possibly seepage and/or ephemeral wetlands), present in low points of the gully areas.

Plate 1: Historic aerial imagery overlaid onto mapped boundary of Fill Area 3 (yellow) and constructed wetland (green).

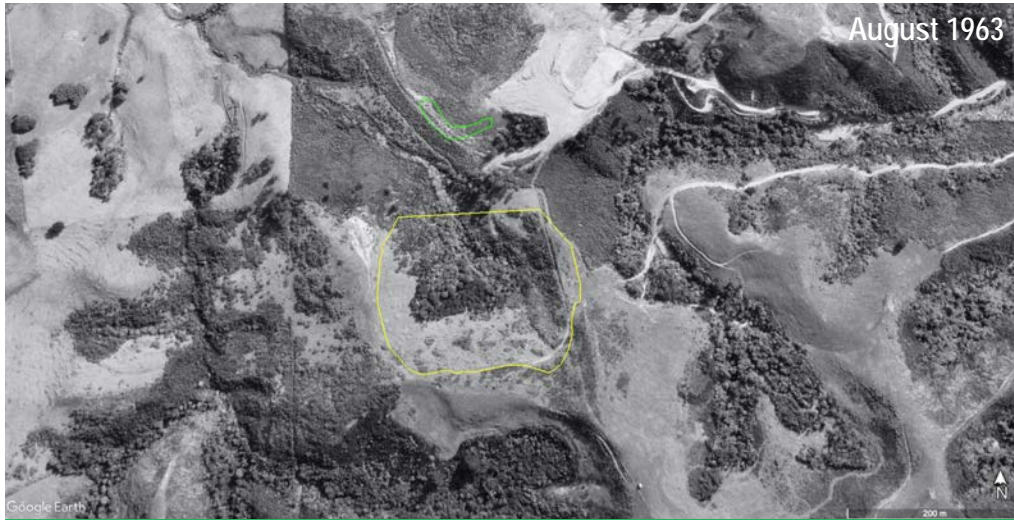
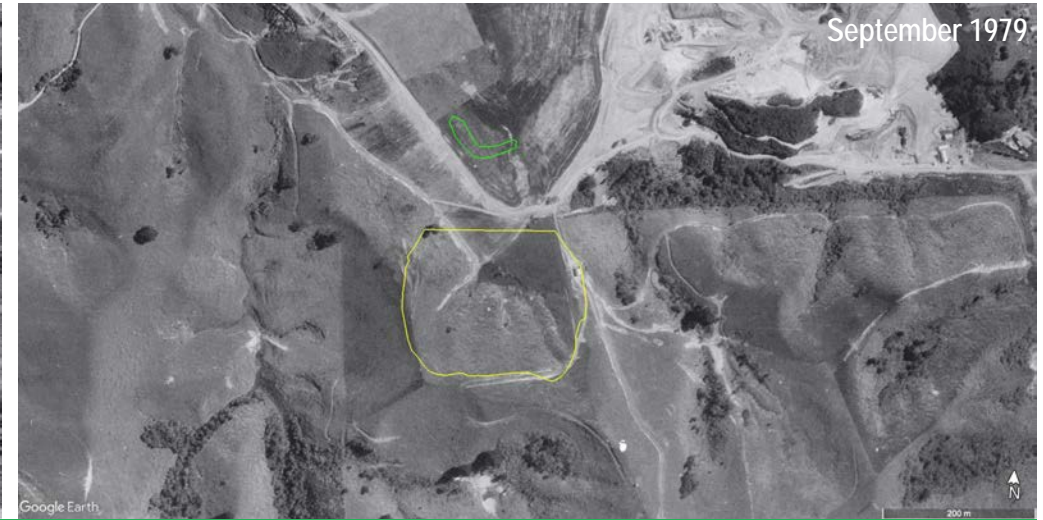
Between 1957 and 1963 coal mining activities from Weaver's pit (now Lake Puketurini) significantly changed the landscape through the filling of gullies with overburden material. The result of these activities left one main flow path down the remaining watercourse that ran north-west of Fill Area 3. Continued backfilling occurred between 1963 and 1979, causing further modification and infilling of watercourses. It appears the removal of natural flow paths caused poor drainage, with water accumulating within the dam in Fill Area 3.

Plate 2: Historic aerial imagery overlaid onto mapped boundary of Fill Area 3 (yellow) and constructed wetland (green).

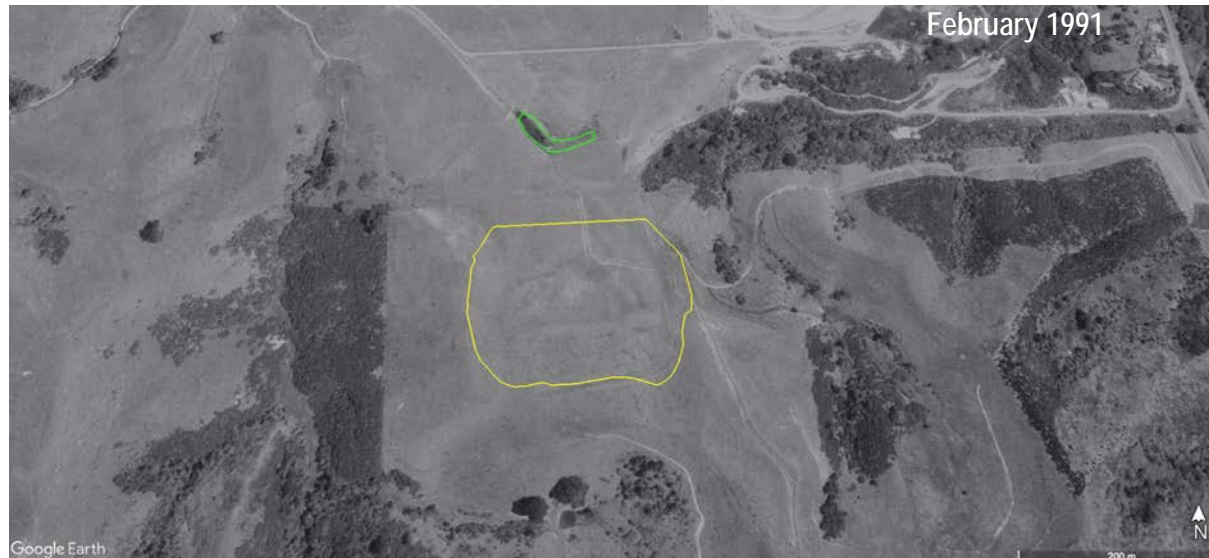
Lack of drainage in the backfill along with landform consolidation (sinking) resulted in a spring formed by compacted clay layers. This spring was problematic being a saturated localised area, and was continuously cleaned out with an excavator to maximise the area of productive farm land (O'Reilly, 2022). The area was eventually re-profiled to create a curved pond for the use of recreational hunting, and has undergone maintenance through tree planting, stock fencing and sediment removal to increase the size of the pond.

Plate 3: Historic aerial imagery overlaid onto mapped boundary of Fill Area 3 (yellow) and constructed wetland (green).

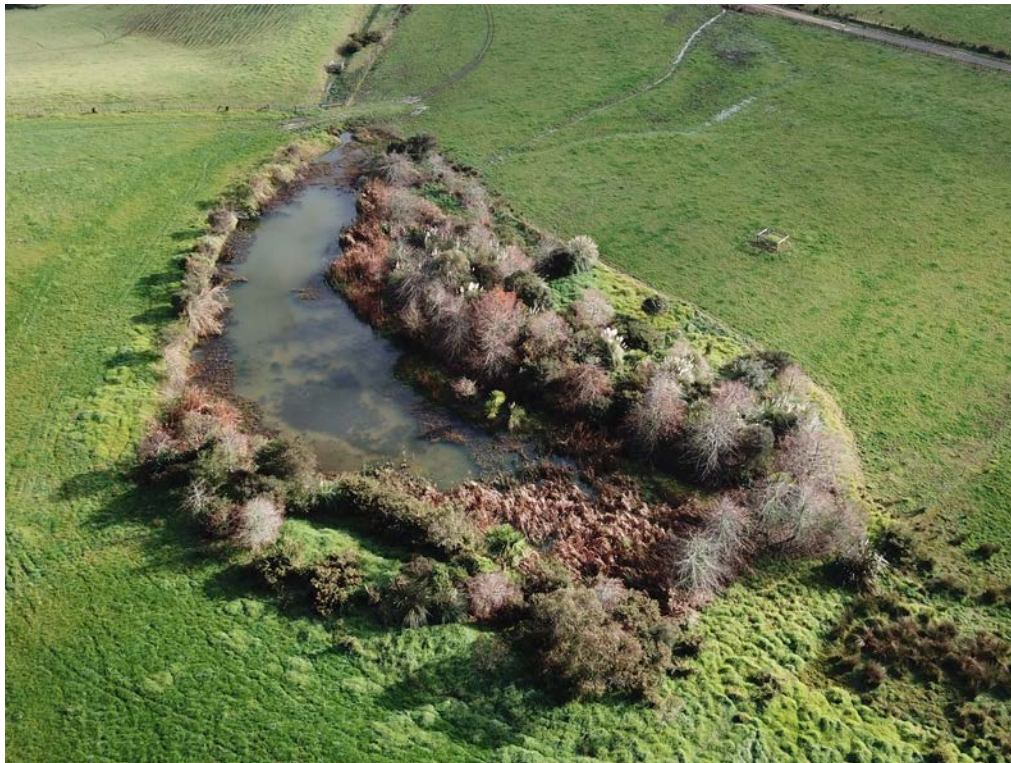
The pond was constructed somewhere between 1979 and 1991 for the purpose of increasing the area of productive farmland, and has since been maintained and utilised as a duck pond.

The pond is classed as an artificially constructed wetland and is excluded from the NES-F and NPS-FW regulations surrounding natural wetlands.

Figure 2: Drone photograph of constructed pond and adjacent wetland, facing north-west.

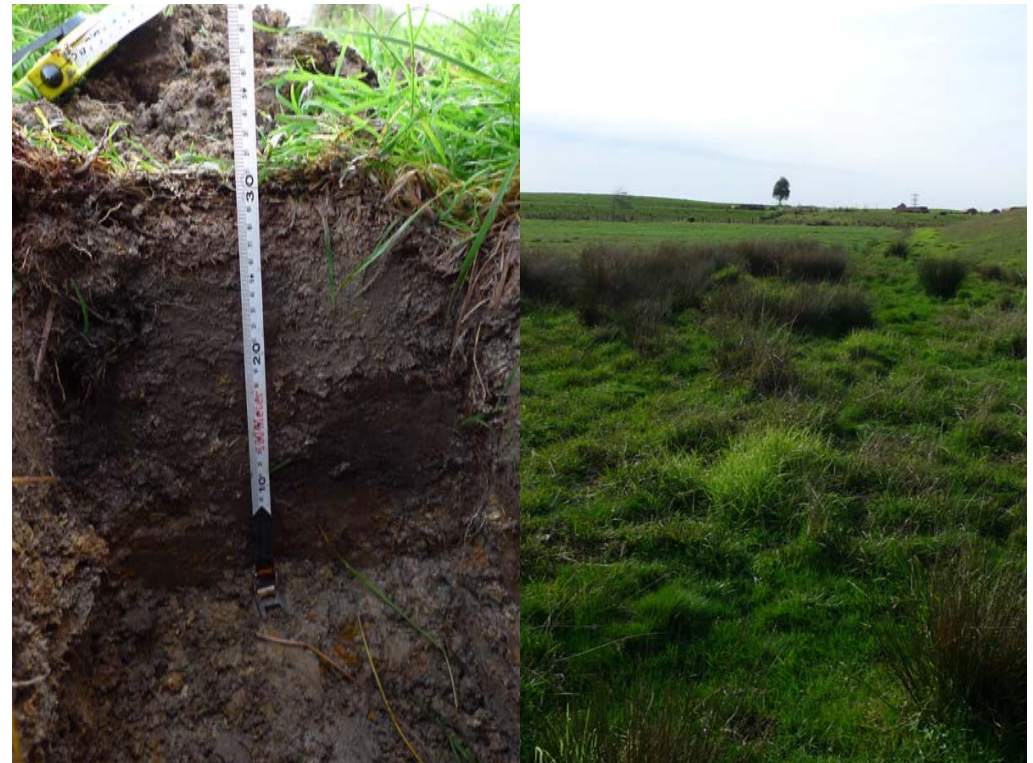
Construction of the pond has resulted in a flat, low-lying area to the east that catches water from the constructed overland flow path that flows down the side of the backfill area. This area is part of managed pasture and contains pasture grasses (>50% of the area) as well as a patchy distribution of facultative wetland species like *Juncus effusus* and *Juncus sarophorus*. The area did not have indicators of hydric soil or wetland hydrology - the water table was not encountered and soil did not display hydric characteristics when examined on site.

Figure 3: Non-hydric soil (left) and typical pasture vegetation (right) in the area east of the pond.

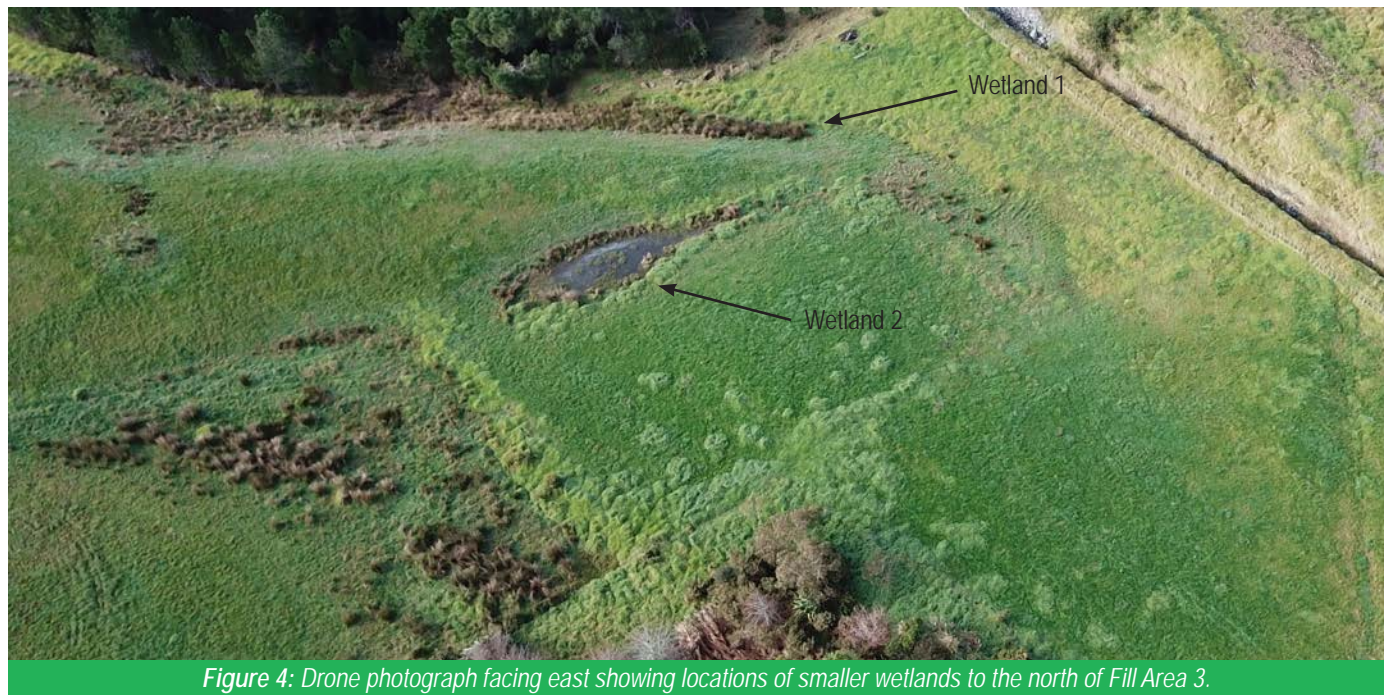
Two small wetlands exist at the foot of a large bund that delineates the edge of the backfill area. The contouring of fill material has resulted in low points in the landscape where water now naturally accumulates. The wetlands do not appear to have been constructed as there is no recent or historical evidence of excavation or maintenance apart from the constructed pond to the north-west. Both sites fit the definition of a wetland under the RMA, but it is of interest whether they meet the natural wetland definition under the NPS-FW. Signs of wetland hydrology are present in both areas, such as surface water, high water tables, soil saturation (present at time of both site visits and evidence of saturation year-round from aerial imagery), and a hydrogen-sulphide odour from disturbed soil.

Figure 4: Drone photograph facing east showing locations of smaller wetlands to the north of Fill Area 3.

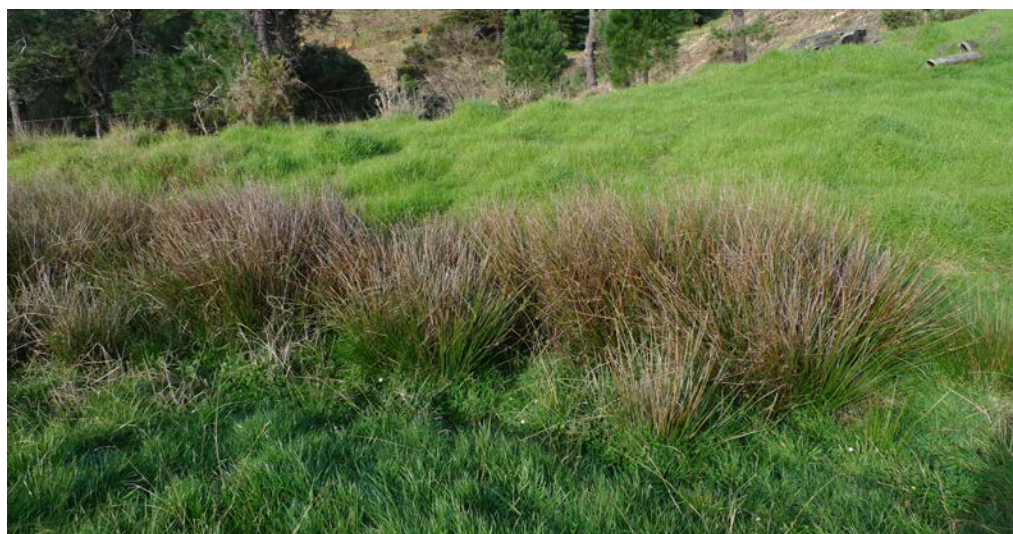
Two vegetation plots (2x2m) were surveyed in each vegetation type (rushes and grasses/pasture). The rush-dominated area (plot 1) passed the hydrophytic vegetation test whereas the grass-dominated area (plot 2) did not (Tables 1 & 2). The wetland can be delineated by the margin of the rush and pasture community. To investigate whether wetland hydrology was present, three soil holes were dug across an elevation gradient in the wetland. All three sites showed signs of hydric soil, with groundwater present at or within 30cm of the soil surface, reddish mottles along root channels, and a hydrogen sulphide odour. It is important to note that these hydric soil conditions have developed relatively recently (approx. 30 years) on a mixture of clay soils imported from Weaver's pit. The wetland appears to be a seepage as a result of contouring of the fill area, lack of drainage in the fill area and landform consolidation.

Figure 5: Wetland 1 showing dominance of *Juncus effusus* surrounded by exotic pasture species.

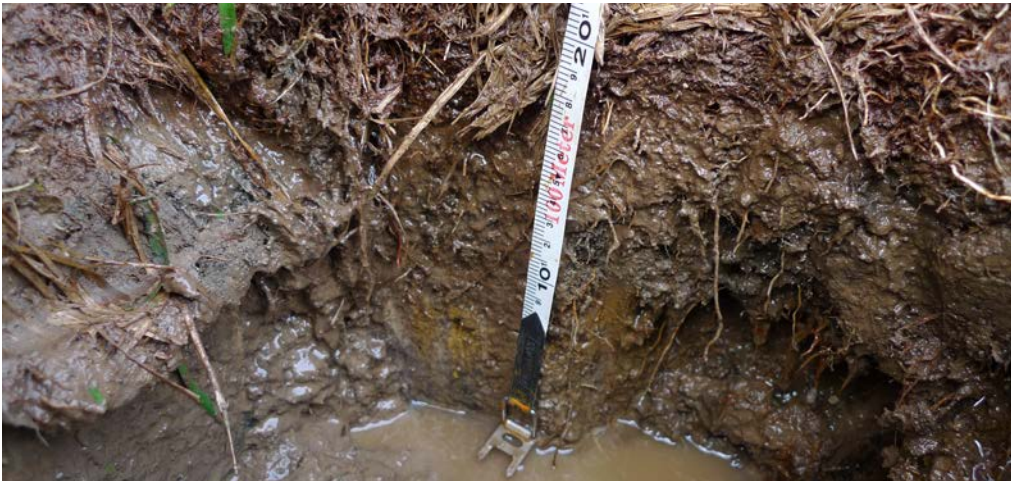
Figure 6: High groundwater table and saturated soil in wetland 1.

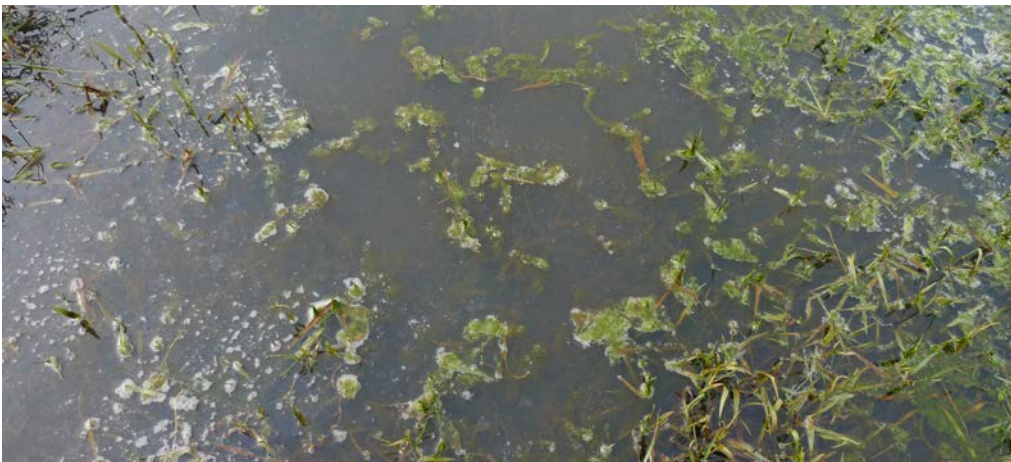
Wetland 2 was unable to undergo a hydrophytic vegetation test due to being inundated with water. Facultative wetland species were present in the ponded area (*Persicaria maculosa* (willow weed)), and on the margins (*Juncus effusus* and *Juncus sarophorus*). Pasture grasses (mainly *Lolium perenne*) and *Chenchrus cladestinus* (kikuyu) were the dominant species in and around the ponded area. Pasture grasses were seen submerged, and there was no emergent vegetation within the ponded area. Vegetation cover in the form of pasture grasses is present in both ponded and exposed areas which indicates this area is only periodically inundated throughout the year. During both site visits the area was inundated, and due to the size, depth, local topography and presence of algae it is likely to be inundated for more than 7 consecutive days. A soil hole was dug near the edge of the water and showed indicators of wetland hydrology and hydric soil (Figure 7). As with wetland 1, this wetland is a result of contouring of fill material, lack of drainage in the fill area and landform consolidation.

Figure 8: Submerged pasture grasses and algae present in wetland.

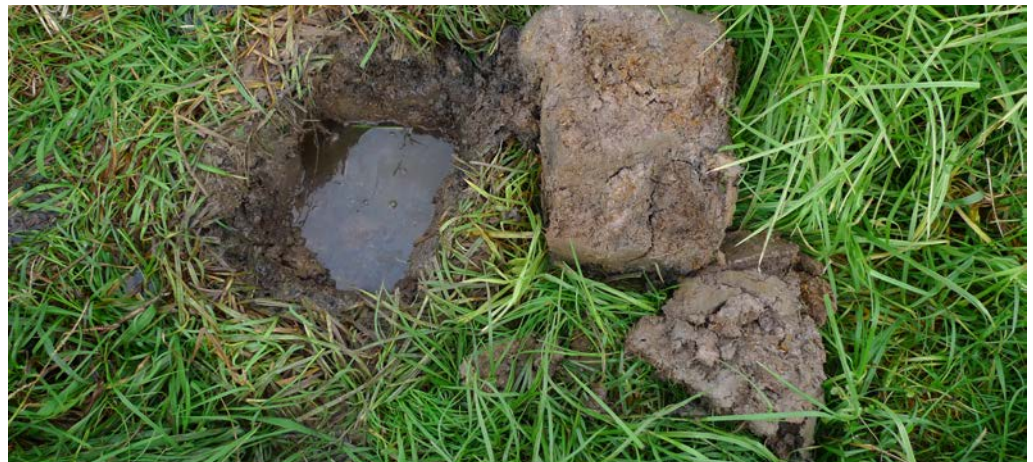
Figure 9: Poorly drained soil near wetland 2 with low chroma colours, mottles and high water table.
