Gleeson Quarries Ltd

Huntly Quarry Disposal Sites

Fill Site 3 – Geotechnical Design Report

Revision A

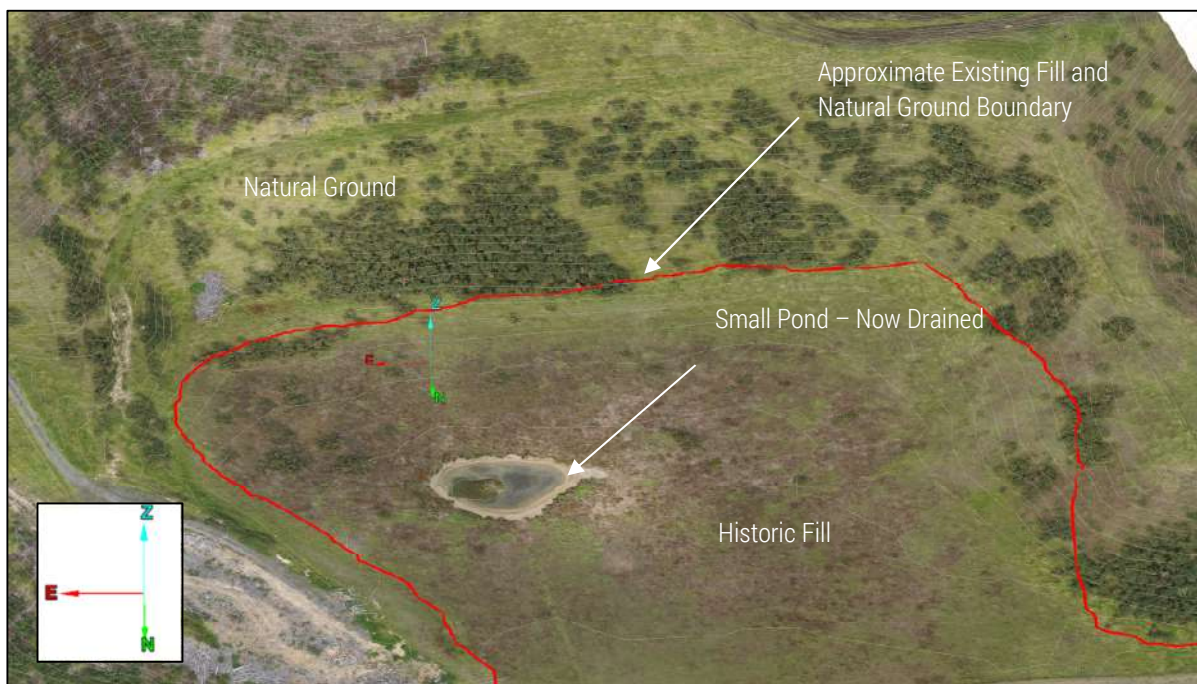
Figure 1: Oblique Image looking South at Fill Site 3 Showing Topographic Features

The general layout and topographical features of Fill Site 3 are shown in Figure 1 below:

Gaia Engineers Ltd have been engaged by Gleeson Quarries Ltd to undertake detailed geotechnical design of the managed fill placement area known as Fill Site 3 located to the north of the existing Huntly Quarry pit as shown in Figure 1.

Gaia Engineers Ltd. have been engaged by Gleeson Quarries Ltd. to provide a geotechnical design for a managed fill placement area known as Fill Site 3 as shown in Figure 1 as well as Drawing No.: 2325-74-06 included in Appendix A.

Fill Site 3 and its relation to the quarry pit and surrounding proposed fill sites is presented in Figure 1 as well as in Drawing No.: 2325-74-06. The site is accessed via the Huntly Quarry located at 300 Riverview Road in the northern Waikato township of Huntly.

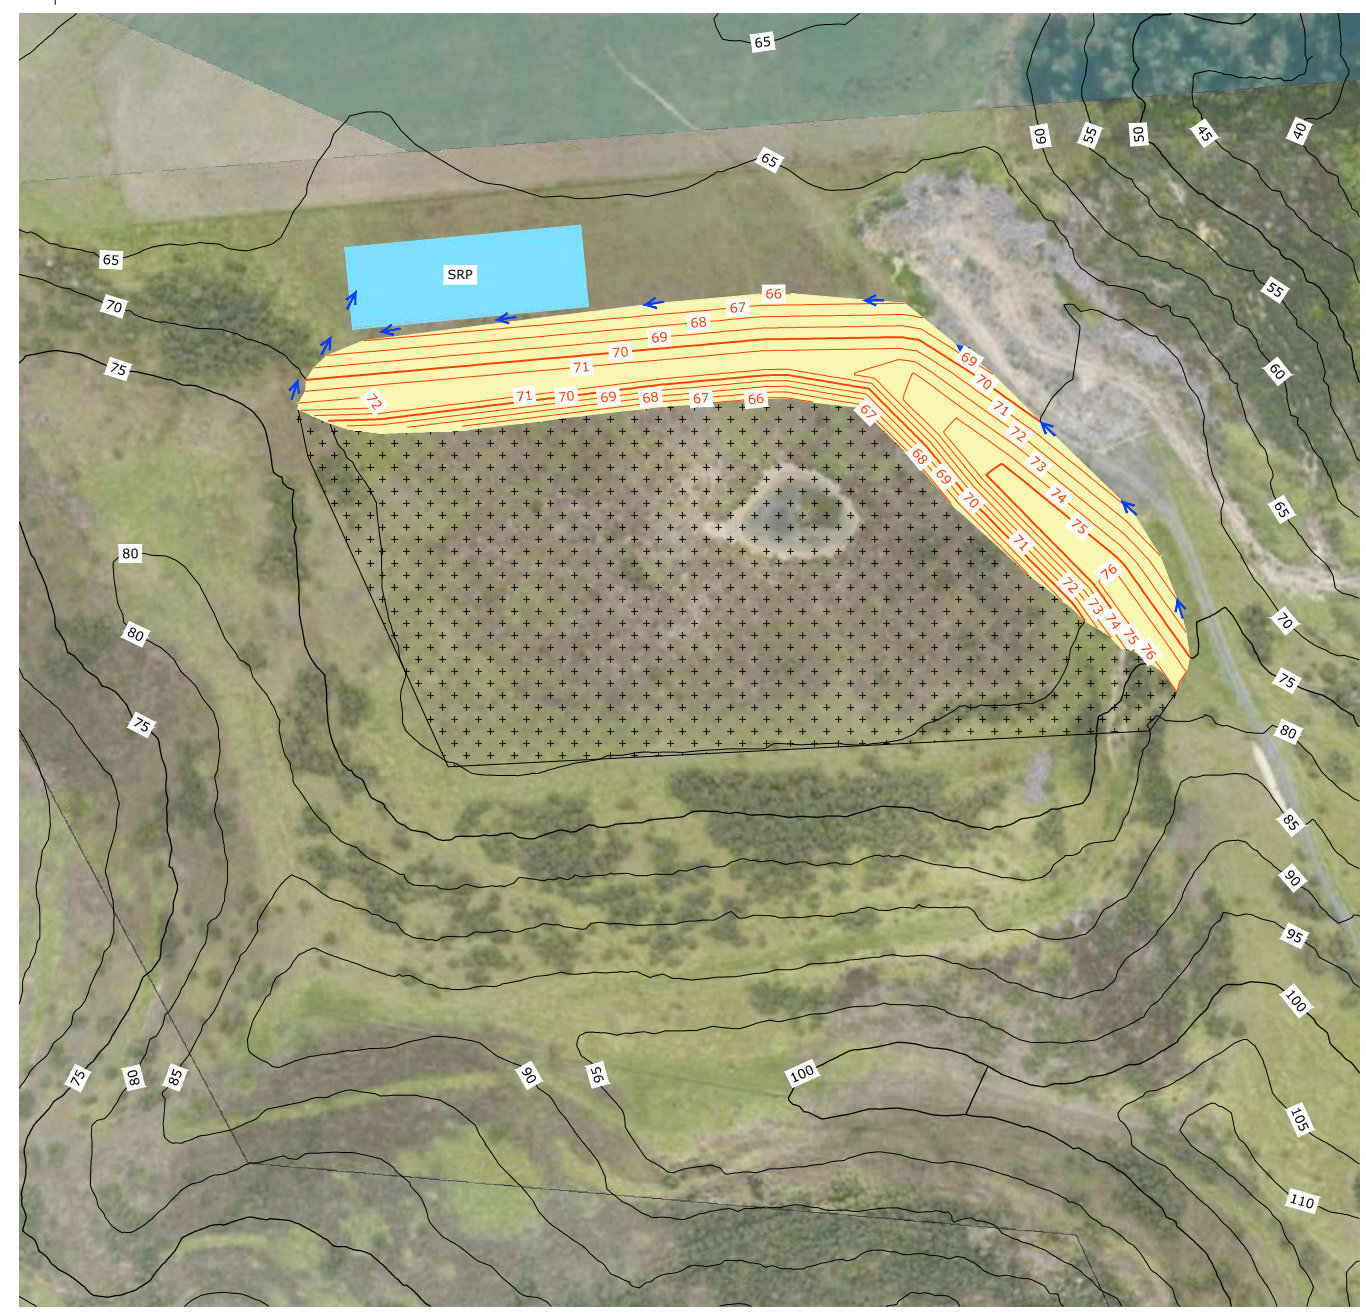
STAGE 1.1 STRUCTURAL FILL (BUND) LAYOUT
 SCALE 1:2000

VOLUME (APPROX.):
MANAGED FILL 103,390m³

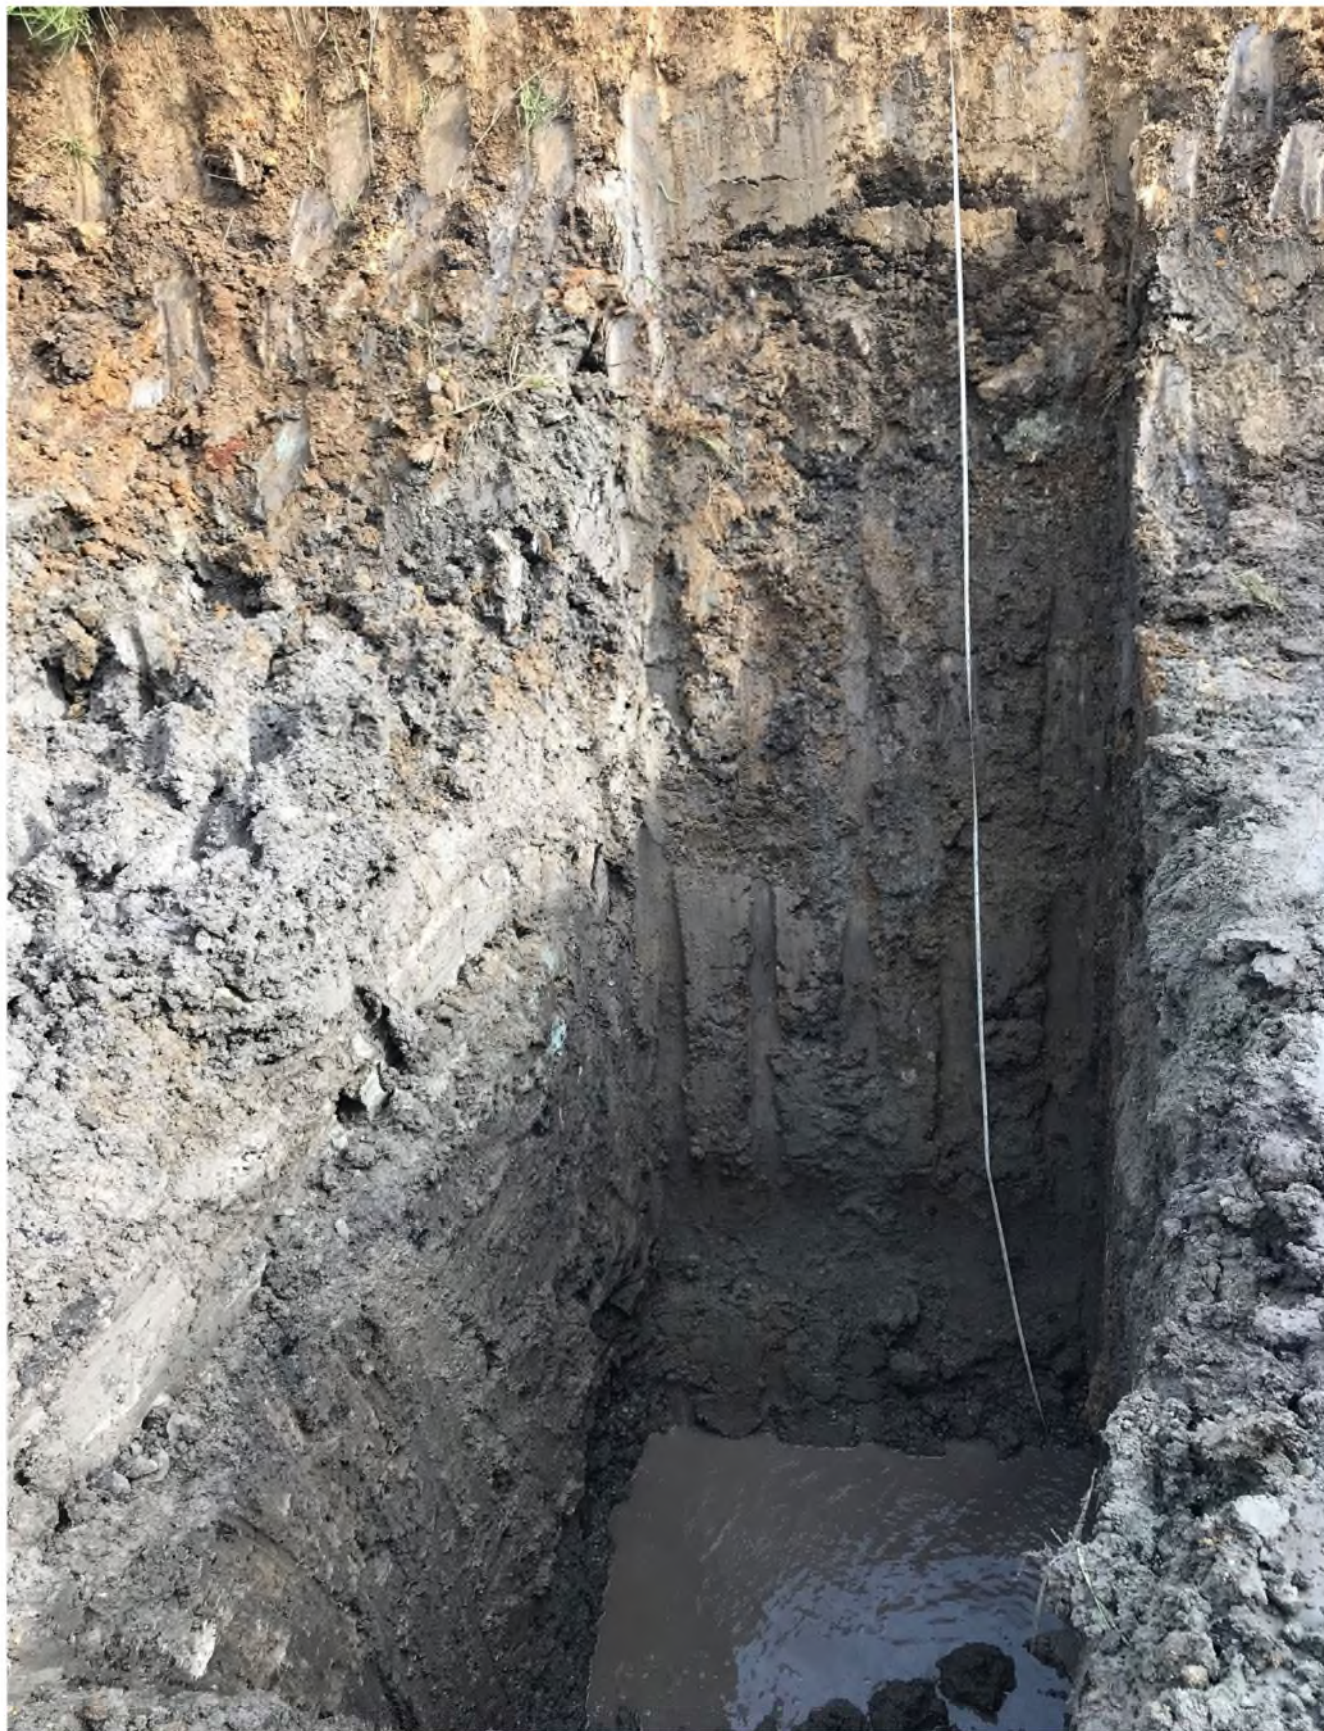
TEST PIT LOG

0.00-0.30 m TOPSOIL														
0.30-5.20 m Clayey SILT with some organic inclusions; grey, orange and dark brown mottles. Very stiff, moist, low plasticity.														
@1.0m - becoming grey with less organics	1					188+	123	55						65.0
@2.5m - becoming stiff, dark grey with some inclusions of green-grey sandy SILT	2					188+	188+							64.0
@3.0m - mottles of inferred Waikato Coal Measures weathered soils (moderate to highly plastic light grey and orange, silty CLAY)	3					188+	75	41						63.0
@3.5m - becoming very stiff						188+								
@4.0m - inclusions of inferred Waikato Coal Measures mudstone boulders and coal	4					188+	106	27						62.0
@4.8m - increase in mudstone boulders, fast seepage observed	5					188+	UTP							61.0
End of Pit @ 5.2 m														
	6													60.0

Contractor: Gleeson Civil Ltd.	Remarks:	Groundwater notes:
Plant: Hitatch 30t Excavator	SV readings corrected to BS1377 - Dial No. 1872	Groundwater Encountered @ 4.8m
Logged: MK		
Checked: KCC		
Approved: KCC	Logged in accordance with NZ Geotechnical Society (2005) guidelines

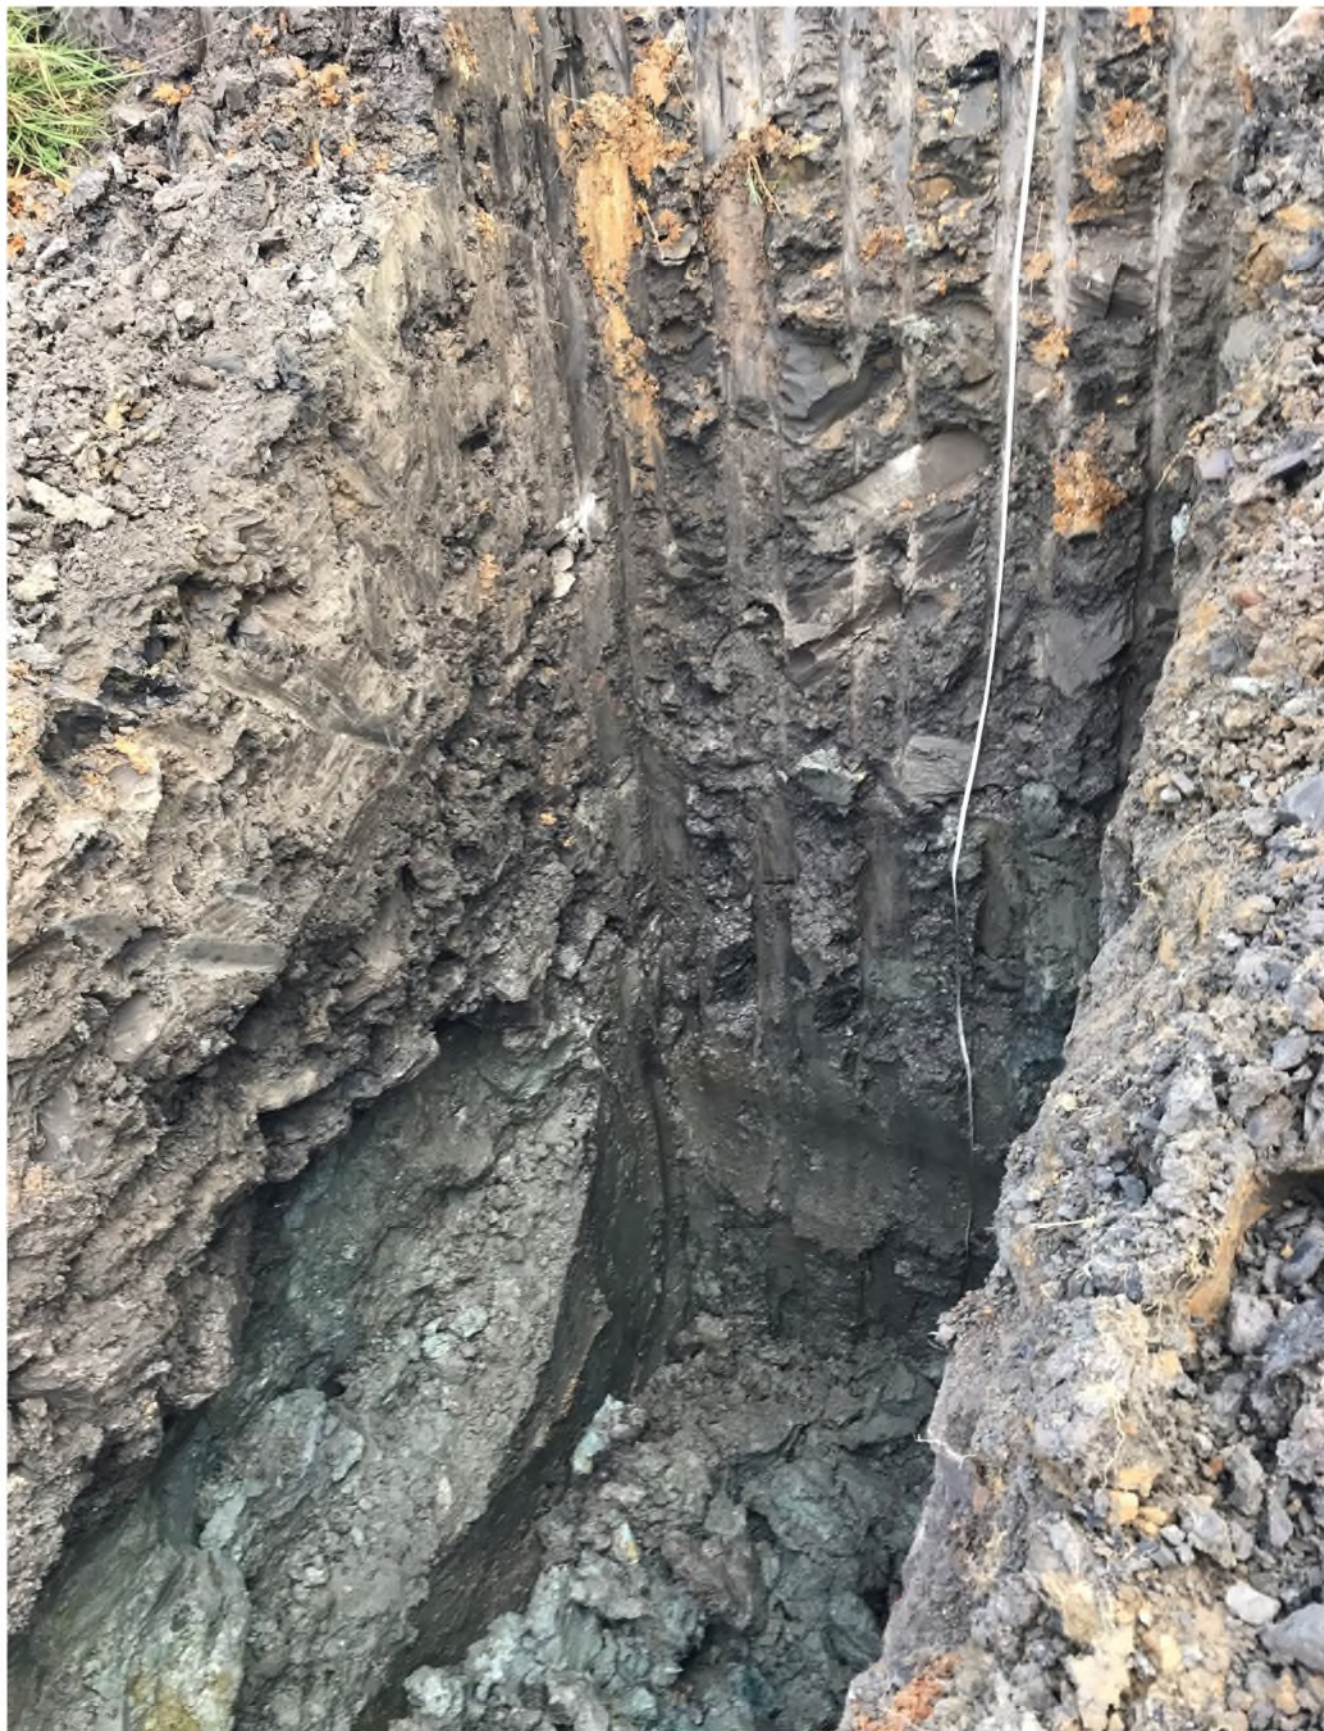
TEST PIT LOG

Soil/Rock Description	Depth(m)	Graphic Log	Geologic Unit	Ground water	Vane Shear Strength (kPa)		Scala (blows/100mm)					Sample ID	Sample Type	R.L (m)
					Tp	Tr	2	4	6	8	10			
0.00-0.10 m TOPSOIL														66.0
0.10-0.30 m Silty CLAY; orange and light grey; Very stiff, moist, low plasticity.														
0.30-5.00 m Clayey SILT; dark grey and black with coal/carbonaceous inclusions @0.5m - becoming dark grey, broken moderately weathered mudstone						UTP								
	1					UTP								65.0
	2					UTP								
						188+								64.0
						130	14							
@3.0m - becoming stiff, blue-grey with some fine sand with limonite and organic staining	3					89	27							63.0
						68	27							
	4					75	27							62.0
						75	27							
End of Pit @ 5.0 m	5					55	14							61.0
	6

Contractor: Gleeson Civil Ltd.	Remarks:	Groundwater notes:
Plant: Hitatch 30t Excavator	SV readings corrected to BS1377 - Dial No. 1872	Groundwater Not Encountered
Logged: MK		
Checked: KCC		
Approved: KCC	Logged in accordance with NZ Geotechnical Society (2005) guidelines

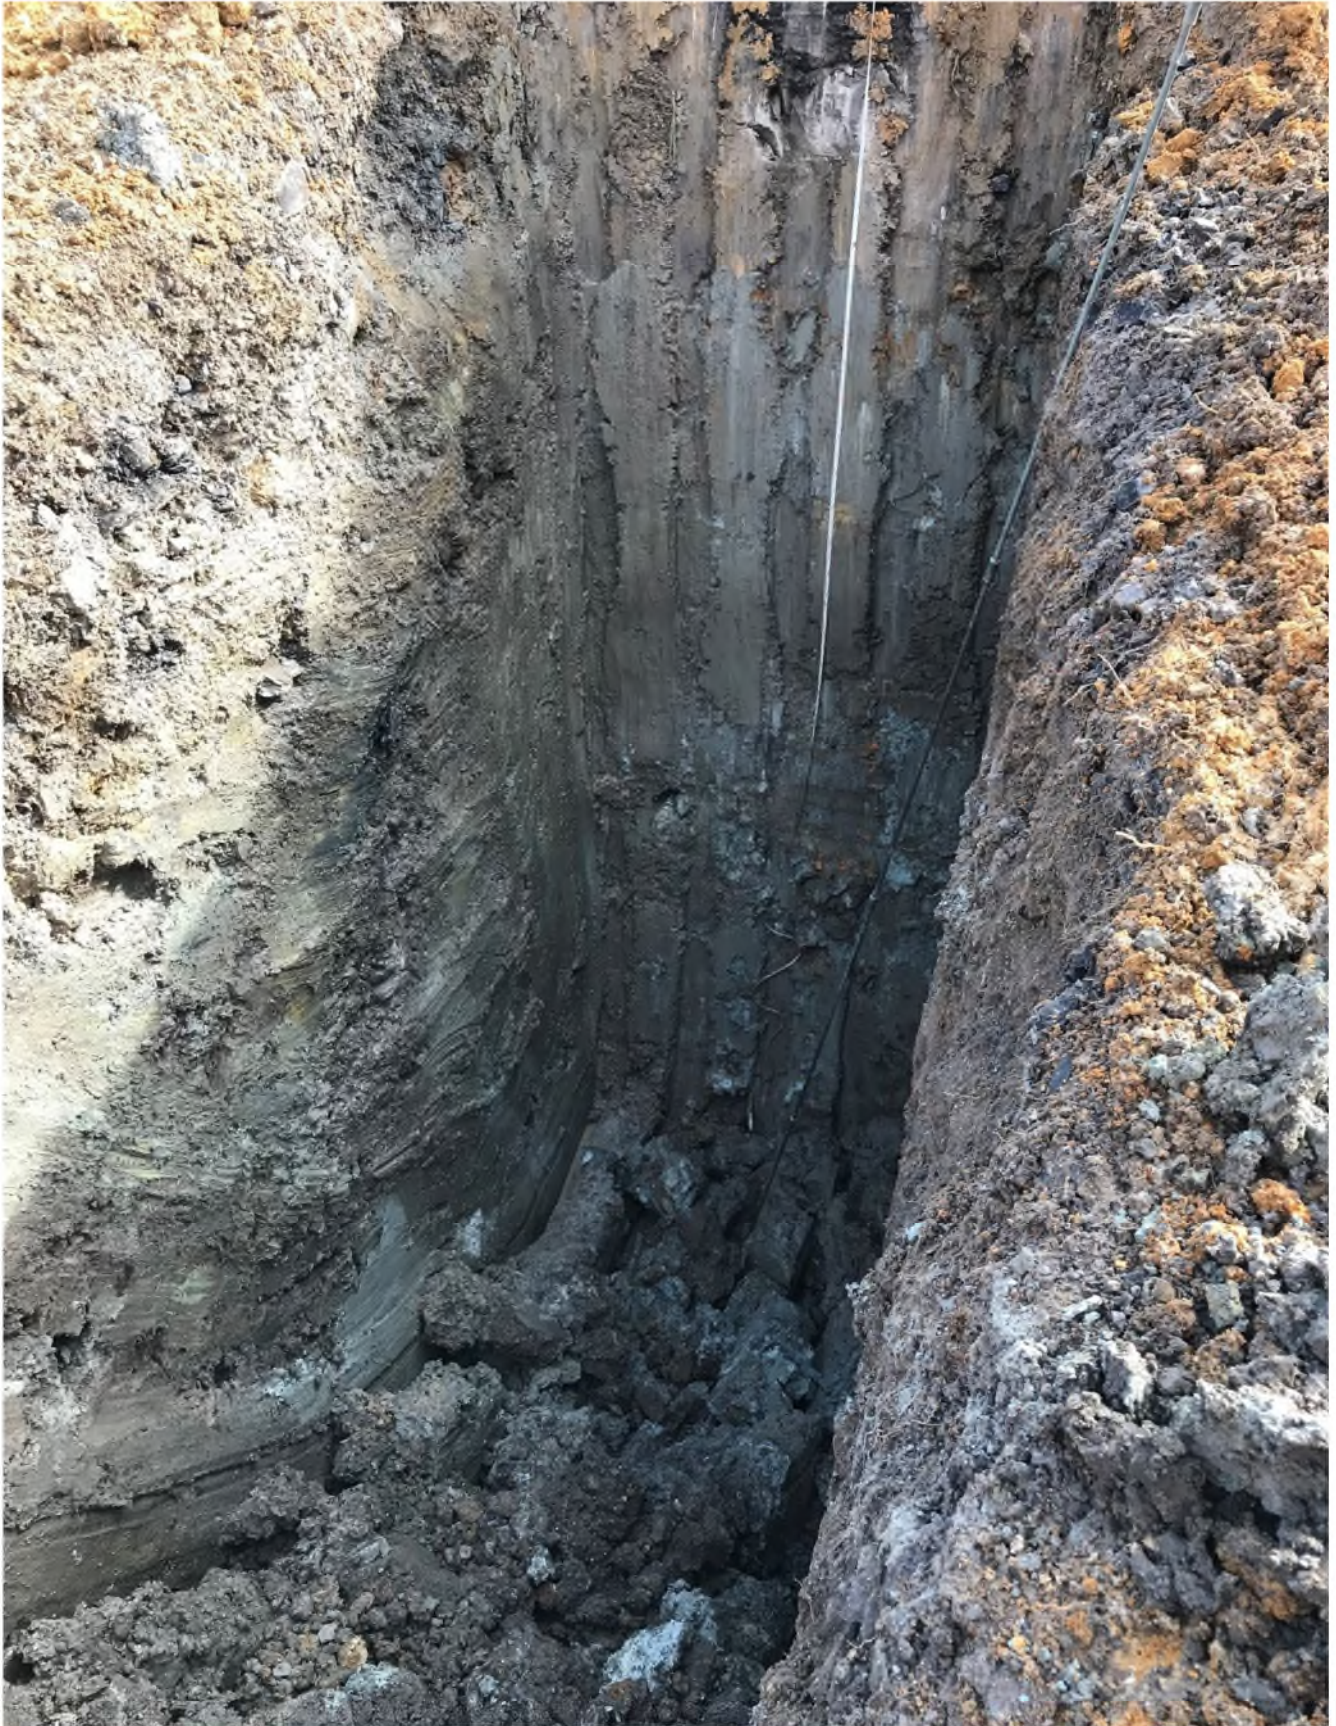
TEST PIT LOG

Soil/Rock Description	Depth(m)	Graphic Log	Geologic Unit	Ground water	Vane Shear Strength (kPa)		Scala (blows/100mm)					Sample ID	Sample Type	R.L (m)
					Tp	Tr	2	4	6	8	10			
0.00-0.10 m TOPSOIL														
0.10-0.30 m Clayey SILT; red, orange and light grey. Very stiff, moist, low plasticity, insensitive.														
0.30-1.50 m Clayey SILT with some carbonized wood fragments and mudstone boulders; dark grey. Very stiff, moist, low plasticity.						102	55							65.0
@1.2m - fast seepage encountered	1					UTP								
1.50-4.50 m Silty CLAY with trace organic staining; light blue-grey. Very stiff, wet, moderate plasticity.														
@2.0m - becoming stiff	2					95	55							64.0
@3.0m - with trace fine sand and fine gravel sized white clasts	3					68	41							63.0
	4					61	34							62.0
End of Pit @ 4.5 m	5					75	41							61.0
	6													60.0

Contractor: Gleeson Civil Ltd.	Remarks:	Groundwater notes:
Plant: Hitatch 30t Excavator	SV readings corrected to BS1377 - Dial No. 1872	Groundwater Not Encountered
Logged: MK		
Checked: KCC		
Approved: KCC	Logged in accordance with NZ Geotechnical Society (2005) guidelines

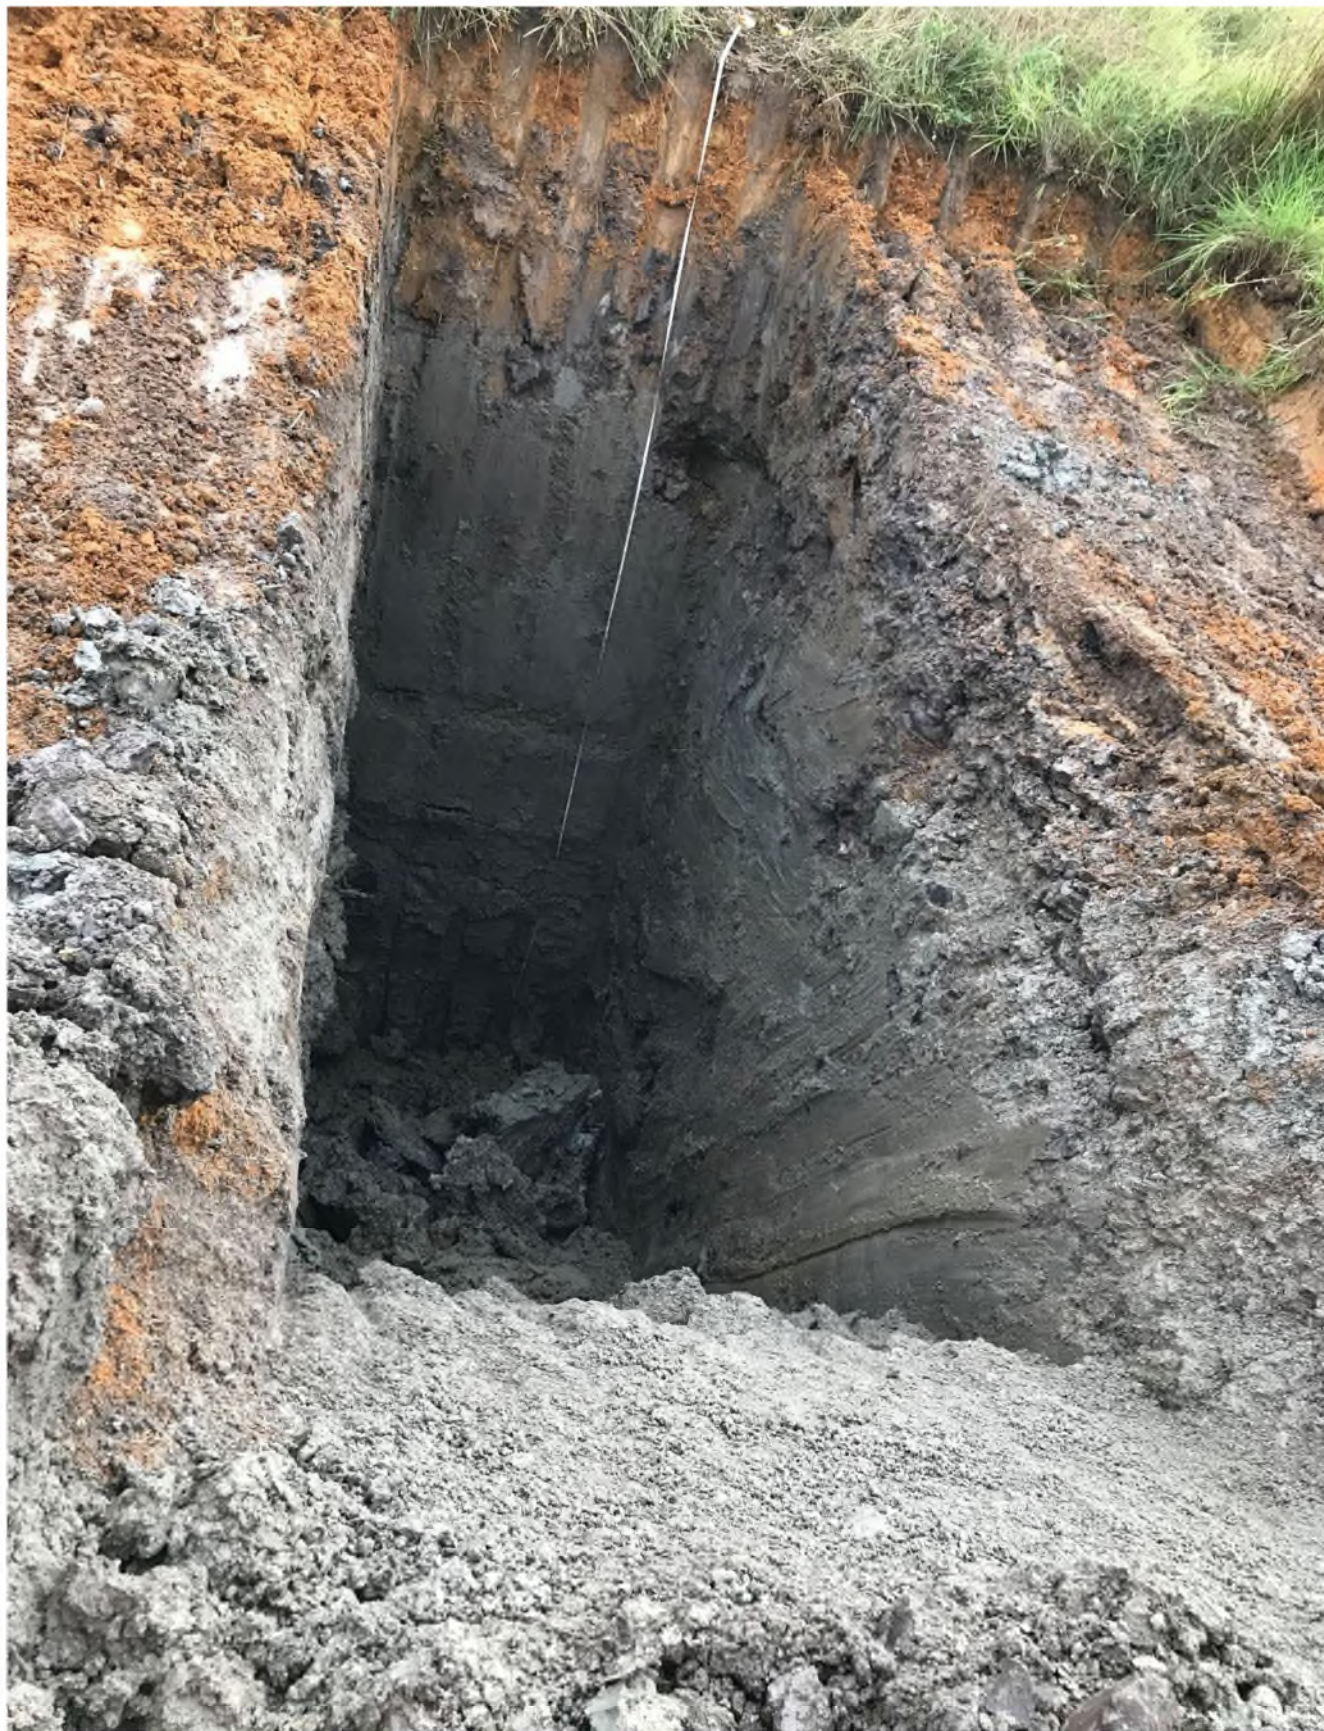
TEST PIT LOG

Soil/Rock Description	Depth(m)	Graphic Log	Geologic Unit	Ground water	Vane Shear Strength (kPa)		Scala (blows/100mm)					Sample ID	Sample Type	R.L (m)	
					Tr	Tr	2	4	6	8	10				12
0.00-0.10 m TOPSOIL														66.0	
0.10-0.50 m Clayey SILT; light brown-orange. Very stiff, moist, low plasticity															
0.50-1.50 m Slightly weathered MUDSTONE boulders in silty CLAY matrix; dark grey with black and light grey mottles. Hard/tightly packed, moist.	1				188+									65.0	
1.50-5.00 m Silty CLAY; light blue-grey. Stiff, moist, moderate plasticity.	2		Historic Mining Fill		82	41									
@2.0m - with some fine sand, remnant mudstone fabric visible					68	41									64.0
	3				75	41									
	4				68	41									63.0
	5				75	34									62.0
End of Pit @ 5.0 m	5			75	41									61.0	
	6

Contractor: Gleeson Civil Ltd.	Remarks:	Groundwater notes:
Plant: Hitatch 30t Excavator	SV readings corrected to BS1377 - Dial No. 1872	Groundwater Not Encountered
Logged: MK		
Checked: KCC		
Approved: KCC	Logged in accordance with NZ Geotechnical Society (2005) guidelines

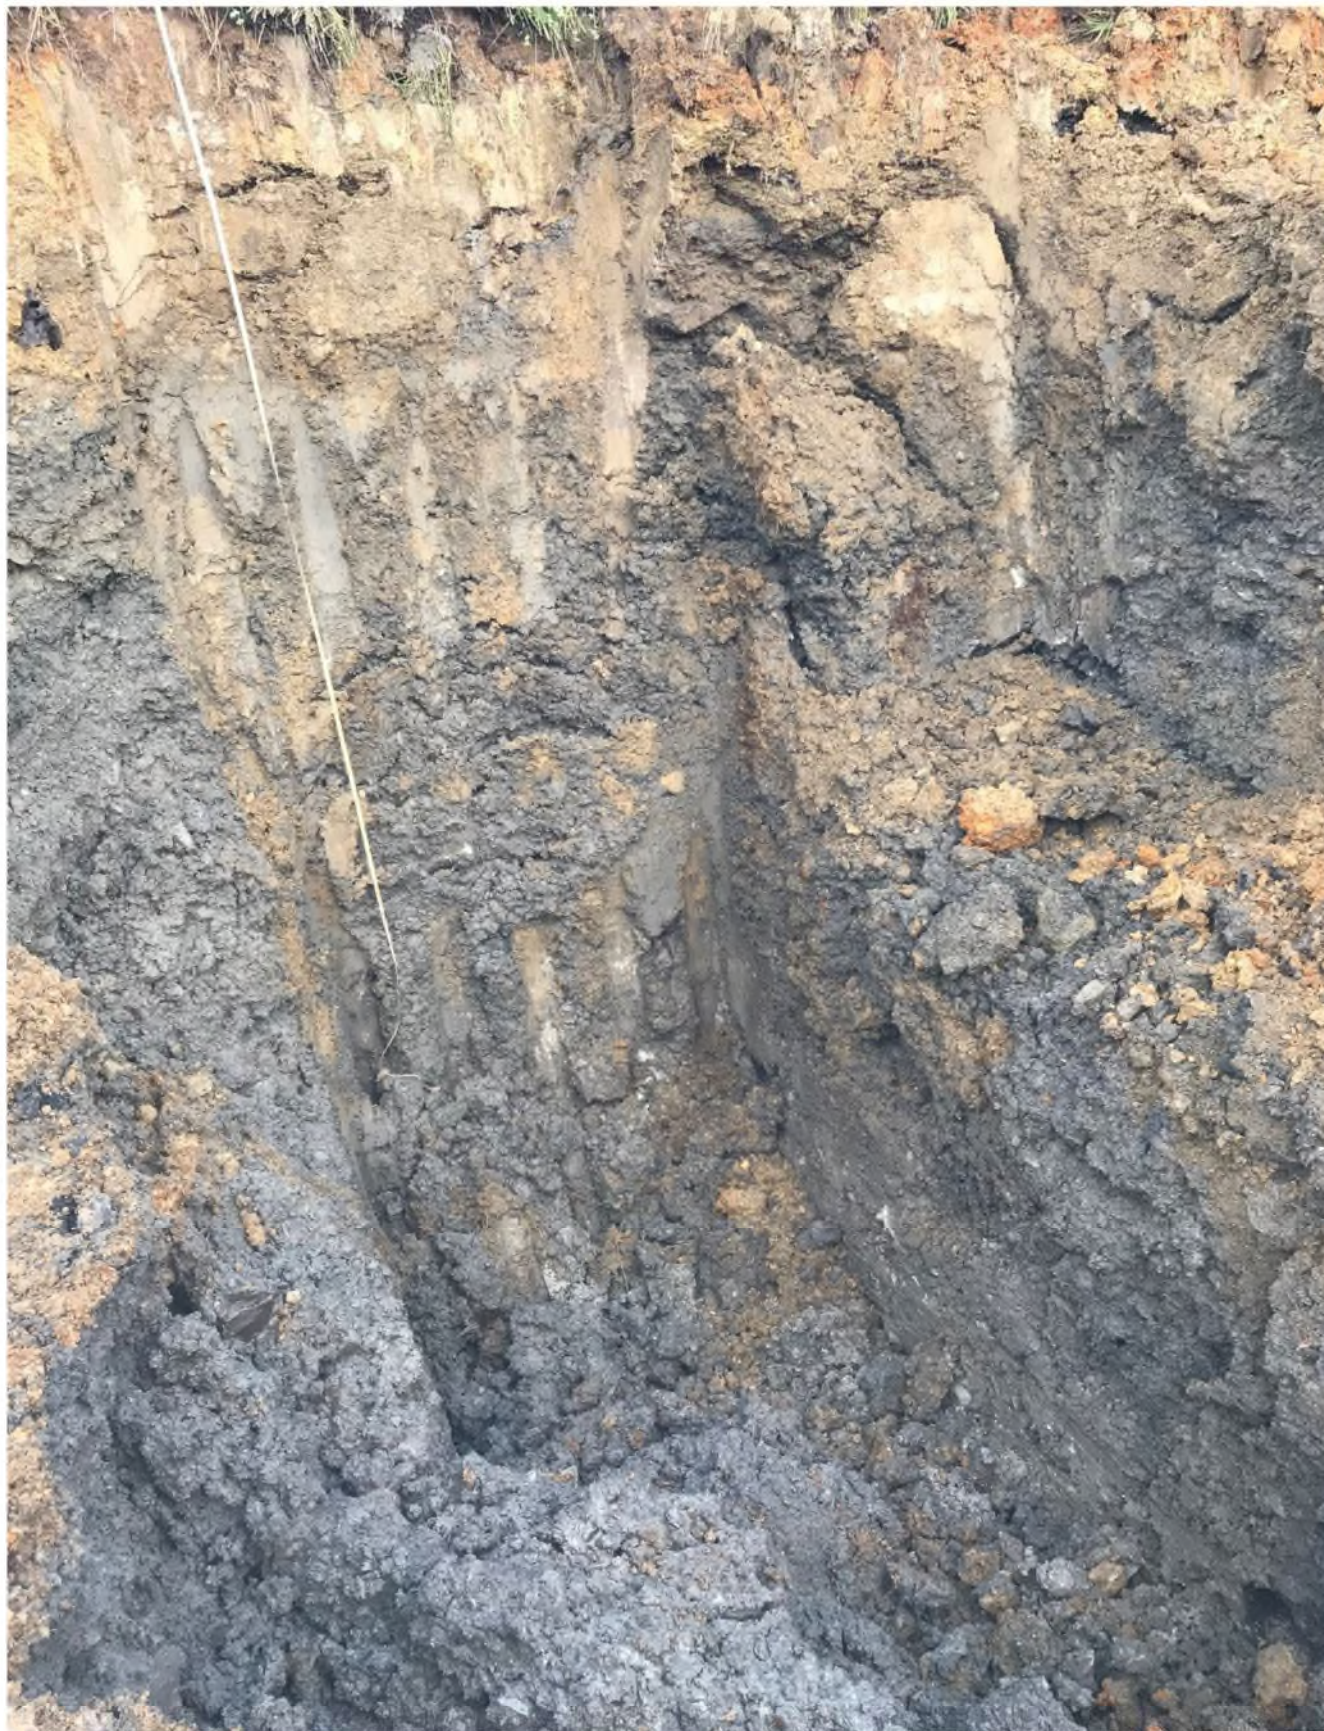
TEST PIT LOG

Soil/Rock Description	Depth(m)	Graphic Log	Geologic Unit	Ground water	Vane Shear Strength (kPa)		Scala (blows/100mm)					Sample ID	Sample Type	R.L (m)	
					Tp	Tr	2	4	6	8	10				12
0.00-0.10 m TOPSOIL															
0.10-1.00 m Clayey SILT; orange-brown. Very stiff, moist, low plasticity															
@0.5 to 1.0m - very weak moderately weathered mudstone inclusions						188+								67.0	
1.00-3.50 m Silty BOULDERS with some silty and clay; dark grey with black and light grey mottles. Tightly packed; moist; slightly weathered mudstone; silt and clay, low plasticity.	1		Historic Mining Fill			95	27								
@1.5m - mudstone inclusions becomes medium to coarse gravel sized.							136	27							66.0
@2.0m - fast seepage encountered	2				▼		82	30							
	3						89	34							65.0
	4						95	27							64.0
End of Pit @ 3.5 m															
	5													63.0	
	6													62.0

Contractor: Gleeson Civil Ltd.	Remarks:	Groundwater notes:
Plant: Hitatch 30t Excavator	SV readings corrected to BS1377 - Dial No. 1872	Groundwater encountered @ 2.0m
Logged: MK	Terminated Due to Pit Collapsing	
Checked: KCC		
Approved: KCC	Logged in accordance with NZ Geotechnical Society (2005) guidelines

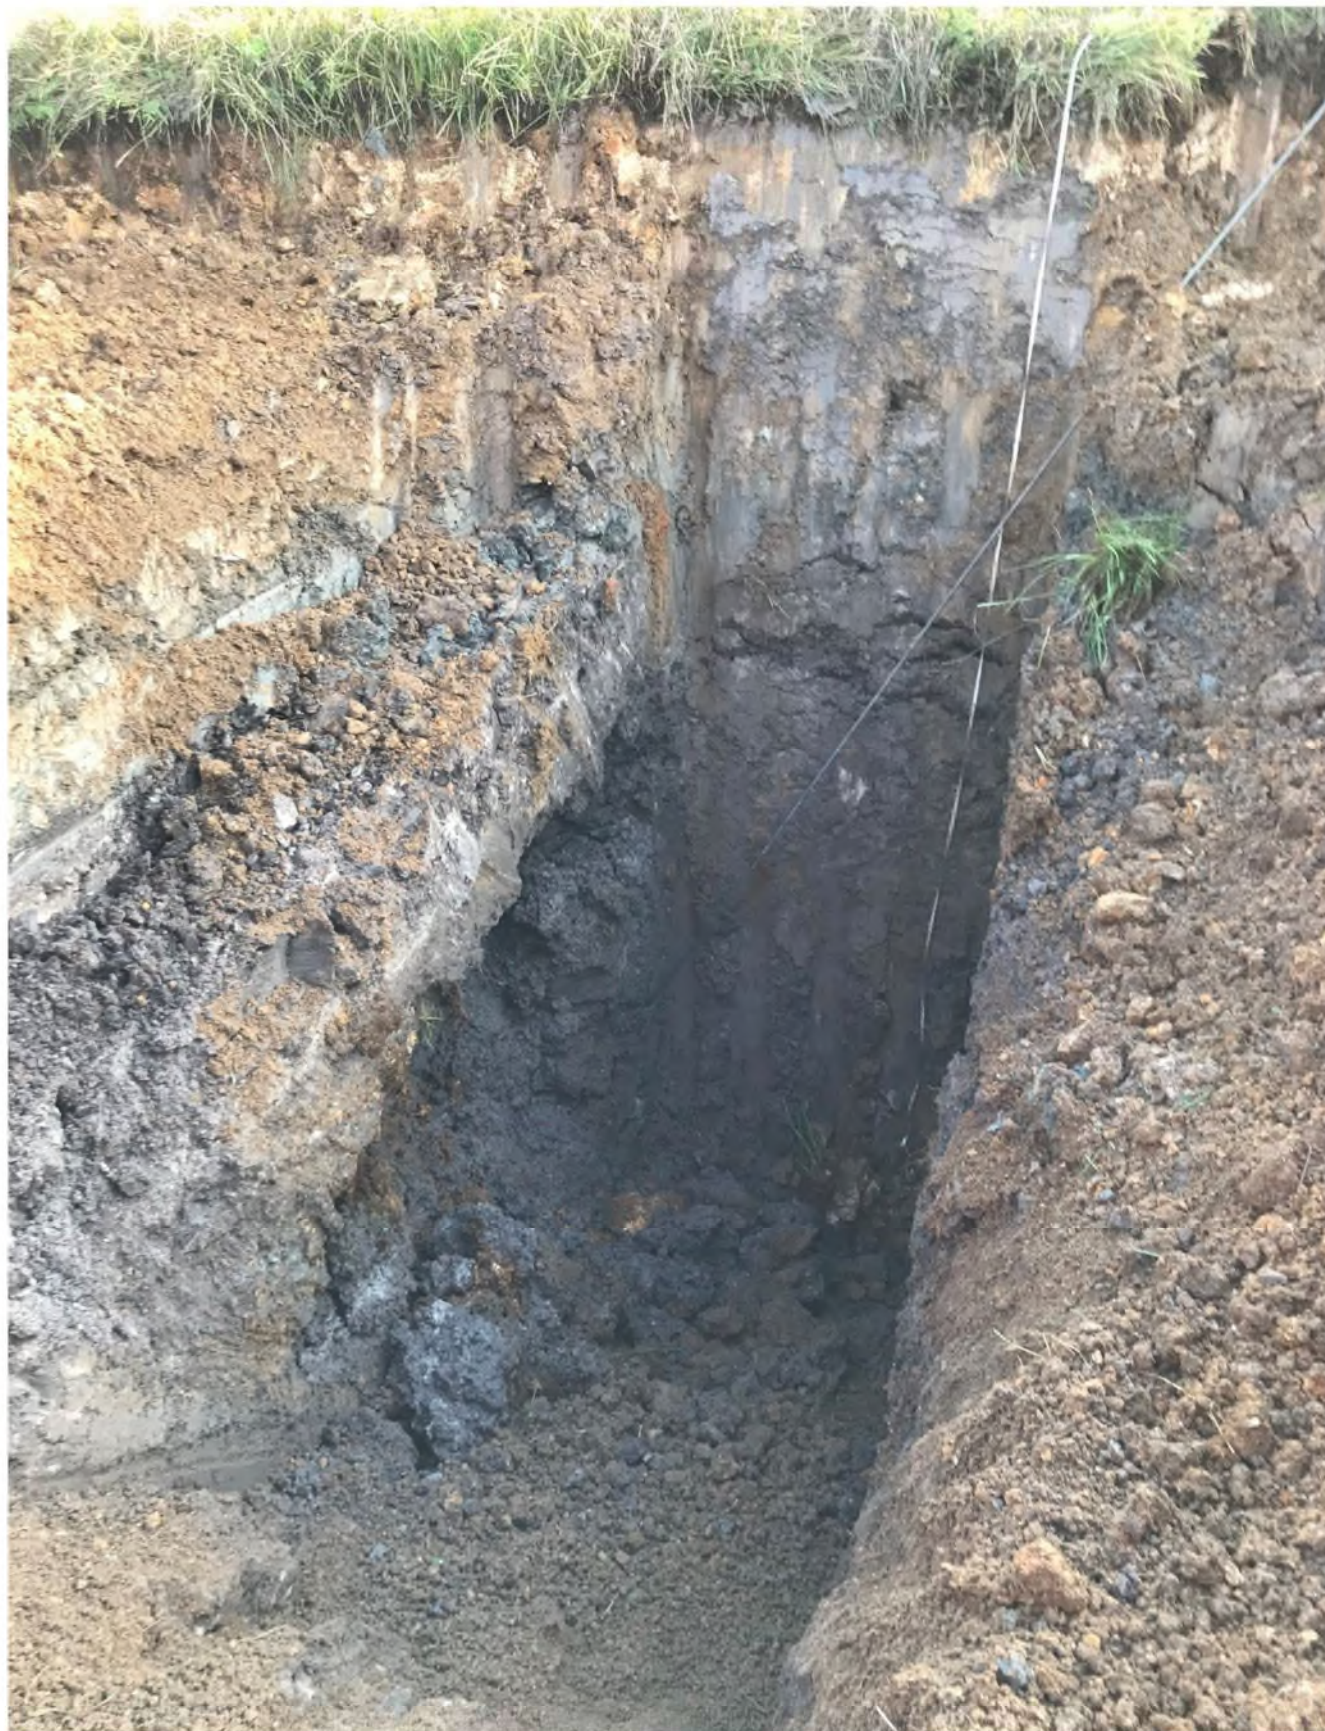
TEST PIT LOG

Soil/Rock Description	Depth(m)	Graphic Log	Geologic Unit	Ground water	Vane Shear Strength (kPa)		Scala (blows/100mm)					Sample ID	Sample Type	R.L (m)	
					Tp	Tr	2	4	6	8	10				12
0.00-0.10 m TOPSOIL															
0.10-0.60 m Clayey SILT with trace topsoil; dark orange, light grey and grey mottles. Very stiff, moist, low plasticity					129	48								67.0	
0.60-1.50 m Silty CLAY with some cobbles; grey. Very stiff, moist, low plasticity; cobbles are moderately weathered mudstone, fractured.	1				UTP										
1.50-4.00 m Silty COBBLES with some clay and boulders; brownish grey. Loosely packed; moist; slightly weathered mudstone; silt and clay, low plasticity.			Historic Mining Fill		116	41								66.0	
@2.0m - mudstone cobbles become fine to coarse gravel.	2					109	41								65.0
	3					129	55								64.0
	4					143	41								63.0
End of Pit @ 4.0 m														62.0

Contractor: Gleeson Civil Ltd.	Remarks:	Groundwater notes:
Plant: Hitatch 30t Excavator	SV readings corrected to BS1377 - Dial No. 1872	Groundwater Not Encountered
Logged: MK	Terminated Due to Pit Collapsing	
Checked: KCC		
Approved: KCC	Logged in accordance with NZ Geotechnical Society (2005) guidelines

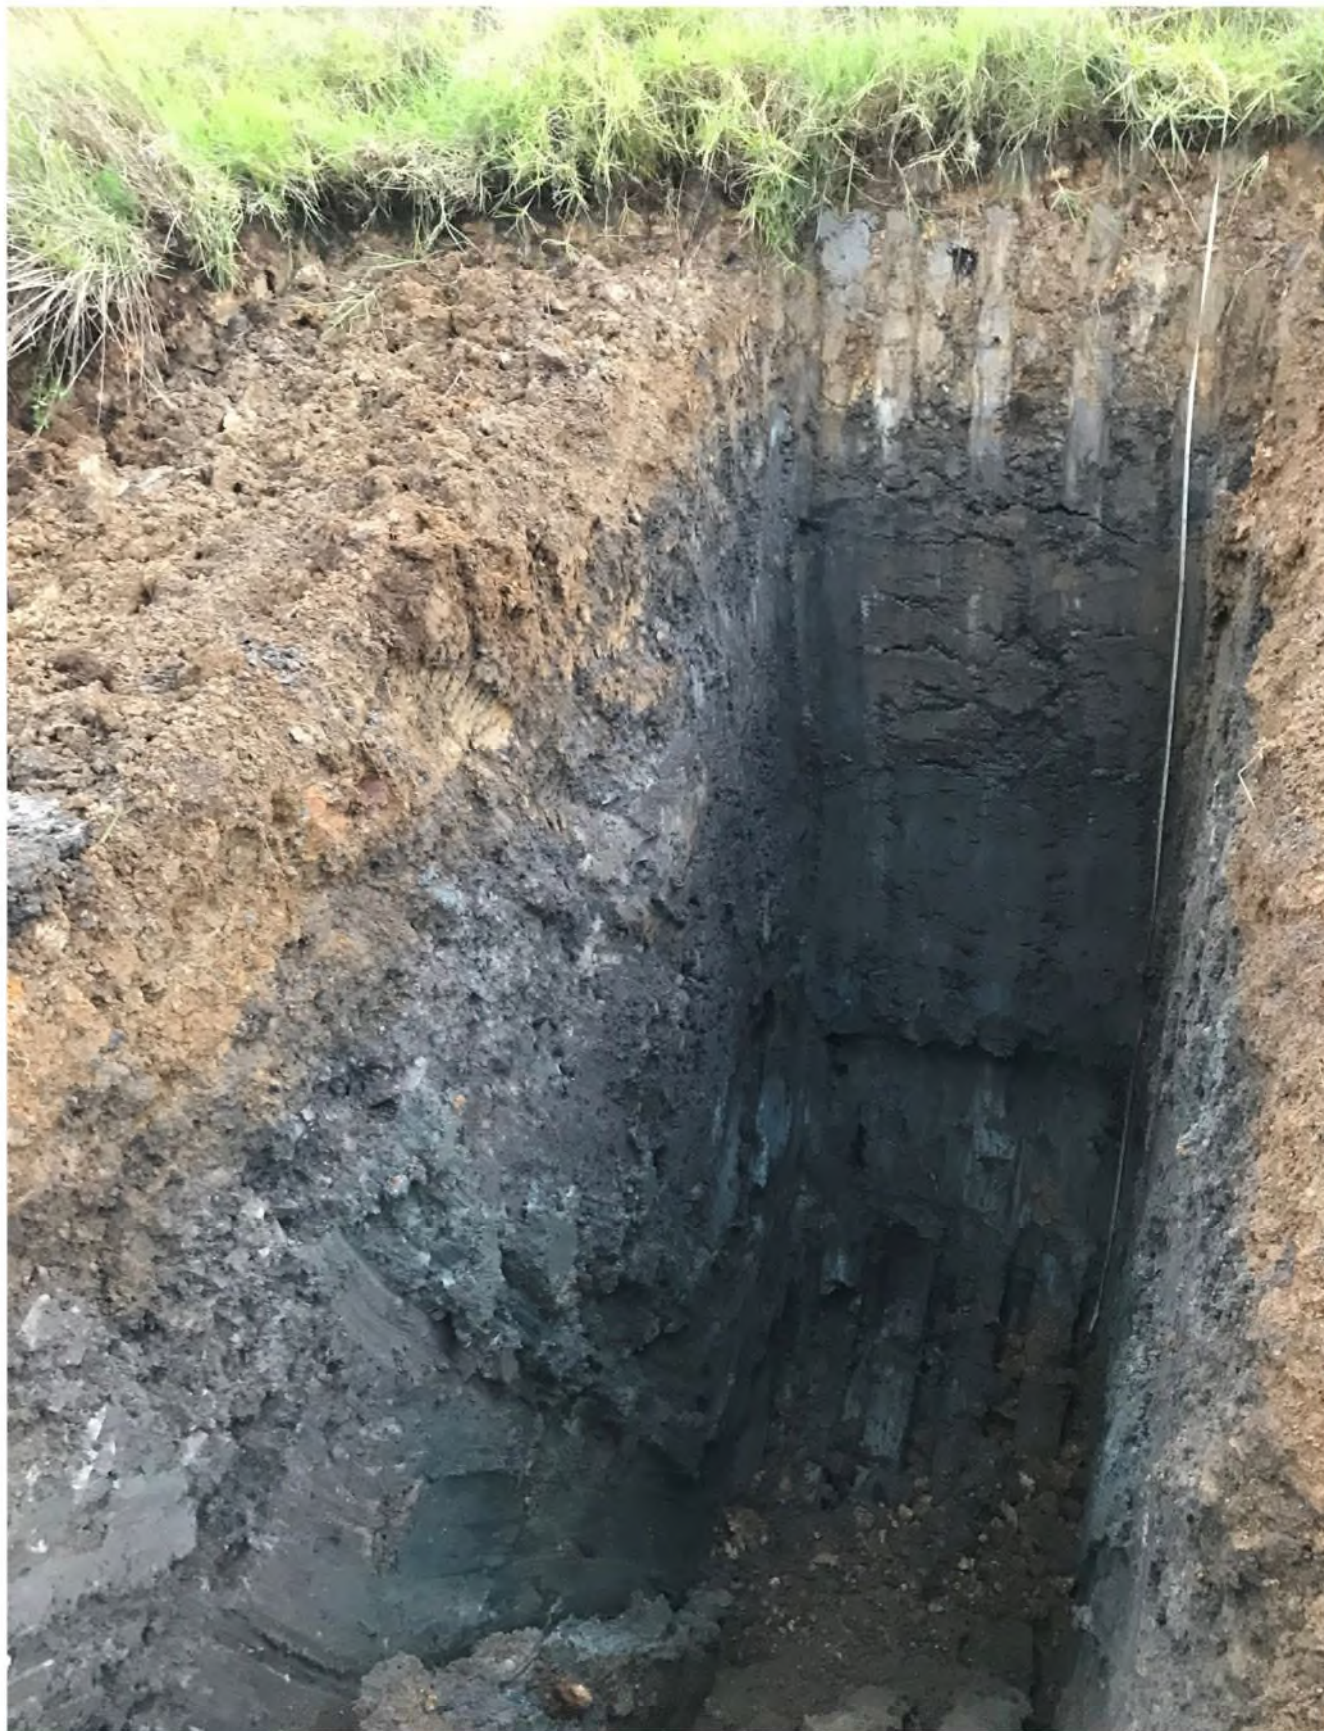
TEST PIT LOG

Soil/Rock Description	Depth(m)	Graphic Log	Geologic Unit	Ground water	Vane Shear Strength (kPa)		Scala (blows/100mm)					Sample ID	Sample Type	R.L (m)
					Tp	Tr	2	4	6	8	10			
0.00-1.00 m Clayey SILT; light brown-orange and brown mottles. Stiff, moist, low plasticity.	0.00 - 1.00	[X-pattern]												67.0
1.00-4.00 m Clayey SILT with some gravel; grey-brown. Stiff, moist, low plasticity; gravels are fine to coarse, mudstone.	1.00 - 4.00	[X-pattern]	Historic Mining Fill											66.0 65.0 64.0
End of Pit @ 4.0 m	4.00													63.0 62.0

Contractor: Gleeson Civil Ltd.	Remarks:	Groundwater notes:
Plant: Hitatch 30t Excavator	SV readings corrected to BS1377 - Dial No. 1872	Groundwater Not Encountered
Logged: MK		
Checked: KCC		
Approved: KCC	Logged in accordance with NZ Geotechnical Society (2005) guidelines
