Gleeson Quarries Ltd

Huntly Quarry Disposal Sites

Fill Site 3 – Geotechnical Design Report

Revision A

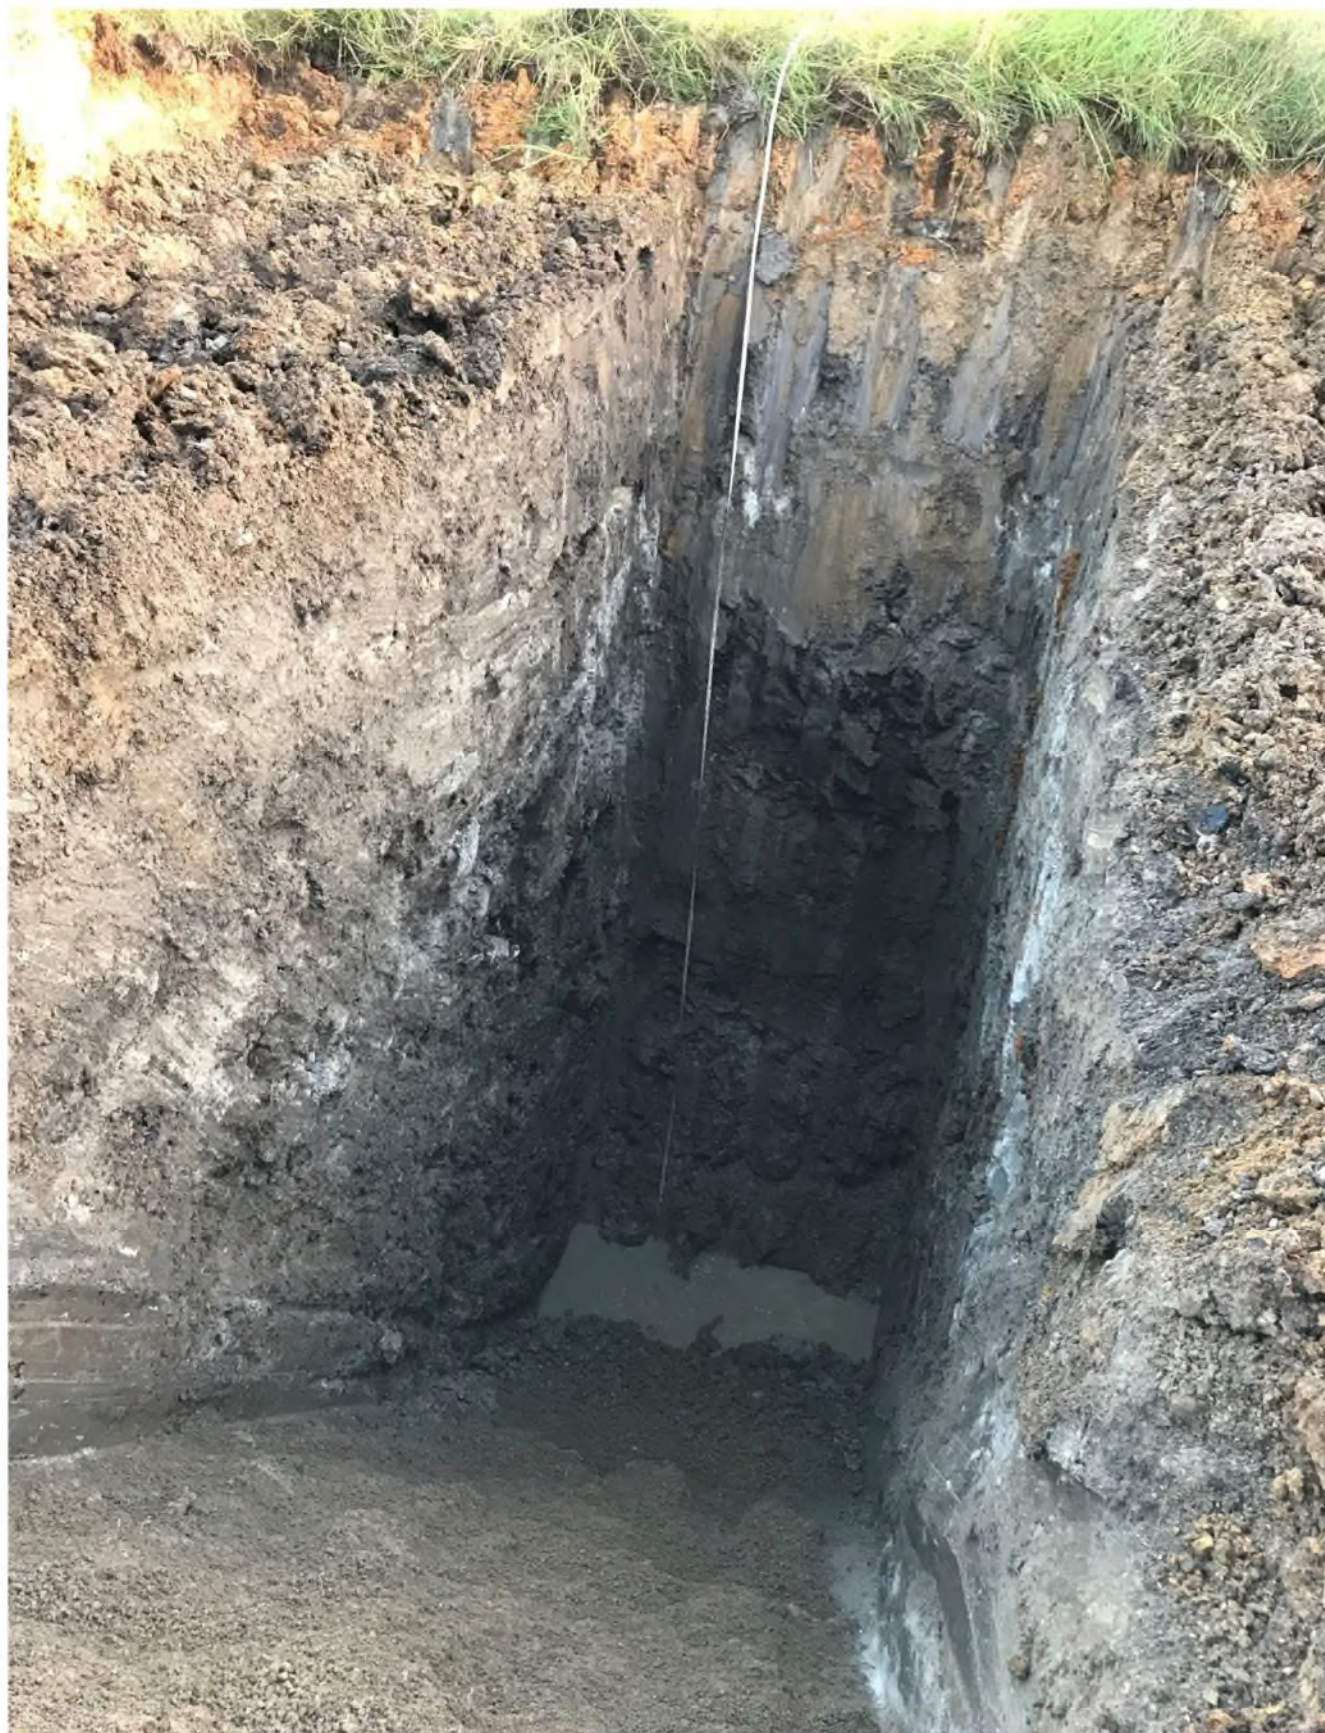
TEST PIT LOG

Soil/Rock Description	Depth(m)	Graphic Log	Geologic Unit	Ground water	Vane Shear Strength (kPa)		Scala (blows/100mm)					Sample ID	Sample Type	R.L (m)
					Tp	Tr	2	4	6	8	10			
0.00-0.10 m TOPSOIL														
0.10-0.50 m Clayey SILT; light brown-orange, grey and brown mottles. Very stiff, moist, low plasticity.														
0.50-5.00 m Clayey SILT with some gravel; grey and brown mottles. Very stiff, moist, low plasticity; gravels are moderately weathered mudstone and coal fragments.	1					188+								66.0
@1.5m - increase in size of mudstone gravel to cobbles and boulders	2					188+								65.0
	3					188+								64.0
@4.0m - fast seepage encountered	4			▼		188+								63.0
	5					188+								62.0
End of Pit @ 5.0 m	6													61.0

Contractor: Gleeson Civil Ltd.	Remarks:	Groundwater notes:
Plant: Hitatch 30t Excavator	SV readings corrected to BS1377 - Dial No. 1872	Groundwater Encountered @ 4.0m
Logged: MK		
Checked: KCC		
Approved: KCC	Logged in accordance with NZ Geotechnical Society (2005) guidelines

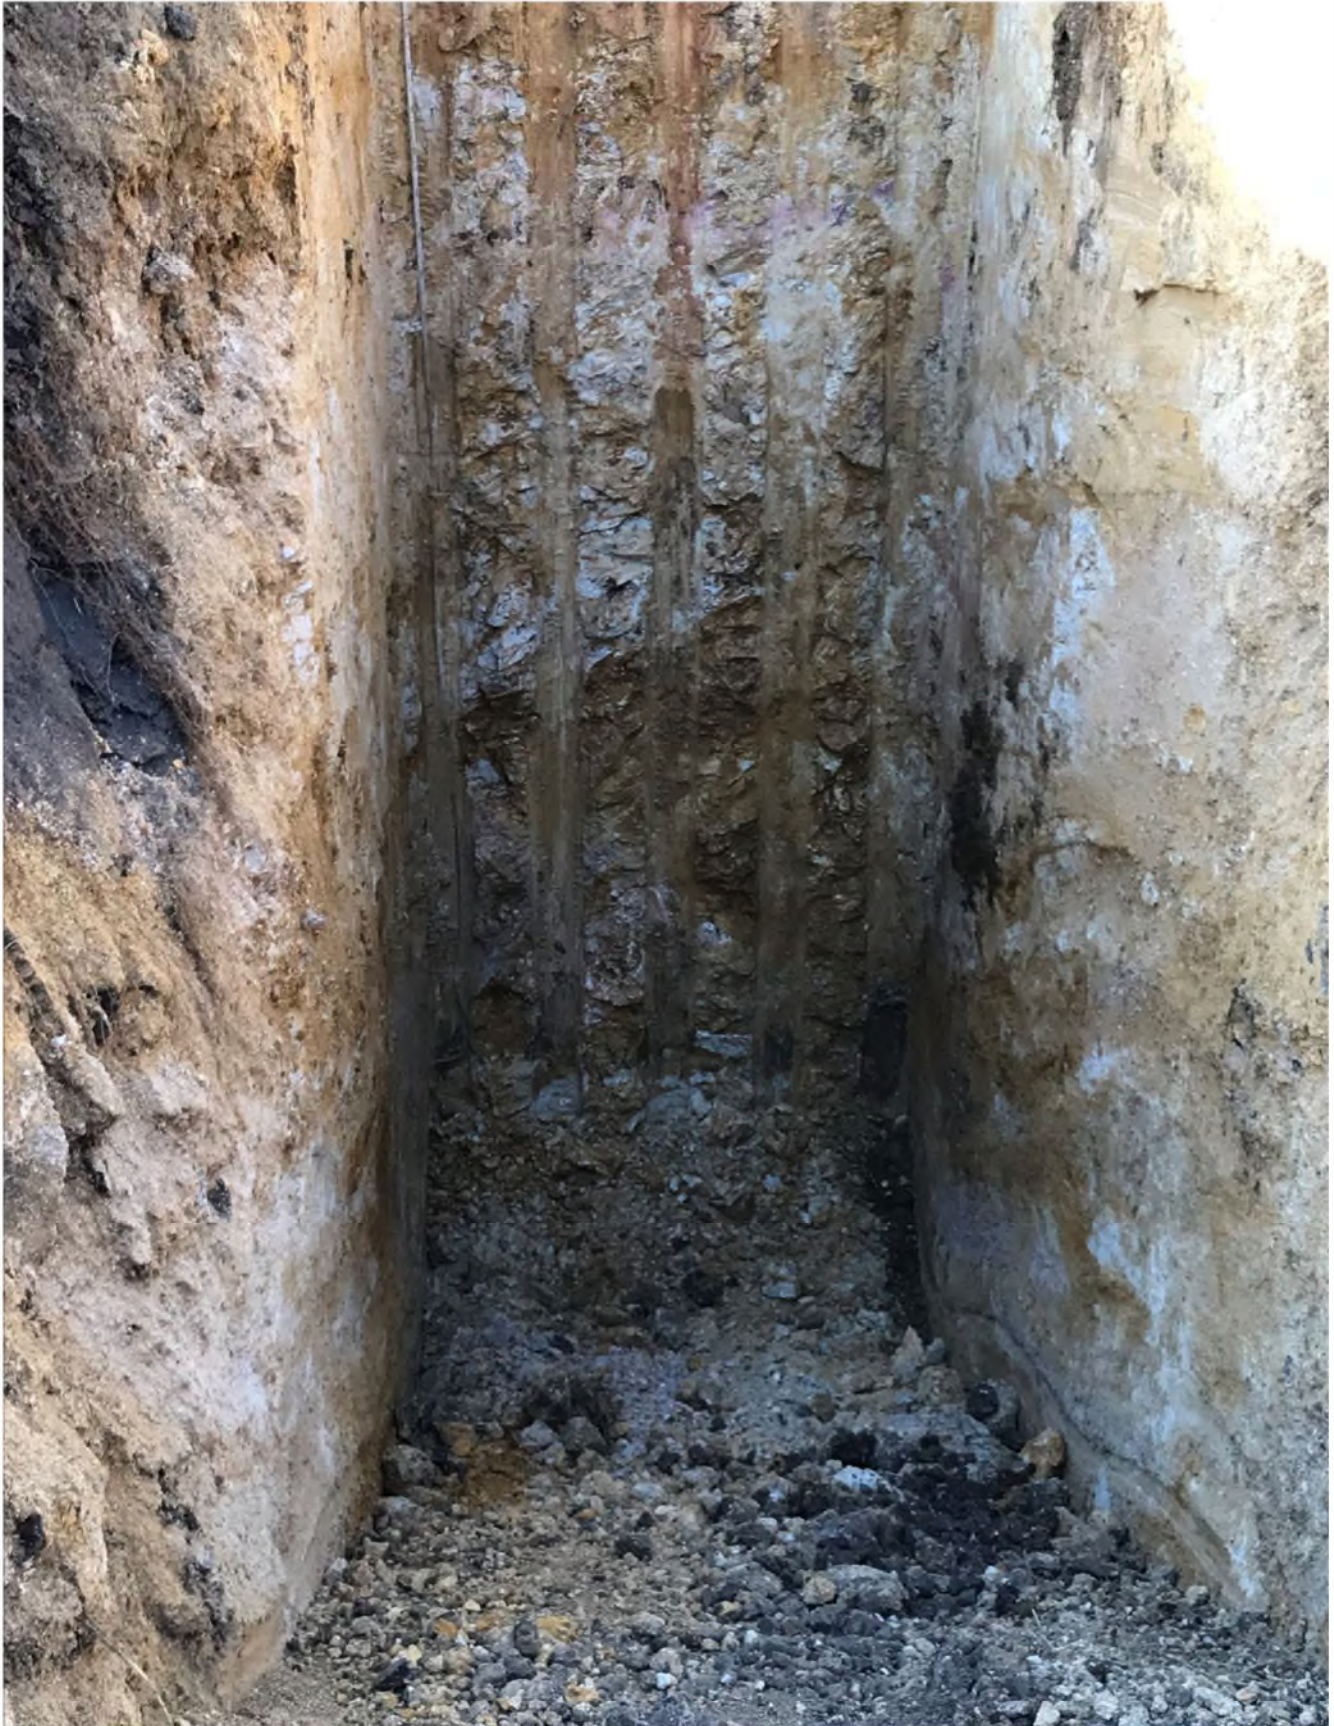
TEST PIT LOG

Soil/Rock Description	Depth(m)	Graphic Log	Geologic Unit	Ground water	Vane Shear Strength (kPa)		Scala (blows/100mm)					Sample ID	Sample Type	R.L (m)
					Tp	Tr	2	4	6	8	10			
0.00-0.20 m TOPSOIL														
0.20-1.20 m Silty CLAY; light grey and orange. Very stiff, moist, moderate to high plasticity.	1				188+									71.0
1.20-4.00 m Completely weathered, light grey with orange streaks, MUDSTONE; extremely weak [clayey SILT; Hard, moist, non plastic].	2				188+									70.0
@2.0 to 2.5m - becoming brown orange with red and pink streaks					143	55								69.0
	3				136	49								68.0
	4				143	41								67.0
4.00-5.50 m Highly weathered, brown-orange with pink and red streaks, MUDSTONE; extremely weak [clayey SILT; hard, moist, non plastic]	5				188+									
End of Pit @ 5.5 m	6													66.0

Contractor: Gleeson Civil Ltd.	Remarks:	Groundwater notes:
Plant: Hitatch 30t Excavator	SV readings corrected to BS1377 - Dial No. 1872	Groundwater Not Encountered
Logged: MK		
Checked: KCC		
Approved: KCC	Logged in accordance with NZ Geotechnical Society (2005) guidelines
