Project No: 2325-12	Ref: Huntly Quarry Managed Fill Sites 2-4 – Geotechnical S92 Response	Revision: A
----------------------------	--	--------------------

2322-12-GQ-03 (Geotechnical RFI Response)

**HUNTLY QUARRY – FILL DISPOSAL SITES
SUMMARY REGISTER OF GEOTECHNICAL COMMENTS FROM PEER REVIEWER**

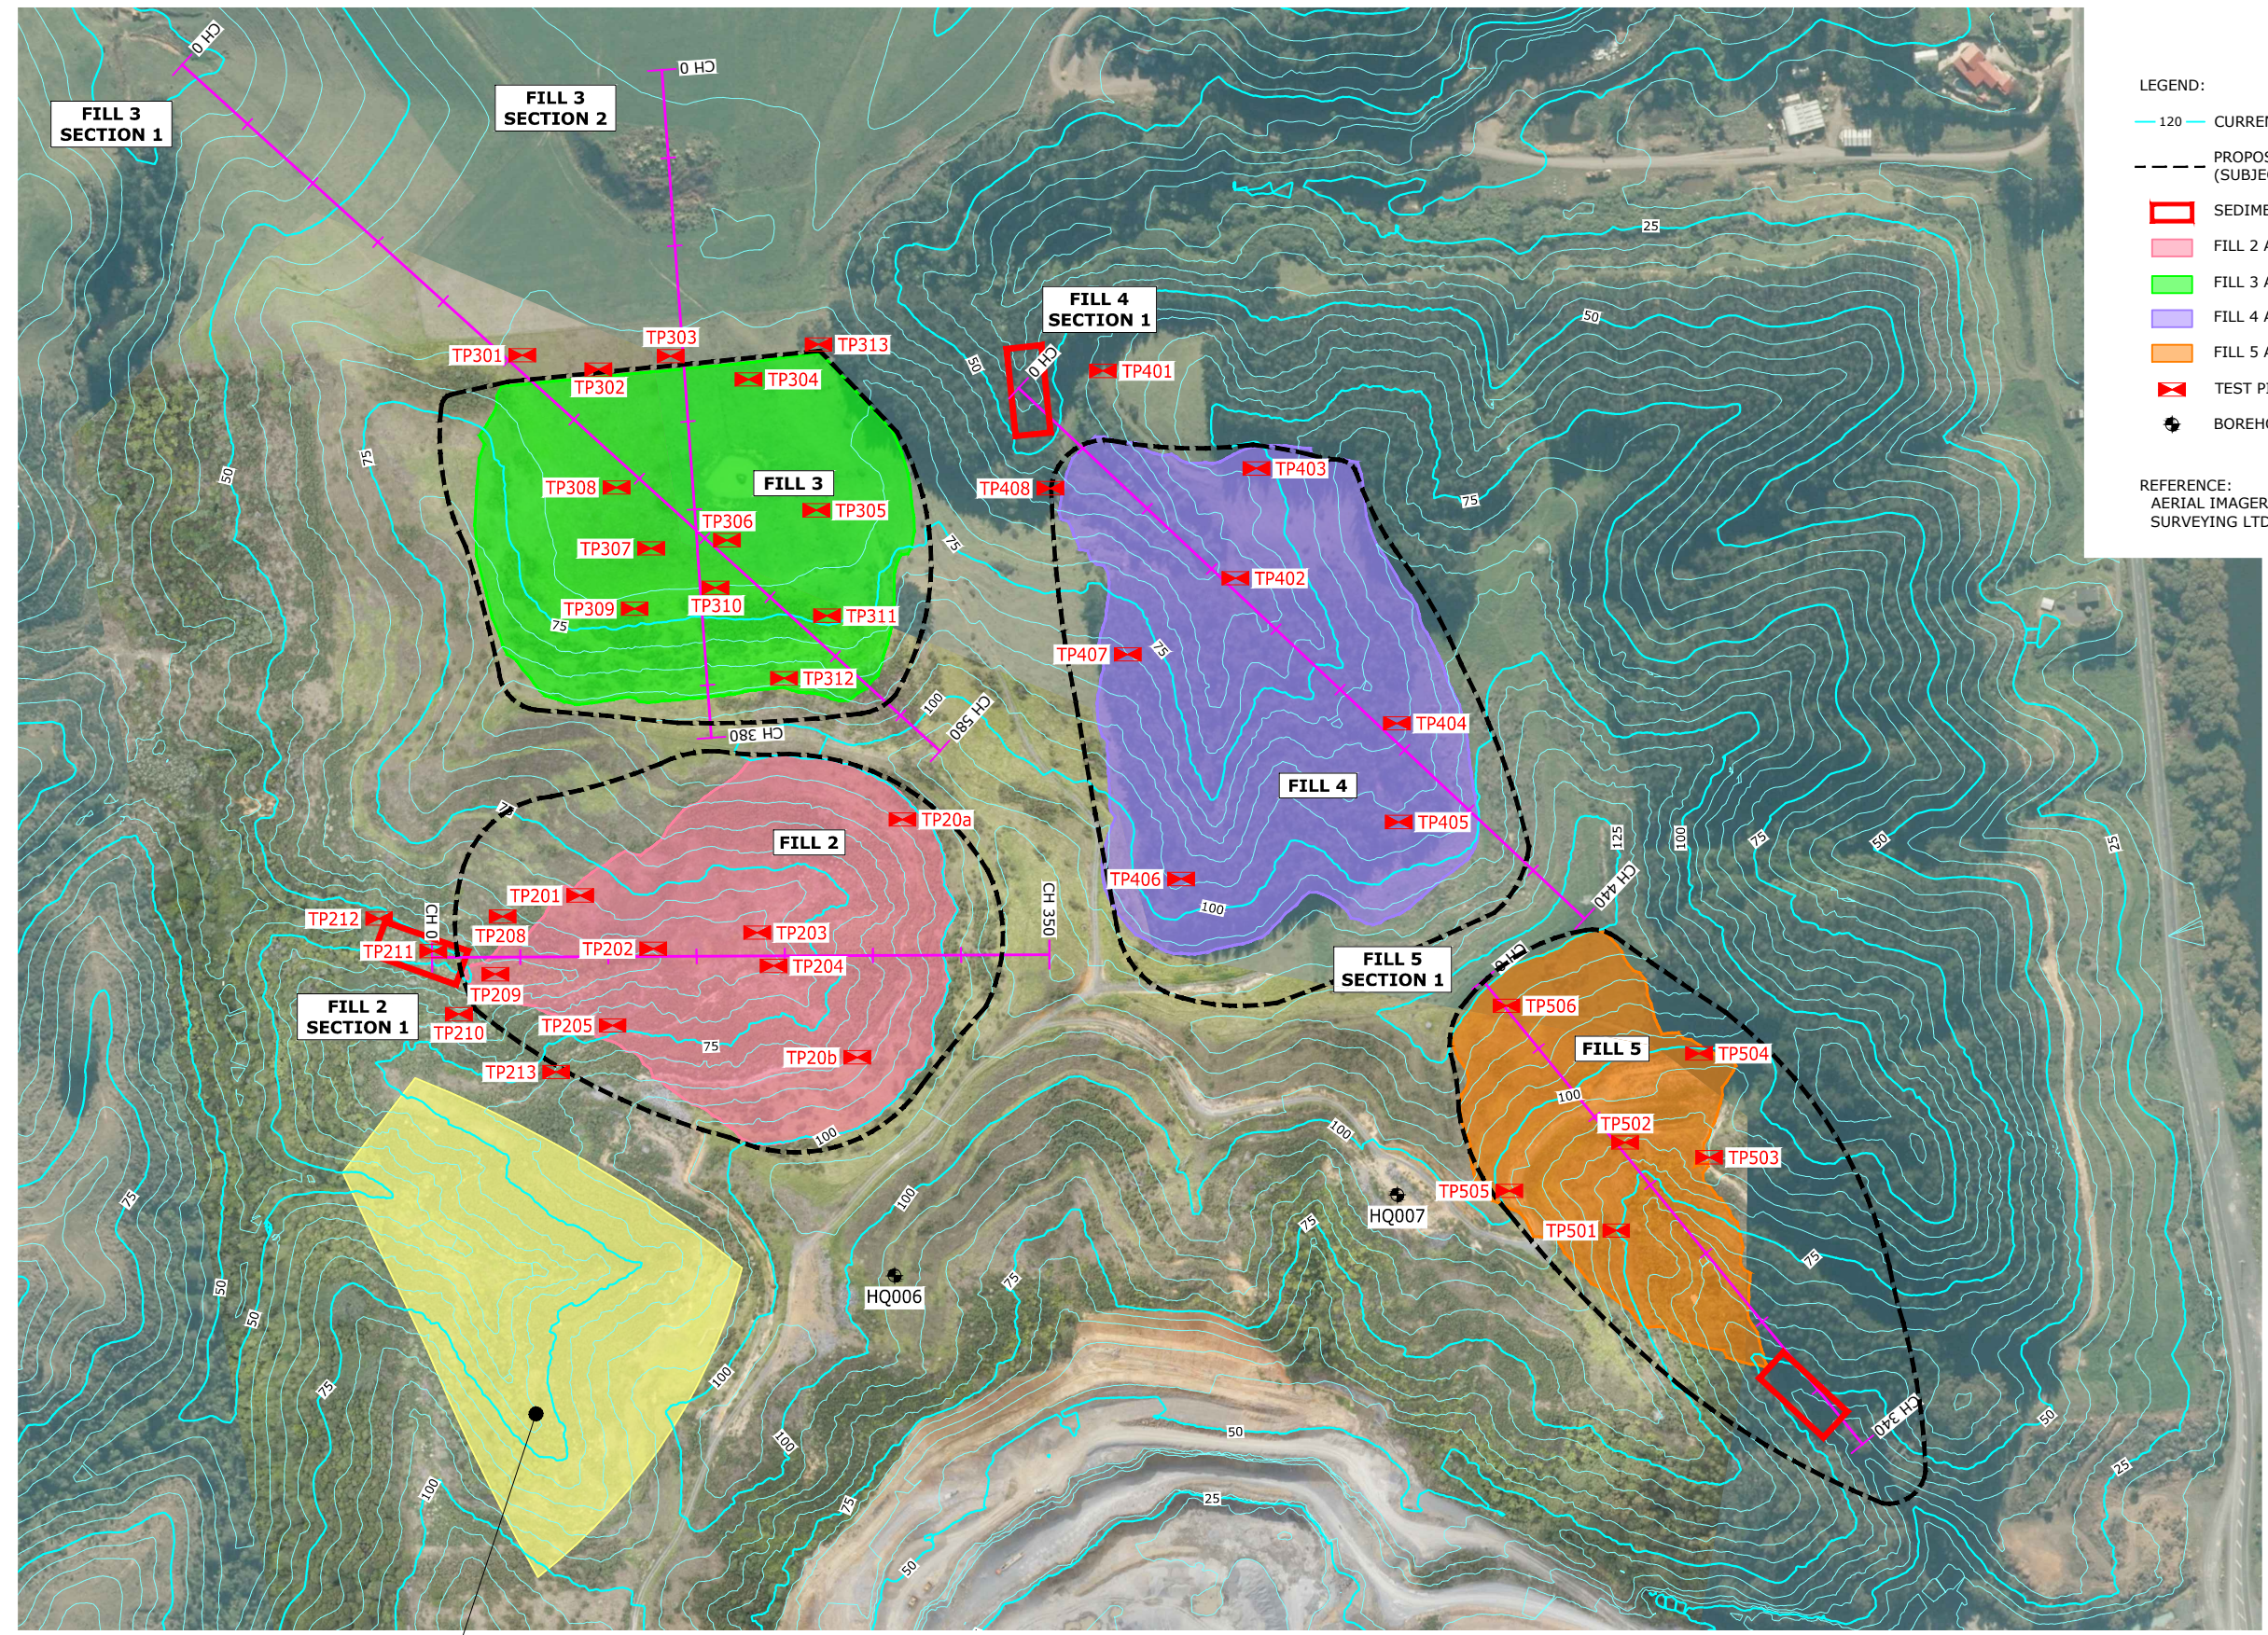
SITE LAYOUT WITH CURRENT CONTOURS
SCALE 1:4000 (A3)

Project:	HUNTLY QUARRY DISPOSAL SITES
Drawing Title:	SITE LAYOUT WITH CURRENT CONTOURS

Appendix B – Test Pit Location Plan and Geological Cross Section

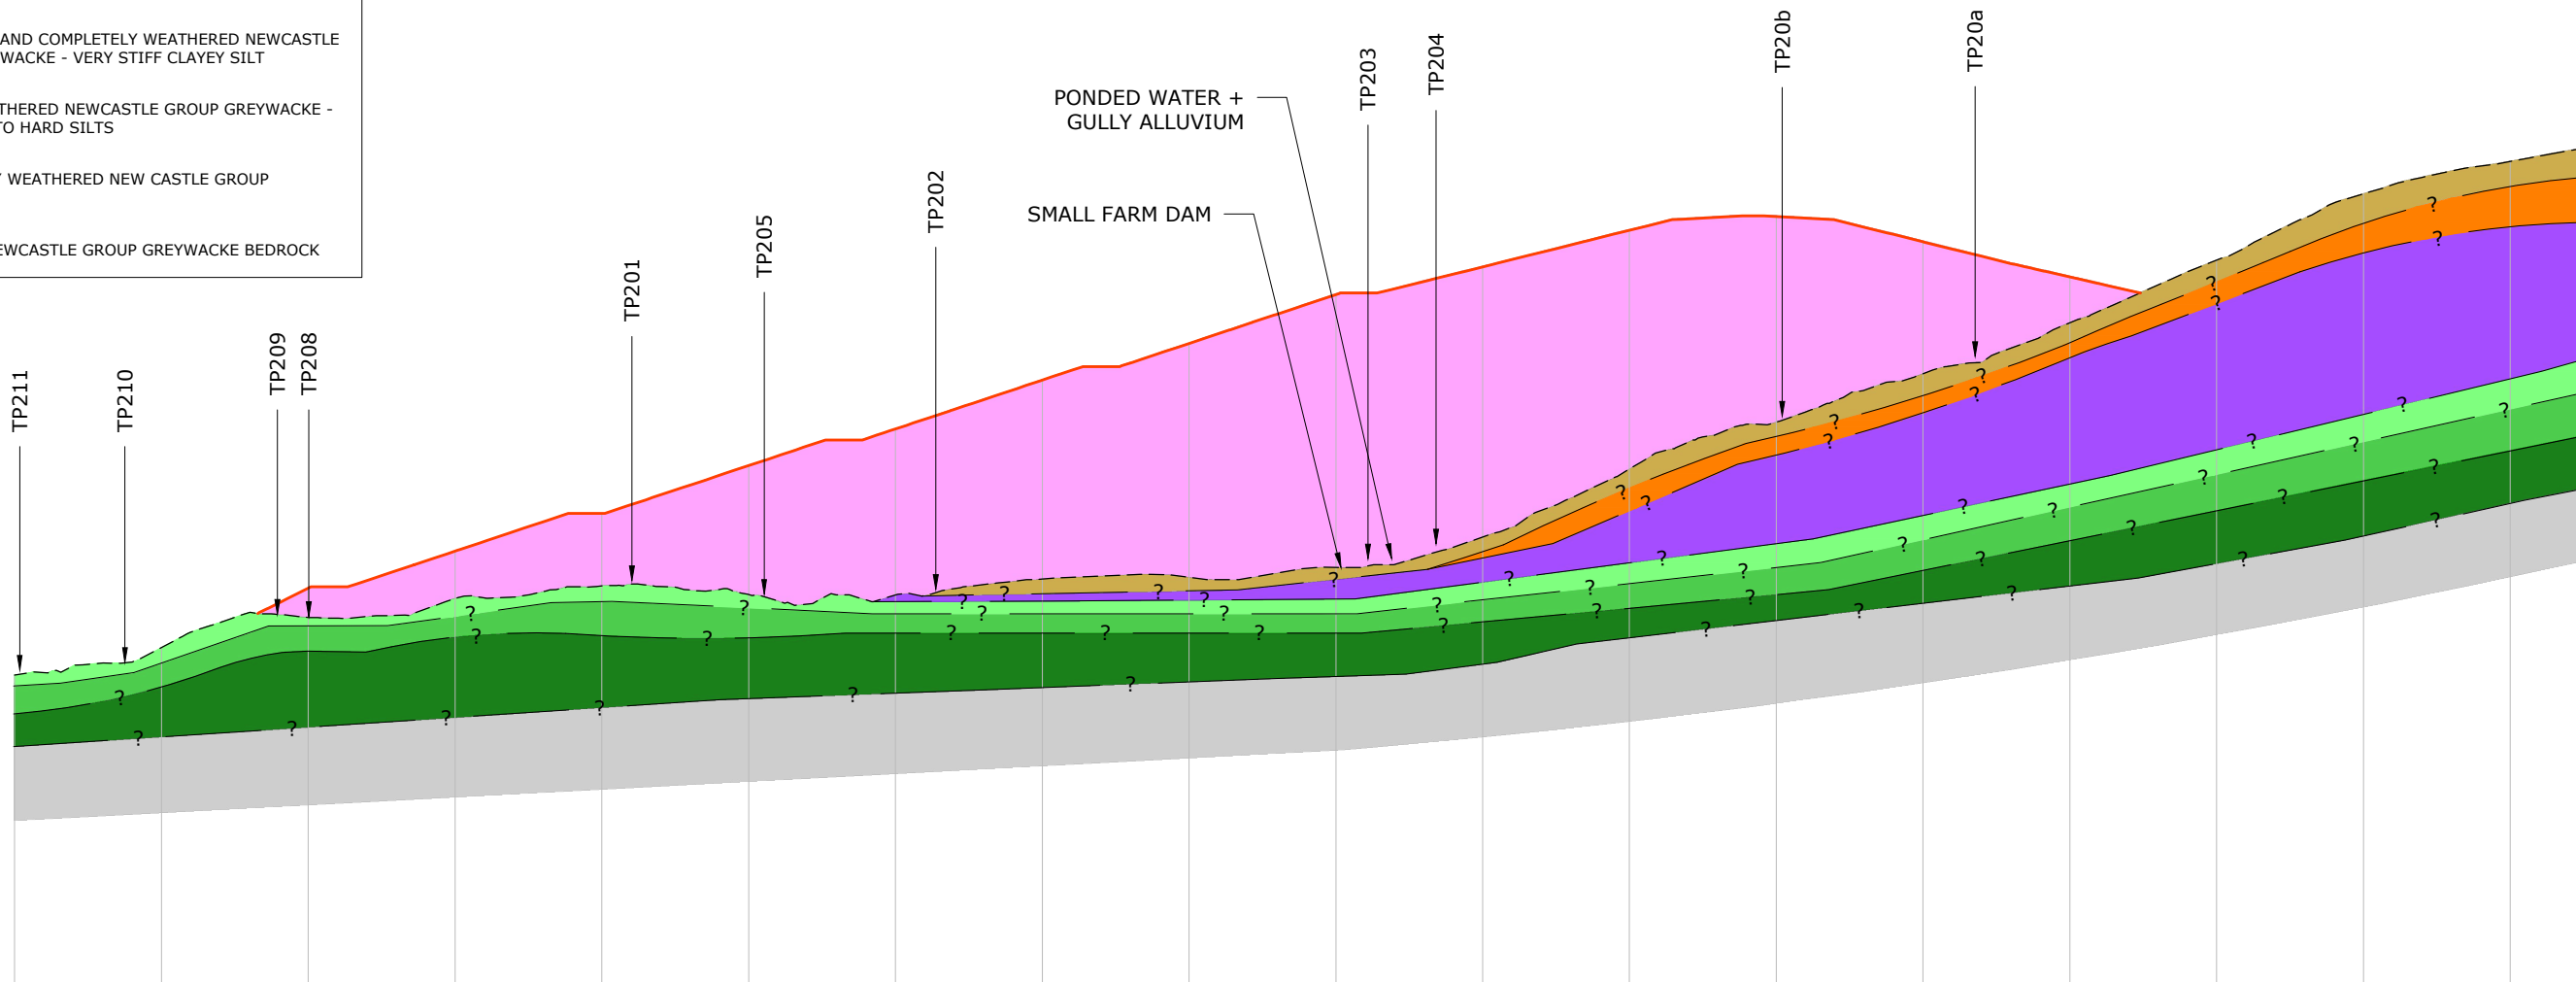
PROPOSED FILL 2 SECTION 1
SCALE 1:1000 (A3)

- PROPOSED FILL
- RESIDUALLY WEATHERED WAIKATO COAL MEASURES - STIFF TO VERY STIFF CLAY/SILT
- COMPLETELY WEATHERED WAIKATO COAL MEASURES - VERY STIFF TO HARD SILT
- MODERATELY TO SLIGHTLY WEATHERED WAIKATO COAL MEASURES - VERY WEAK MUDSTONE/FINE SANDSTONE
- RESIDUALLY AND COMPLETELY WEATHERED NEWCASTLE GROUP GREYWACKE - VERY STIFF CLAYEY SILT
- HIGHLY WEATHERED NEWCASTLE GROUP GREYWACKE - VERY STIFF TO HARD SILTS
- MODERATELY WEATHERED NEW CASTLE GROUP GREYWACKE
- INFERRED NEWCASTLE GROUP GREYWACKE BEDROCK

PROPOSED LEVELS			59.82	64.87	70.00	76.51	81.50	88.15	93.14	99.80	103.57	108.55	110.41	106.99	102.21					
CURRENT LEVELS	48.00	51.74	55.83	58.43	60.15	58.98	58.90	61.08	61.32	62.66	66.80	76.05	82.42	89.00	95.97	104.50	113.51	117.92	119.71	
CUT/FILL DEPTHS			3.99	6.44	9.85	17.53	22.60	27.07	31.83	37.14	36.77	32.51	27.99	17.98	6.24					
CHAINAGE	0	20	40	60	80	100	120	140	160	180	200	220	240	260	280	300	320	340	350

The additional test pits encountered improved ground conditions over those initially used for concept stability calculations. The improved ground conditions comprise weathered greywacke soils of the Newcastle Group in place of the previously assumed Waikato Coal Measures. Weathering depth to weak highly weathered material was found to be within 1.5m of the surface near the invert of the gully such as in TP209 and TP211.

Revised slope stability calculations based on the weathered greywacke toe founding material as opposed to the original Waikato Coal Measures toe founding material are provided in Appendix D.

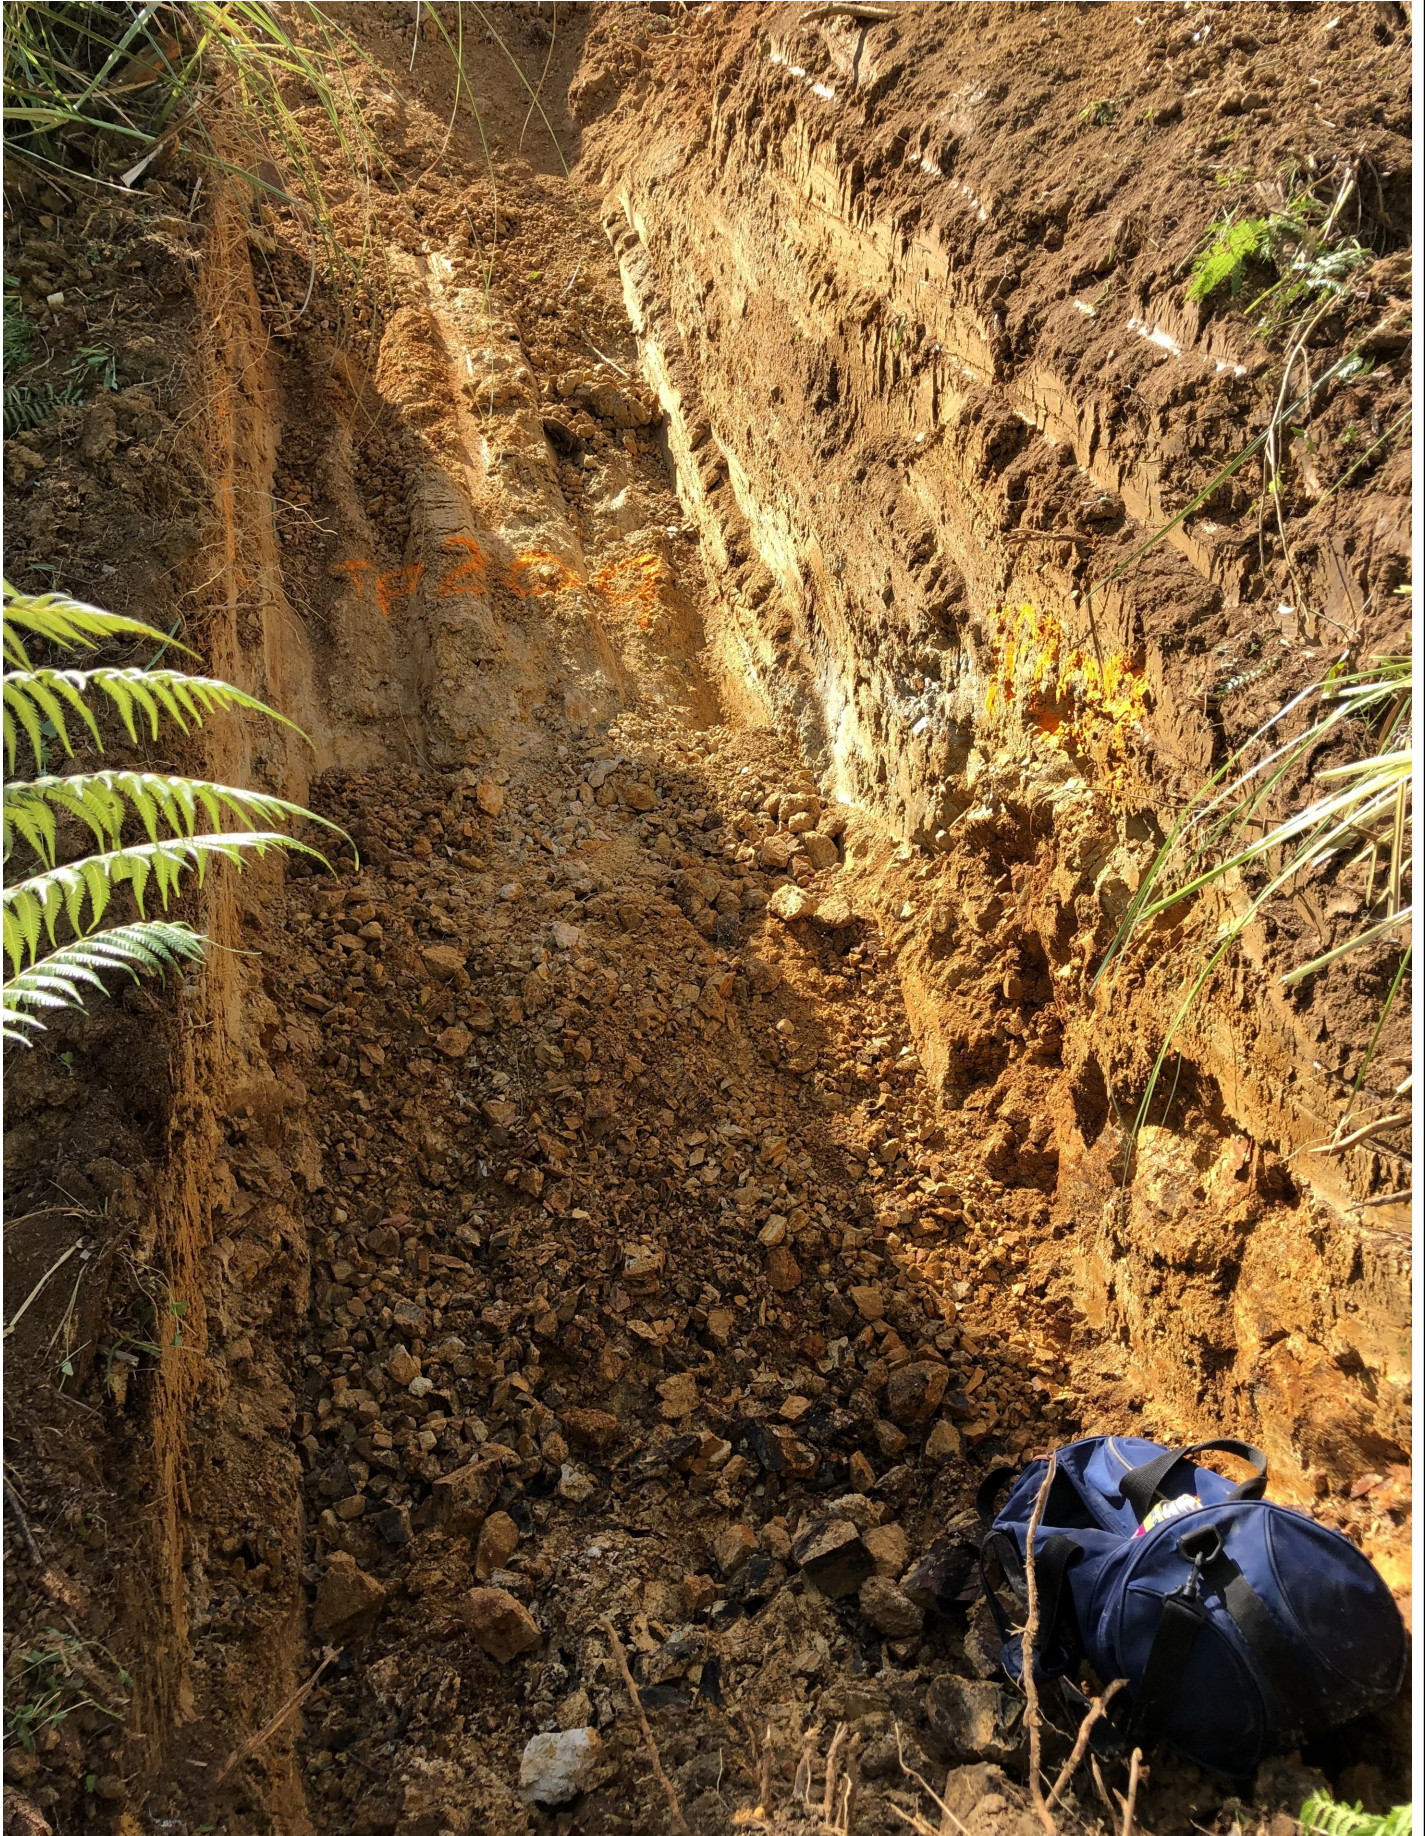
TEST PIT ID.
TP209
1:30 Sheet 1 of 1

Soil/Rock Description	Depth (m)	Graphic Log	Geologic Unit	Ground water	Vane Shear Strength (kPa)		Scala (blows/100mm)					Sample ID	Sample Type	R.L (m)	
					Tp	Tr	2	4	6	8	10				12
0.00-0.30 m TOPSOIL			Colluvium												51.0
0.30-0.80 m Clayey SILT; yellow-brown. Stiff, moist, moderate plasticity, slightly fissured texture.															
0.80-1.50 m Clayey SILT with some sand; yellow-brown and light grey mottles. Hard, low plasticity, moist [inferred completely weathered greywacke, limonite and MnO staining on relict fractures]	1		Newcastle Group Material												50.0
1.50-2.00 m Highly weatherd, grey, brown and orange, SANDSTONE; Very weak, very closely spaced joints with limonite and MnO staining, rare moderately weathered core stones															
End of Pit @ 2.0 m	2														49.0
	3														48.0
	4														47.0
	5														46.0
	6

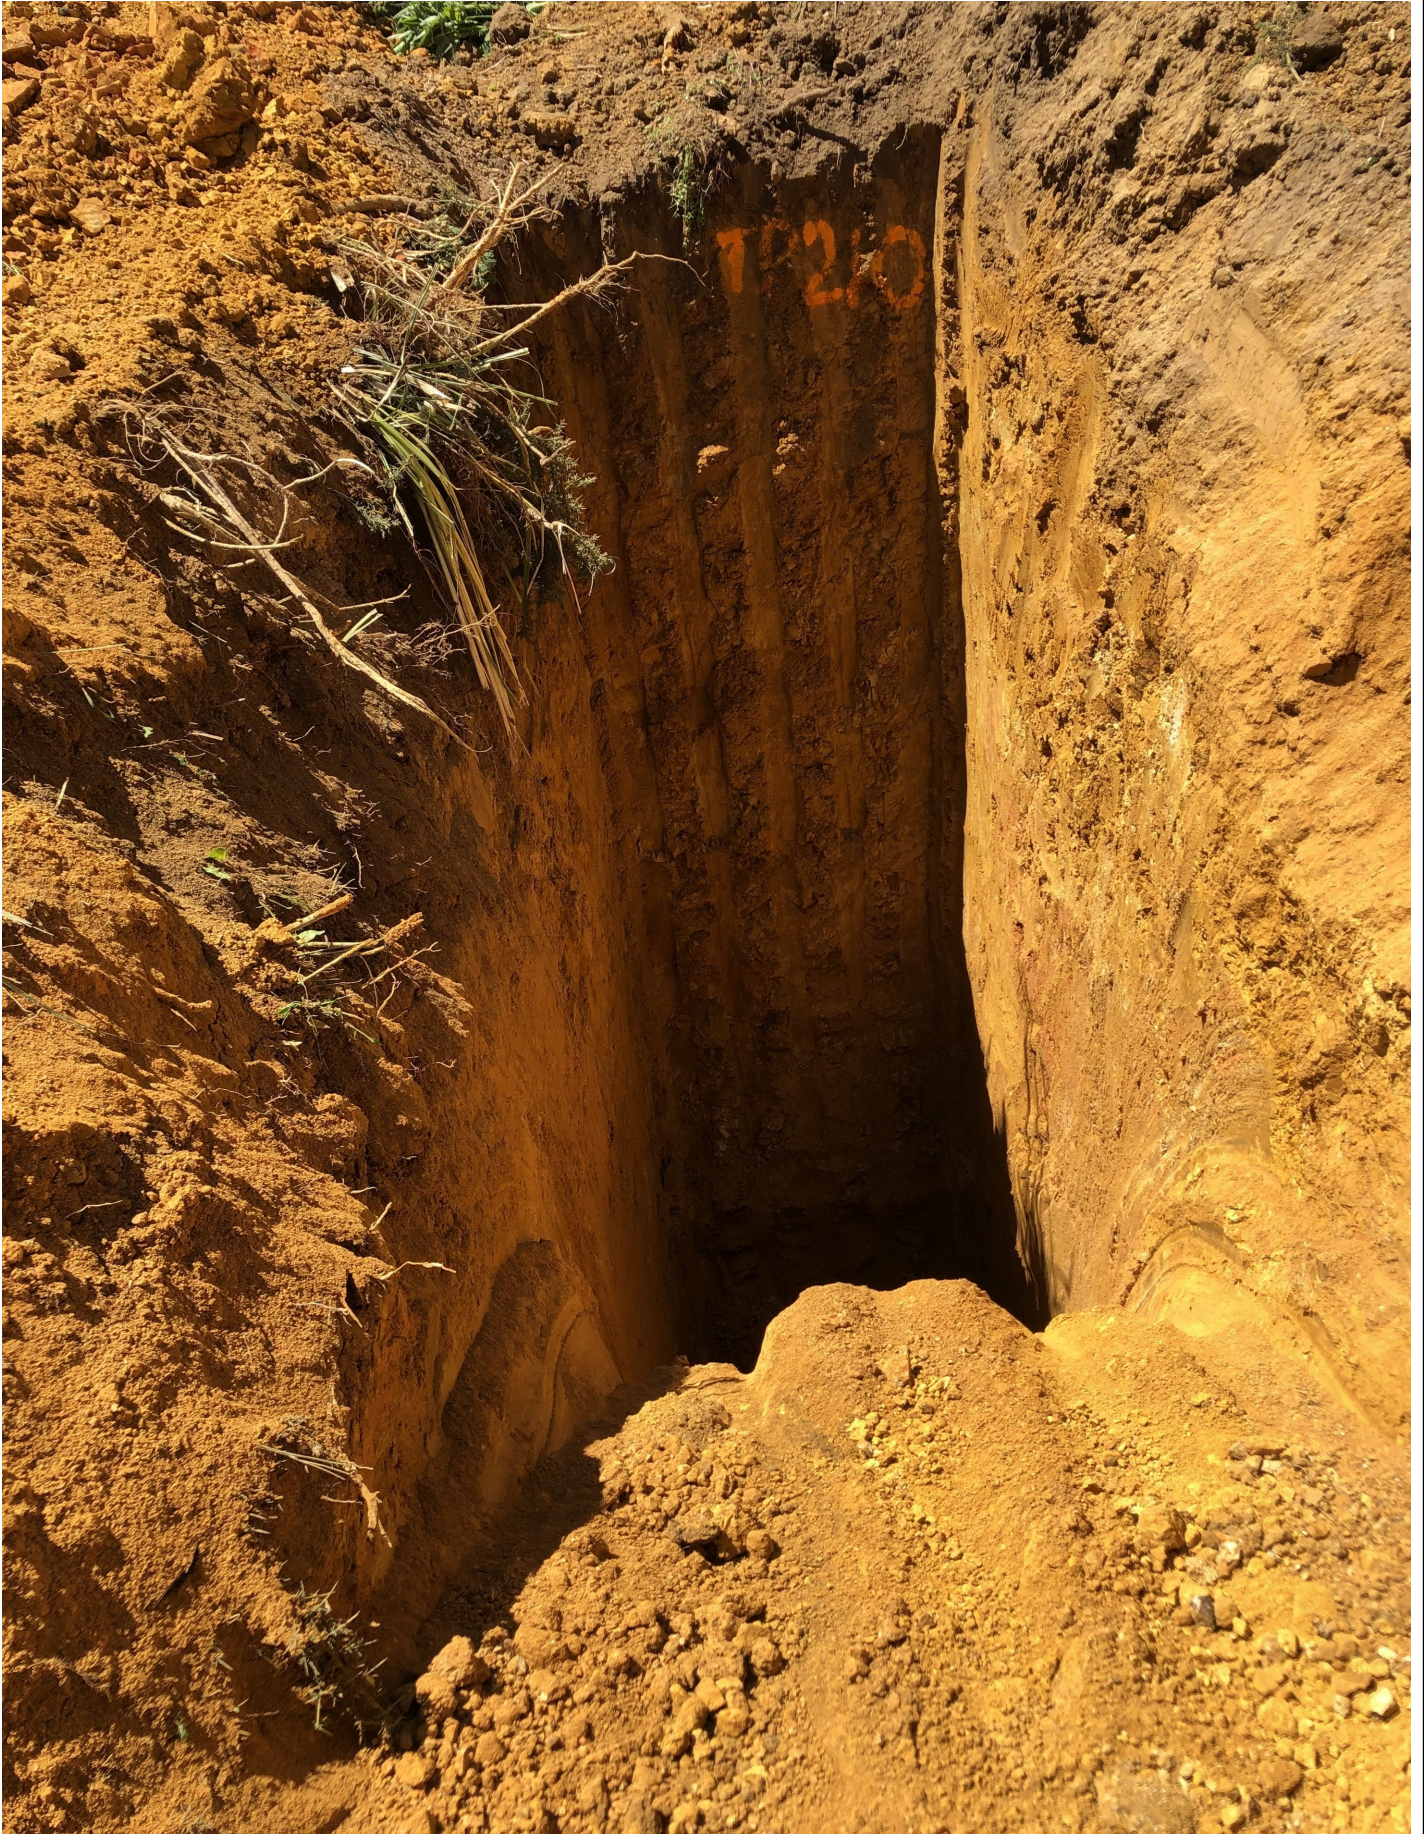
TEST PIT ID.
TP211
1:30 Sheet 1 of 1

Soil/Rock Description	Depth(m)	Graphic Log	Geologic Unit	Ground water	Vane Shear Strength (kPa)		Scala (blows/100mm)					Sample ID	Sample Type	R.L (m)	
					Tp	Tr	2	4	6	8	10				12
0.00-0.20 m TOPSOIL	0.00		Newcastle Group Material											48.0	
0.20-0.60 m Sandy SILT with some clay; light grey and yellow-brown. Hard, non plastic, moist [inferred completely weathered greywacke].	0.20														
0.60-1.60 m Highly weathered, grey, brown and orange, SANDSTONE; Very weak, very closely spaced, smooth, planar joints with limonite and MnO staining, rare moderately weathered core stones	1.00														47.0
End of Pit @ 1.6 m	1.60													46.0	
	2.00													45.0	
	3.00													44.0	
	4.00													43.0	
	5.00														
	6.00

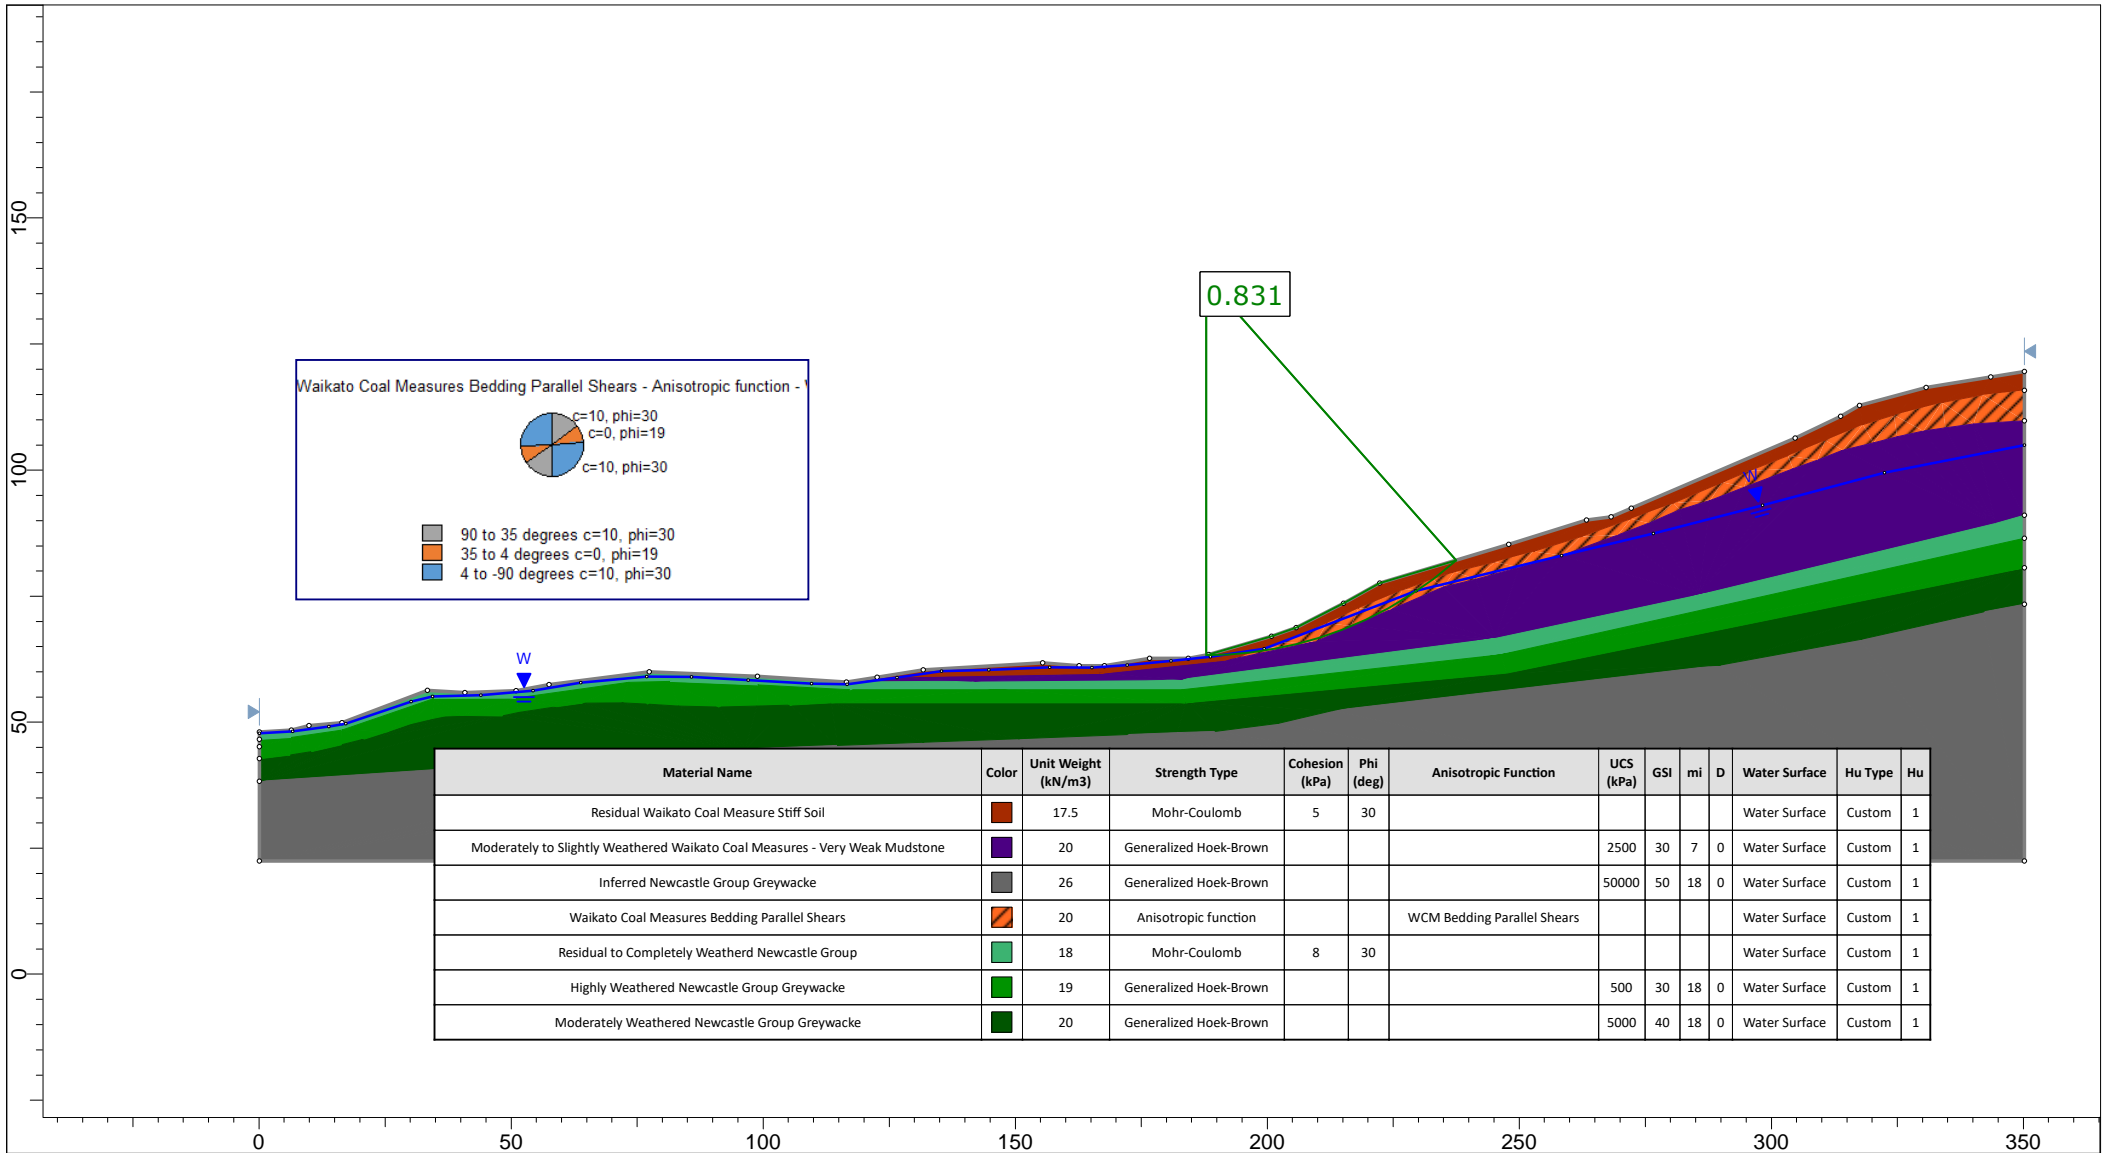
Project		Huntly Quarry - Fill Disposal Sites	
Analysis Description		Fill Site 2 - Cross Section 1, Existing Ground - Bedding Parallel Shears	
Drawn By	MK	Scale	1:1500
Date		Oct 2019	
Company		Gaia Engineers Ltd.	
File Name		Fill Site 2 - Concept Stability Calcs Rev B.slm

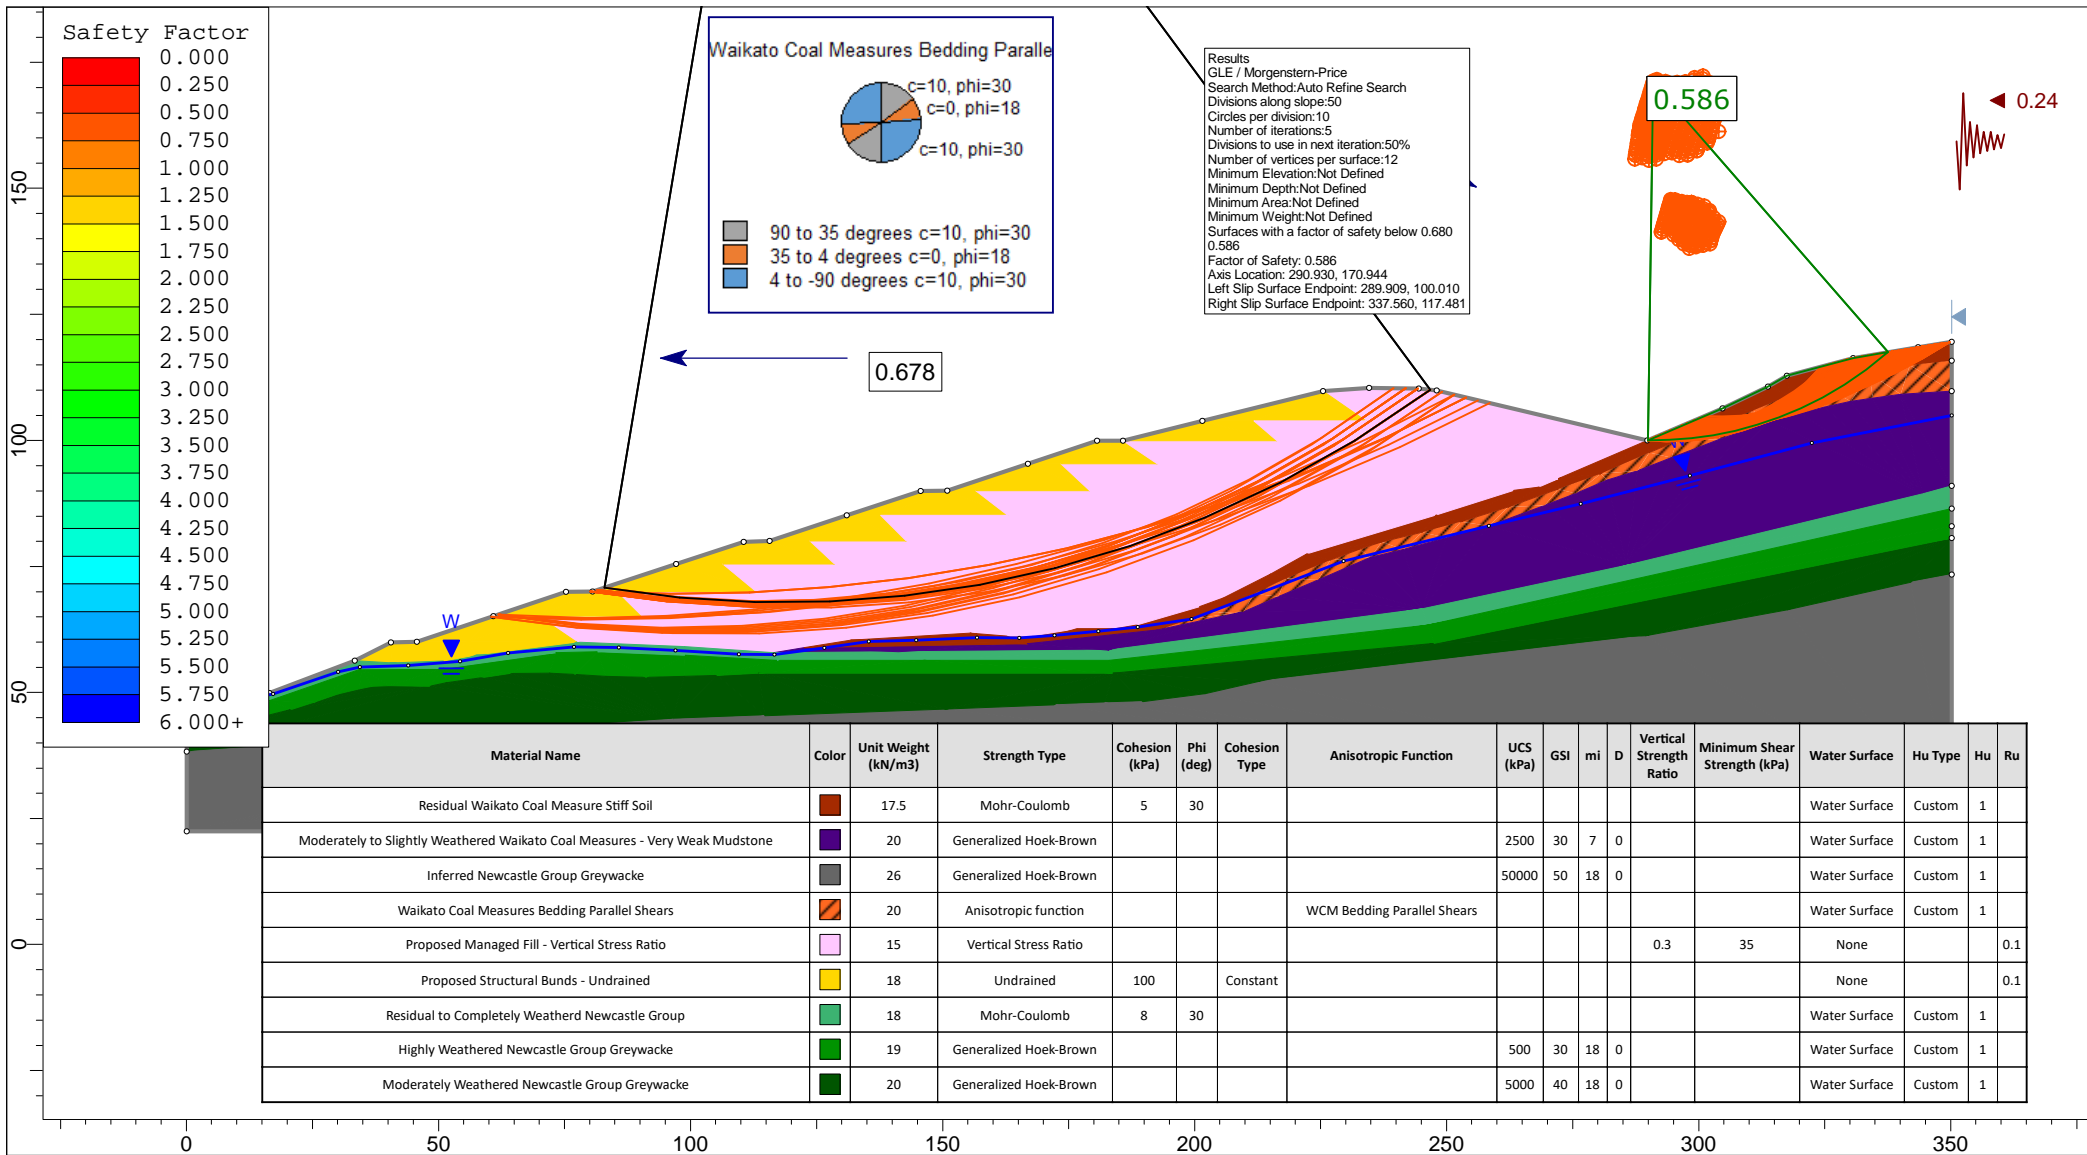
Project		Huntly Quarry - Fill Disposal Sites	
Analysis Description		Fill Site 2 - Cross Section 1, Proposed Fill - Undrained Case	
Drawn By	MK	Scale	1:1500
Date		Oct 2019	
Company		Gaia Engineers Ltd.	
File Name		Fill Site 2 - Concept Stability Calcs Rev B.sldm

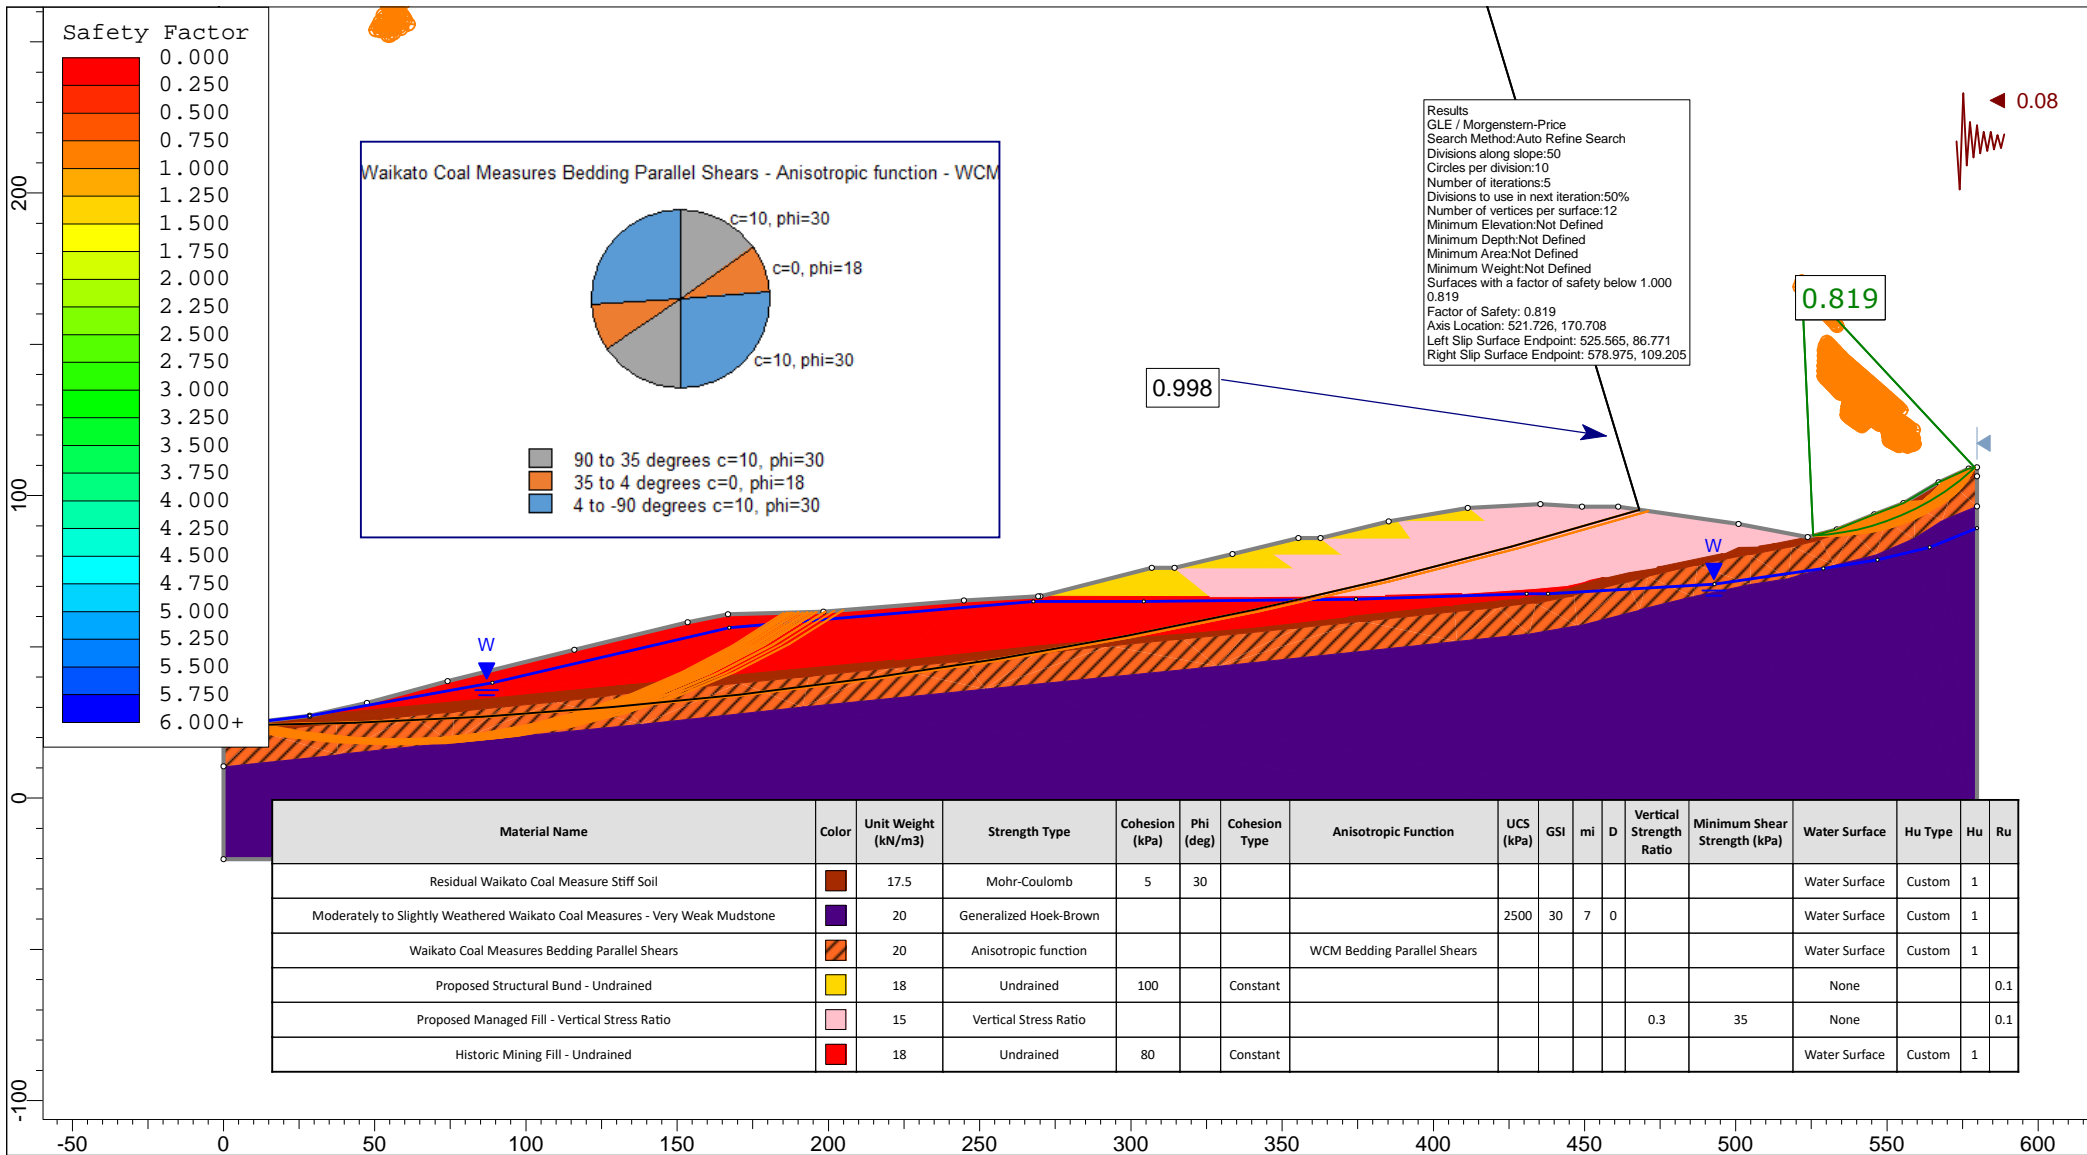
Project		Huntly Quarry - Fill Disposal Sites	
	Analysis Description		Fill Site 3, Cross Section 1, Proposed Fill - Seismic Loading	
	Drawn By	MK	Scale	1:2500
	Date		Oct 2019	
		Company	Gaia Engineers	
		File Name	Fill Site 3 Cross Section 1.slmd

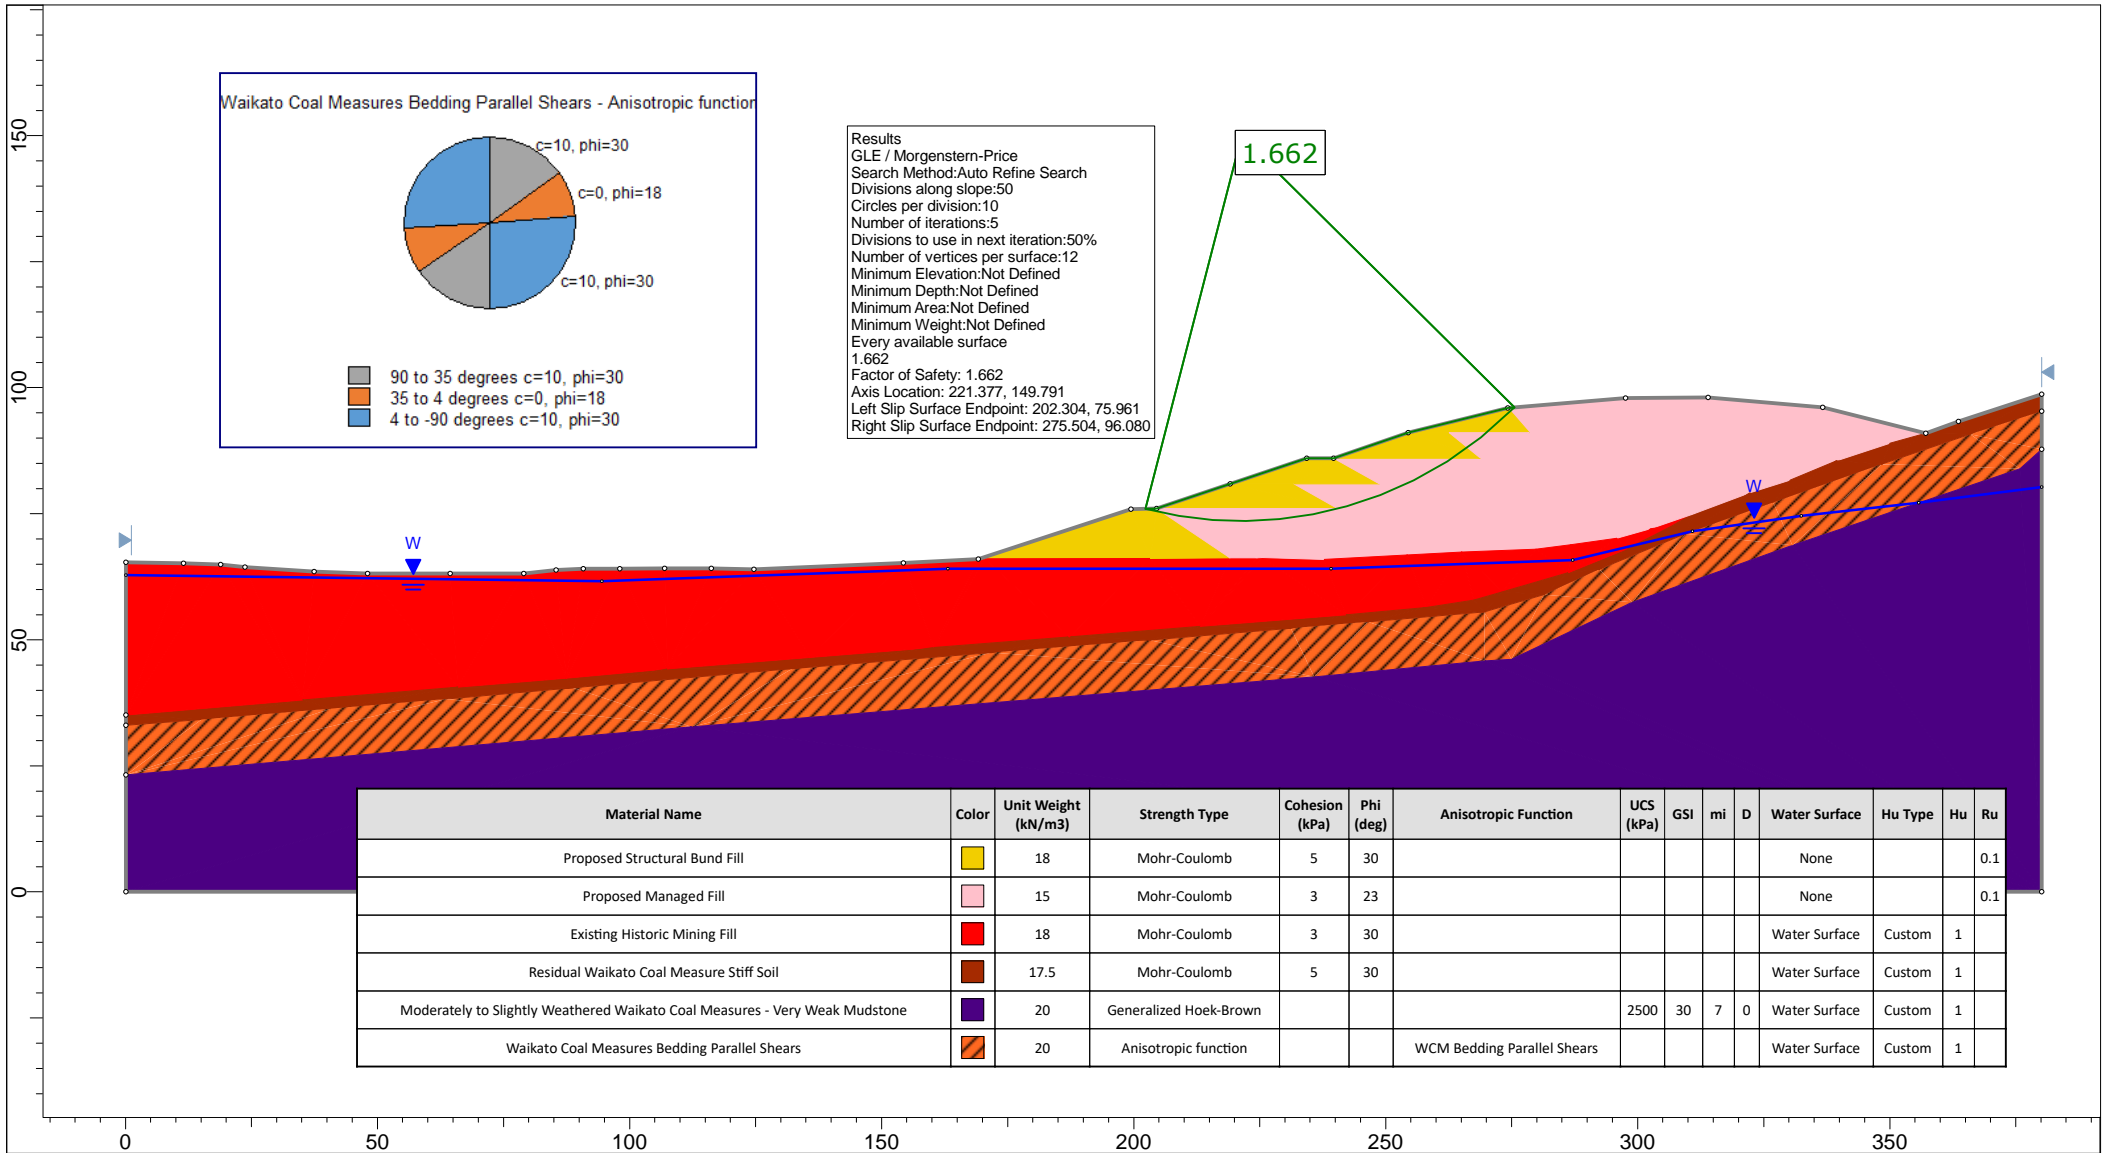
Project		Huntly Quarry - Fill Disposal Sites	
Analysis Description		Fill Site 3 - Cross Section 2, Existing Slope - Bedding Parallel Shears	
Drawn By	MK	Scale	1:2000
Date		Oct 2019	
Company		Gaia Engineers	
File Name		Fill Site 3 Cross Section 2.slmd
