Project No: 2325-12	Ref: Huntly Quarry Managed Fill Sites 2-4 – Geotechnical S92 Response	Revision: A
----------------------------	--	--------------------

2322-12-GQ-03 (Geotechnical RFI Response)

**HUNTLY QUARRY – FILL DISPOSAL SITES
SUMMARY REGISTER OF GEOTECHNICAL COMMENTS FROM PEER REVIEWER**

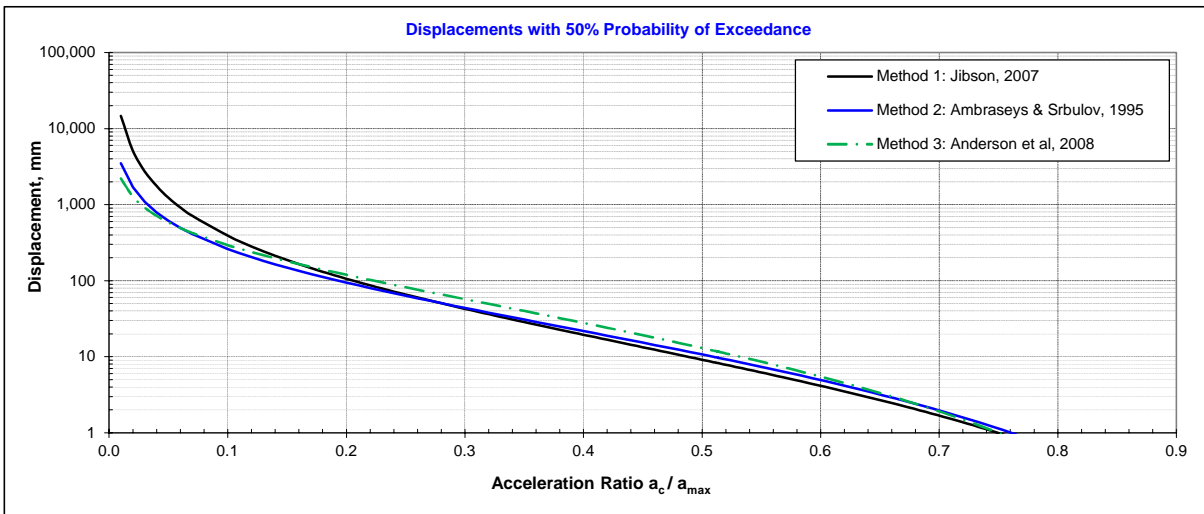
Sliding Block Displacement Analysis

Degraded period	$1.5T_s$	0.27	s	Used in Bray & Travararou 2007. Taken as $1.5 \times T_s$
Spectral acceleration at $1.5T_s$	$S_a(1.5T_s)$	0.42	g	Used in Bray & Travararou 2007 with consideration of depth reduction factor r_d
Acceleration ratio: a_c / a_{max}	a_r	0.25		
Normal distribution factor	Z_n	1.036		$Z_n = \text{NORMINV}((1-p/100),0,1)$ - Excel Function
Calculated Displacements				
Method 1: Jibson, 2007	d_j	63	mm	Uses M_w - moment magnitude
Ambraseys & Menu, 1988	d_{am}	356	mm	Based on M_s between 6.6 to 7.2 ($M_s > M_w$)
Method 2: Ambraseys & Srbulov, 1995	d_{as}	63	mm	Uses M_s - surface wave magnitude
RRU Bulletin 84 (Wood & Elms)	d_{rru}	165	mm	
Method 3: Anderson et al, 2008	d_{an}	63	mm	
Bray & Travararou, 2007	d_{br}	298	mm	
Upper Bound Displacement				
	d	63	mm	Upper bound value from 3 methods - Based on Bridge Manual Section 6.1.2 & 6.3.4
	$d_{200\%}$	165	mm	200% of displacement from one ULS event, Not relevant for MCE event

Based on Bridge Manual Section 6.3.4

Seismic Displacement analysis based on the revised limit equilibrium analysis has increased the predicted displacements in the order of 80mm with a 15% probability of exceedance. We consider the risk of such displacements on a fill slope that is able to be maintained to be sufficiently low. A copy of the calculation is also provided in Appendix D.
