# Raglan Wastewater Treatment Plant - Assessment of Effects of Pond Seepage to Land

Prepared for Waikato District Council  
Prepared by Beca Limited

1 November 2019

# Raglan Wastewater Treatment Plant - Water Quality and Ecology Baseline Assessment

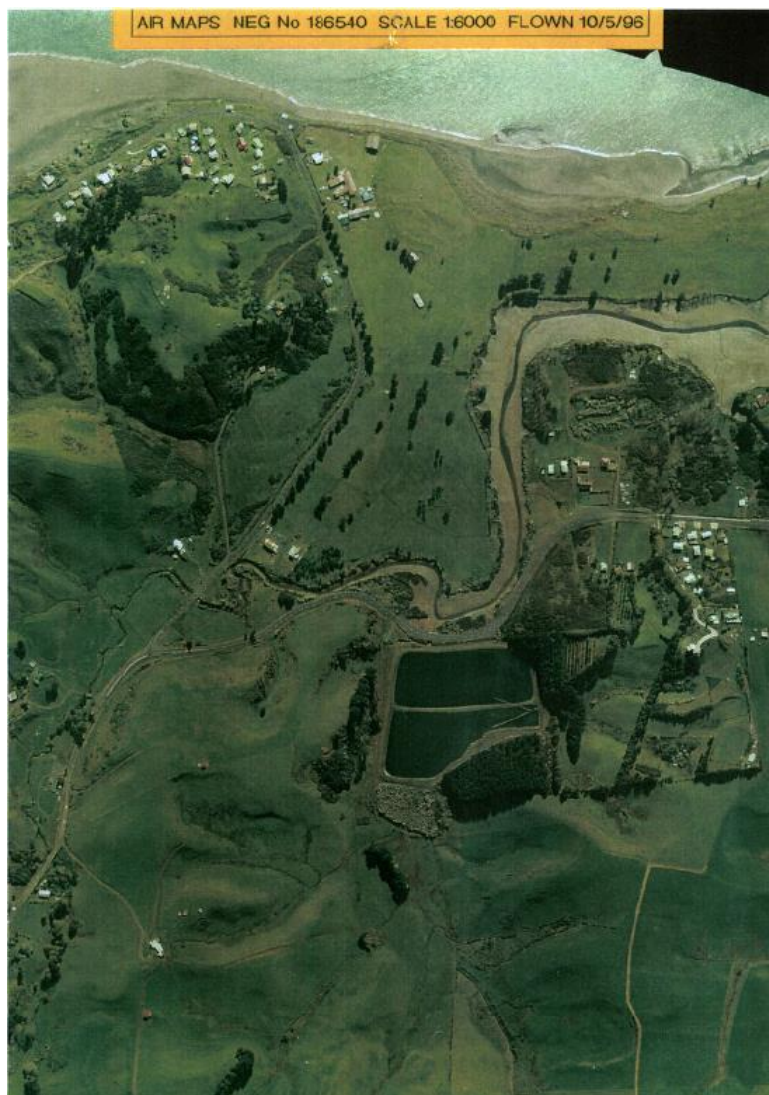
Figure 1.2: Raglan Wastewater Treatment Plant Oxidation Ponds as at May 1996<sup>2</sup>

The Raglan WWTP was originally commissioned in 1977<sup>1</sup> and consisted of two oxidation ponds. The treated wastewater was then pumped to an outfall at the harbour mouth for discharge on the outgoing tide. An aerial photograph showing the ponds as they existed in May 1996 is shown in Figure 1.2.

It is not known whether the original ponds were built with a constructed liner. However, it is assumed they were formed into the underlying natural ground which is dominated by clay soils.

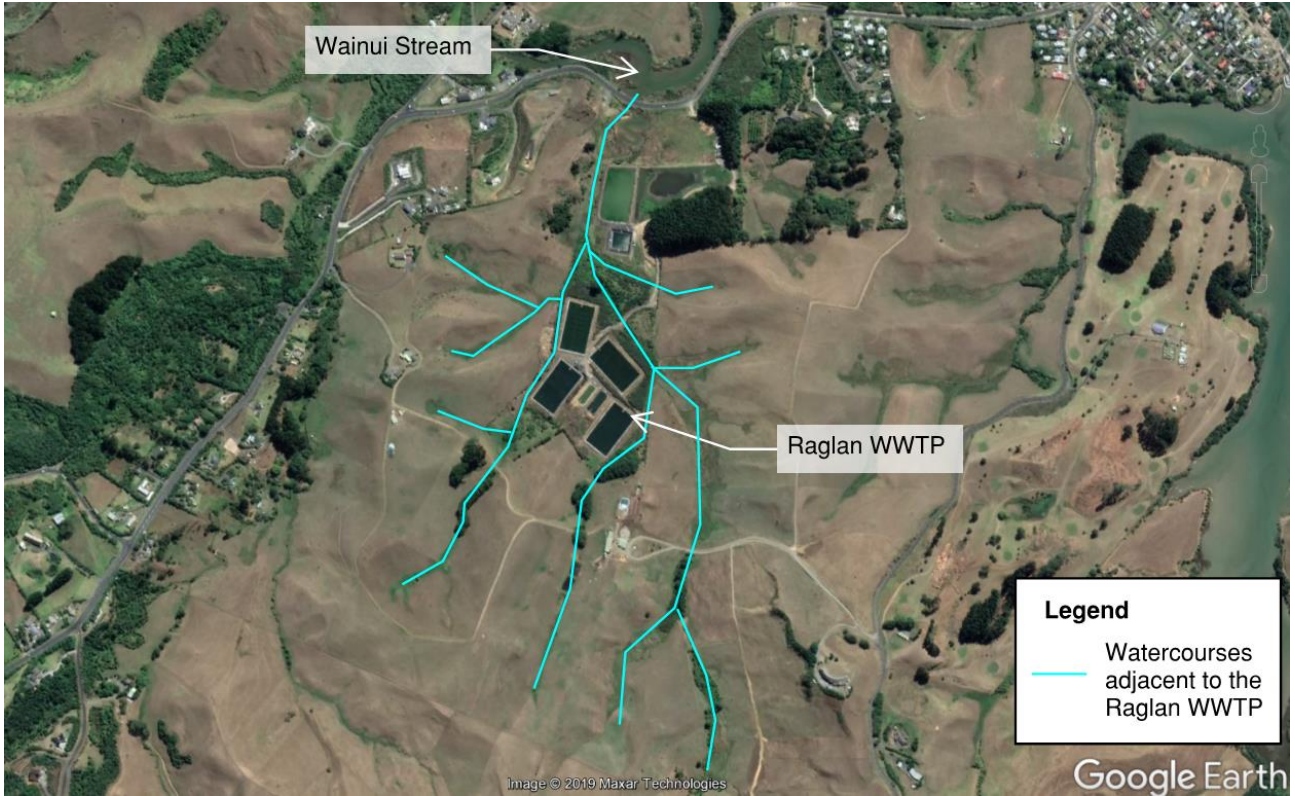
Figure 2. Raglan WWTP and adjacent watercourses in the associated 138ha sub-catchment of the Wainui Stream.

The subject site is within the Waikato District with pastoral farming forming the predominant land use (Figure 2). The watercourses that run past the Raglan WWTP feed into the Wainui Stream, which flows into the Raglan Harbour. These watercourses form part of a 138ha sub-catchment within the larger 1300ha Waipa Stream catchment (River Environment Classification, MfE data service).

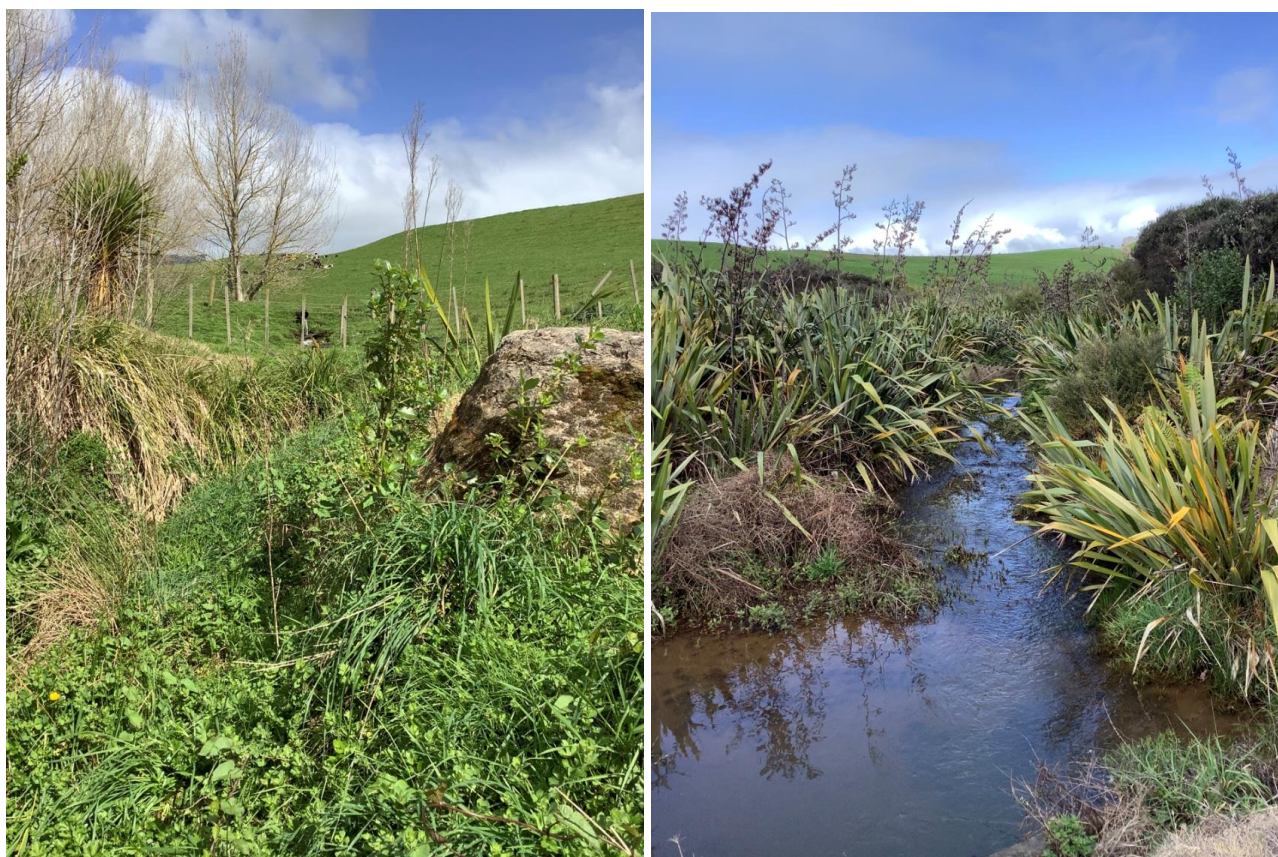
Figure 4. Watercourse 1: 'upstream 1' sampling location (left) and 'pond trib 1' sampling location (right).

Watercourse 1 flows around the eastern side of the Raglan WWTP (Figure 3), under the access road via a culvert before converging with the western channel. The upper reaches consisted of grassed banks and an overgrown channel with low levels of shading. Further downstream, the riparian margin consisted largely of flax, manuka, and hebe (Figure 4). The stream banks were largely stable, with very minor erosion scars observed in places and fair connectivity to the floodplain along the true right bank. Minimal pools or riffle zones were observed within the channel. The channel has retained some of its natural form but has been straightened to accommodate the wastewater treatment ponds. Watercourse 1 includes flows from the neighbouring paddocks via ephemeral and intermittent flow paths draining the surrounding farmland.

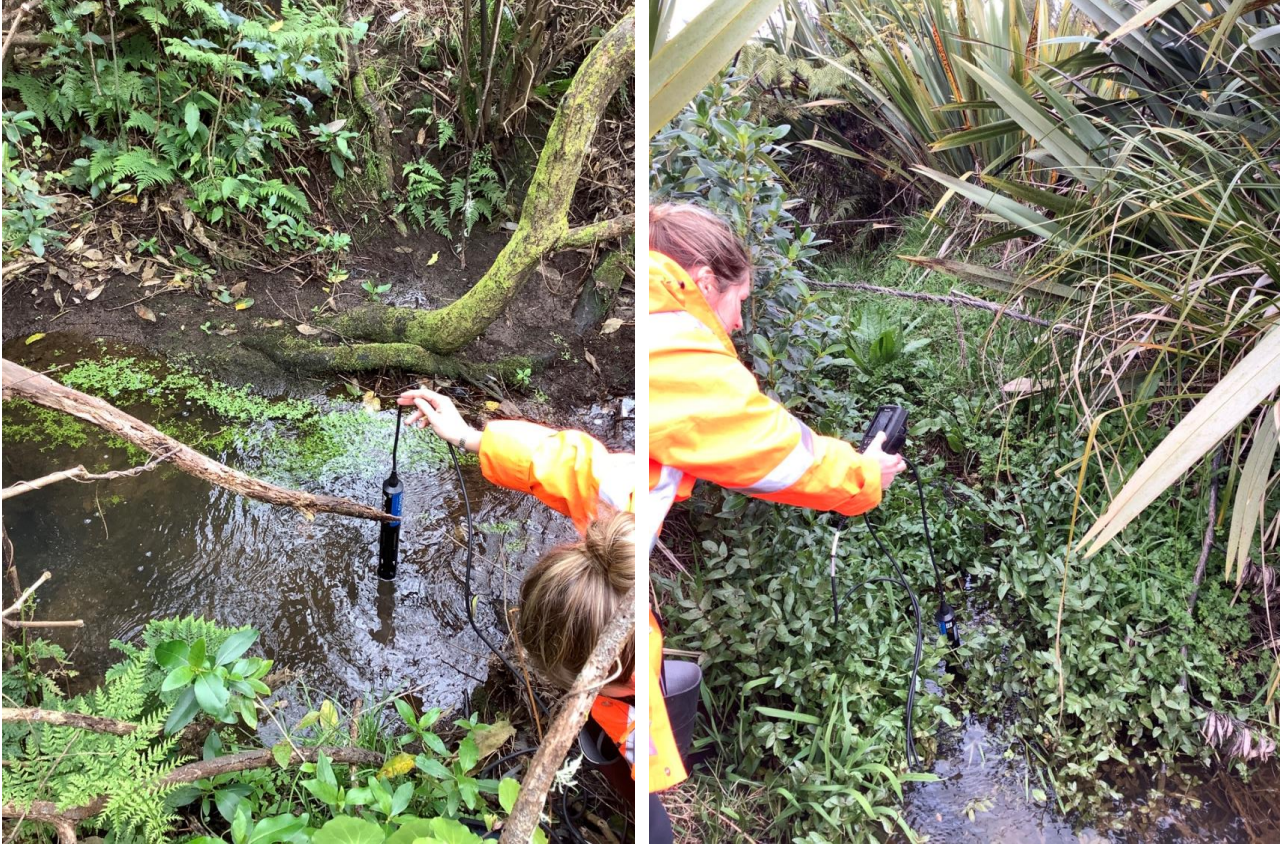
Figure 5. Watercourse 2: 'upstream 2' sampling location (left) and 'pond trib 2' sampling location (right).

Further downstream, the riparian margin consisted of a mix of native plantings and exotic weeds, including flax, manuka, and hebe (Figure 5). The stream banks were steep in places, with some minor bank slumping observed. Minimal pools or riffle zones were observed within the channel as the stream has been straightened and channelised to accommodate the treatment ponds. A tributary that flows from the neighbouring dairy farm enters Watercourse 2 above the confluence with Watercourse 1.

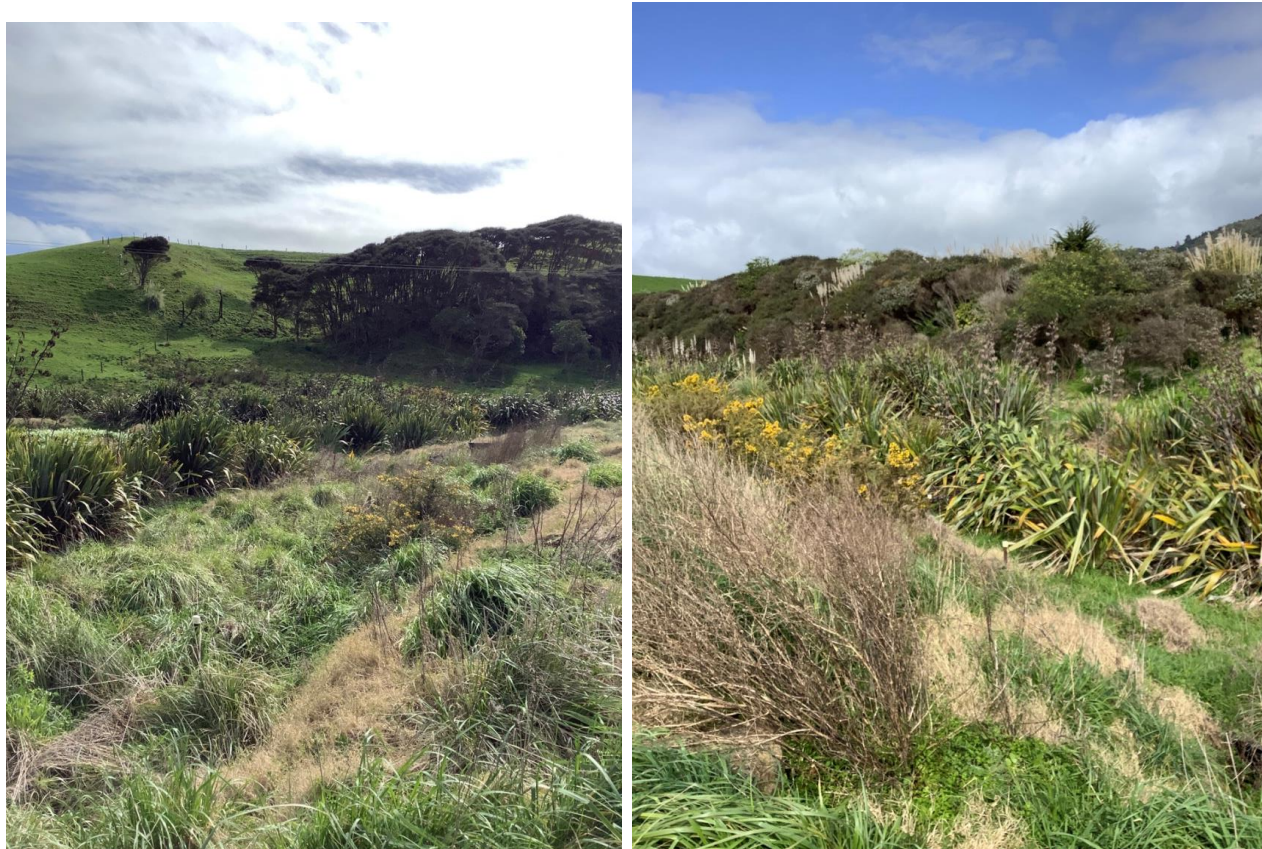
Figure 6. Downstream of the confluence between Watercourse 1 and Watercourse 2.

Downstream of the confluence between Watercourse 1 and Watercourse 2, the channel was very incised with steep banks. Moderate levels of macrophyte and periphyton cover were surveyed. Erosion scars were observed along the banks, including slumping. Minor amounts of debris were present in the channel. Bank vegetation consisted mainly of dense flax, contributing to a high level of channel shading (Figure 6). Gorse and pampas were also present on the upper banks. The surrounding wetland was identified as a suitable fish spawning area.

Minimal erosion and scour present within the streams or on the banks. Some minor bank slumping was observed in Watercourse 2 and downstream of the confluence point.
