Appendix D
Catchment Management Plan
Glen Massey Structure Plan Area

Waikato District Council

March 2015

T&T Ref: 61814.2000

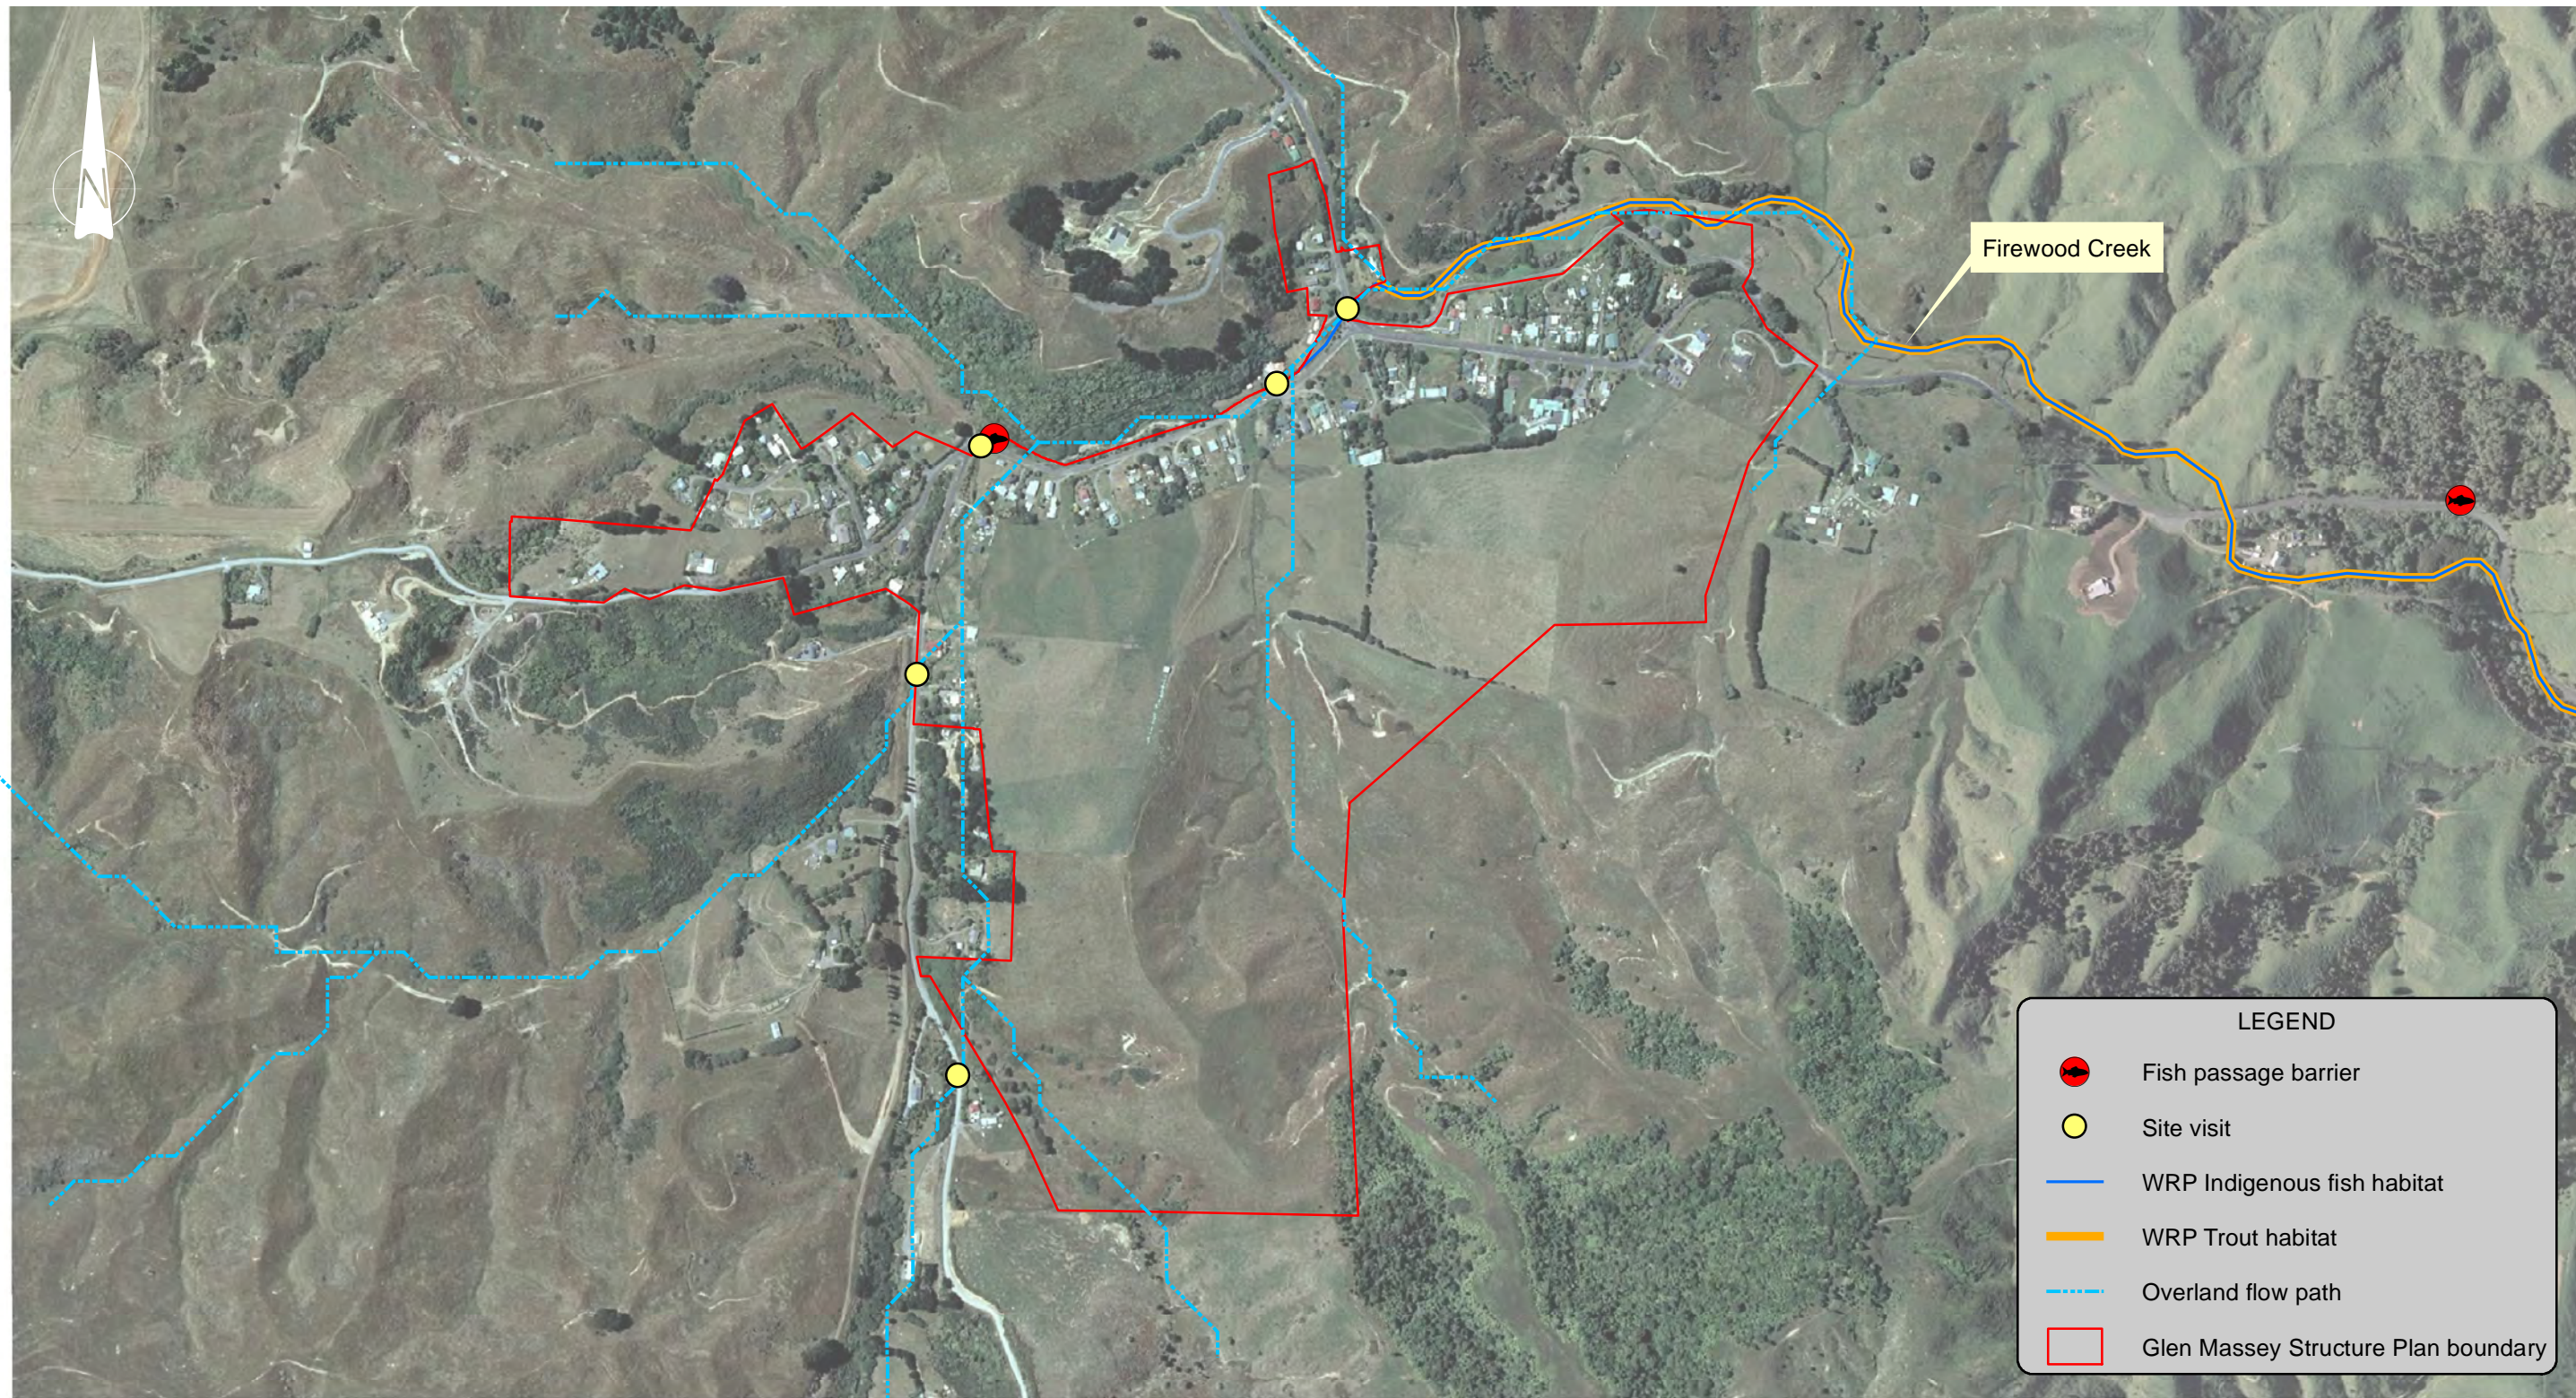
FIGURE No. **Figure 292** Rev. **0**

**WAIKATO DISTRICT COUNCIL
CATCHMENT MANAGEMENT PLAN OF
GLEN MASSEY STRUCTURE PLAN AREA
Ecological Map**

In addition, a site walk over of streams at publicly accessible locations was conducted by a T&T ecologist on 9 April 2014 to confirm levels of development, observe in stream structures, assess fish passage conditions and visually assess habitat condition. The sites assessed during the field assessment are shown on Figure 292 in Appendix DA.

A site inspection of publicly accessible locations on Firewood creek and its unnamed tributaries in the Glen Massey SPA was conducted on 9 April, 2014. Locations inspected are shown on Figure 292 in Appendix DA.

A barrier to upstream fish passage was identified at the culvert under Wilton Collieries Rd east of the intersection with Kereru Rd. This culvert has previously been retrofitted for fish passage but a small concrete lip on the downstream end would prevent the migration of non-climbing fish species such as inanga during low flows. It is noted that inanga and longfin eel are present in all catchment streams and are classified as At Risk: Declining (Goodman, 2014).
