Catchment Management Plan
Ngaruawahia & Surrounds Structure
Plan Area

Report prepared for:
Waikato District Council

Report prepared by:
Tonkin & Taylor Ltd

March 2015

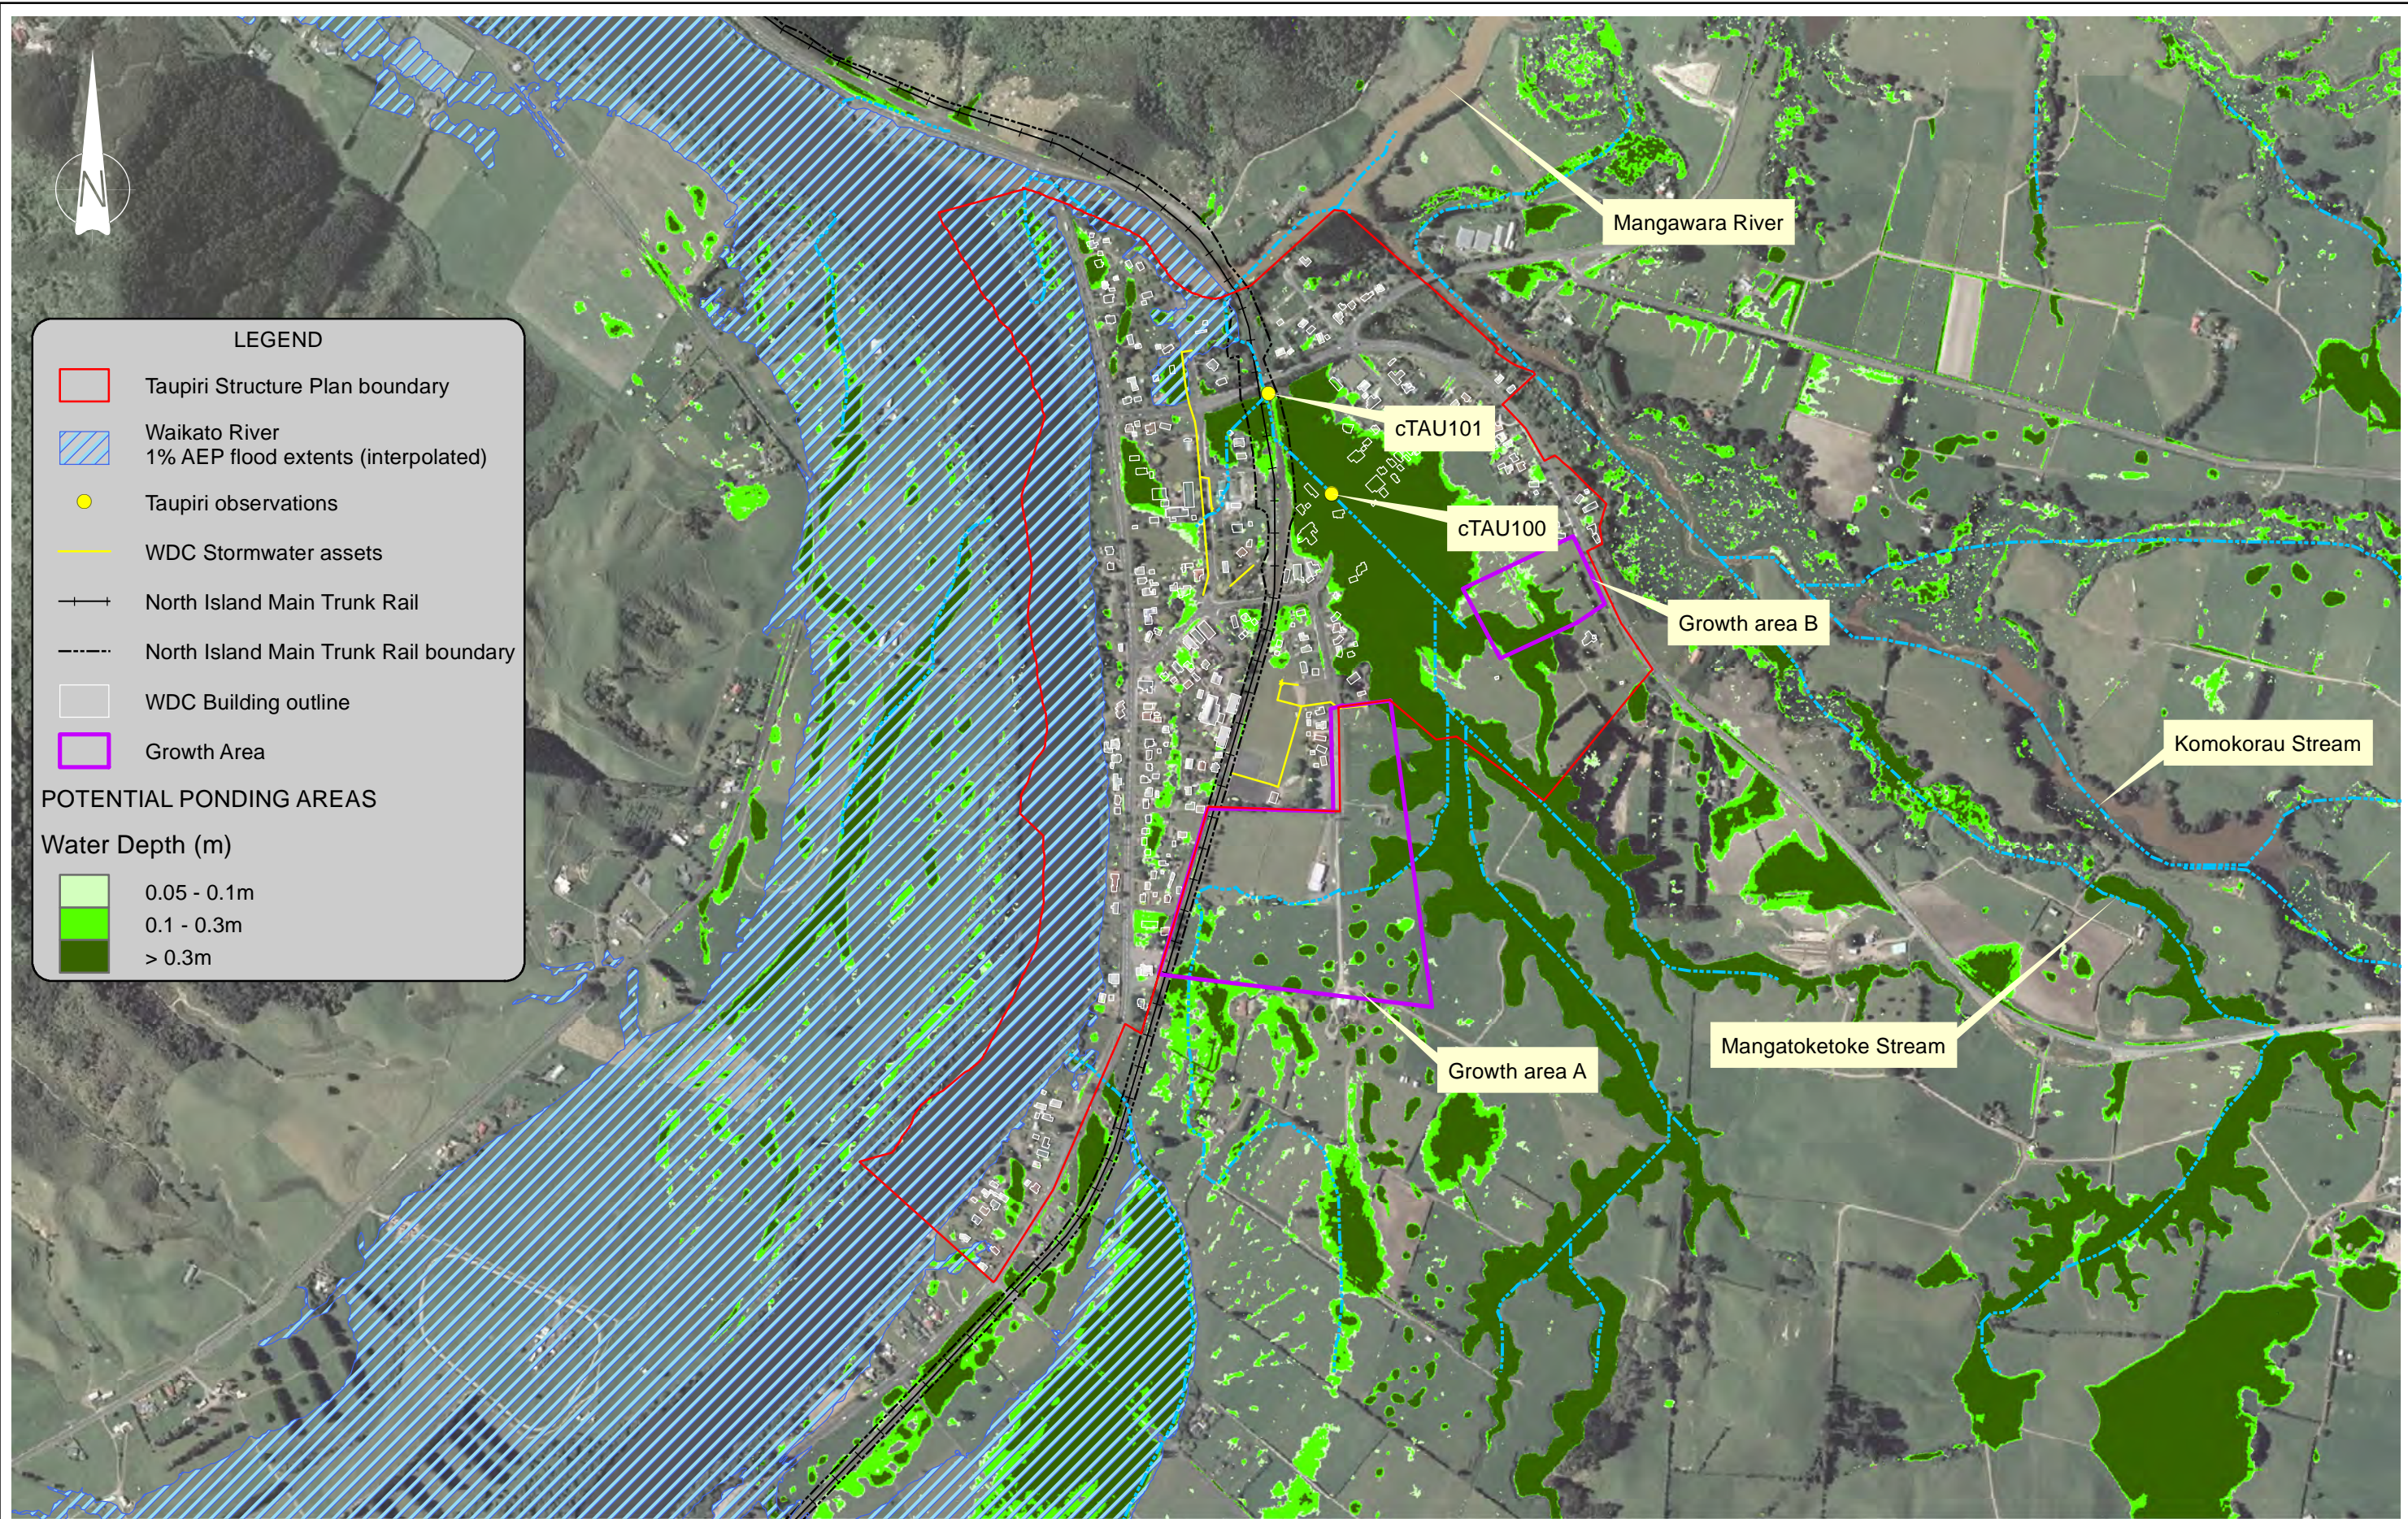
- Taupiri Structure Plan boundary
- Waikato River
1% AEP flood extents (interpolated)
- Taupiri observations
- WDC Stormwater assets
- North Island Main Trunk Rail
- North Island Main Trunk Rail boundary
- WDC Building outline
- Growth Area

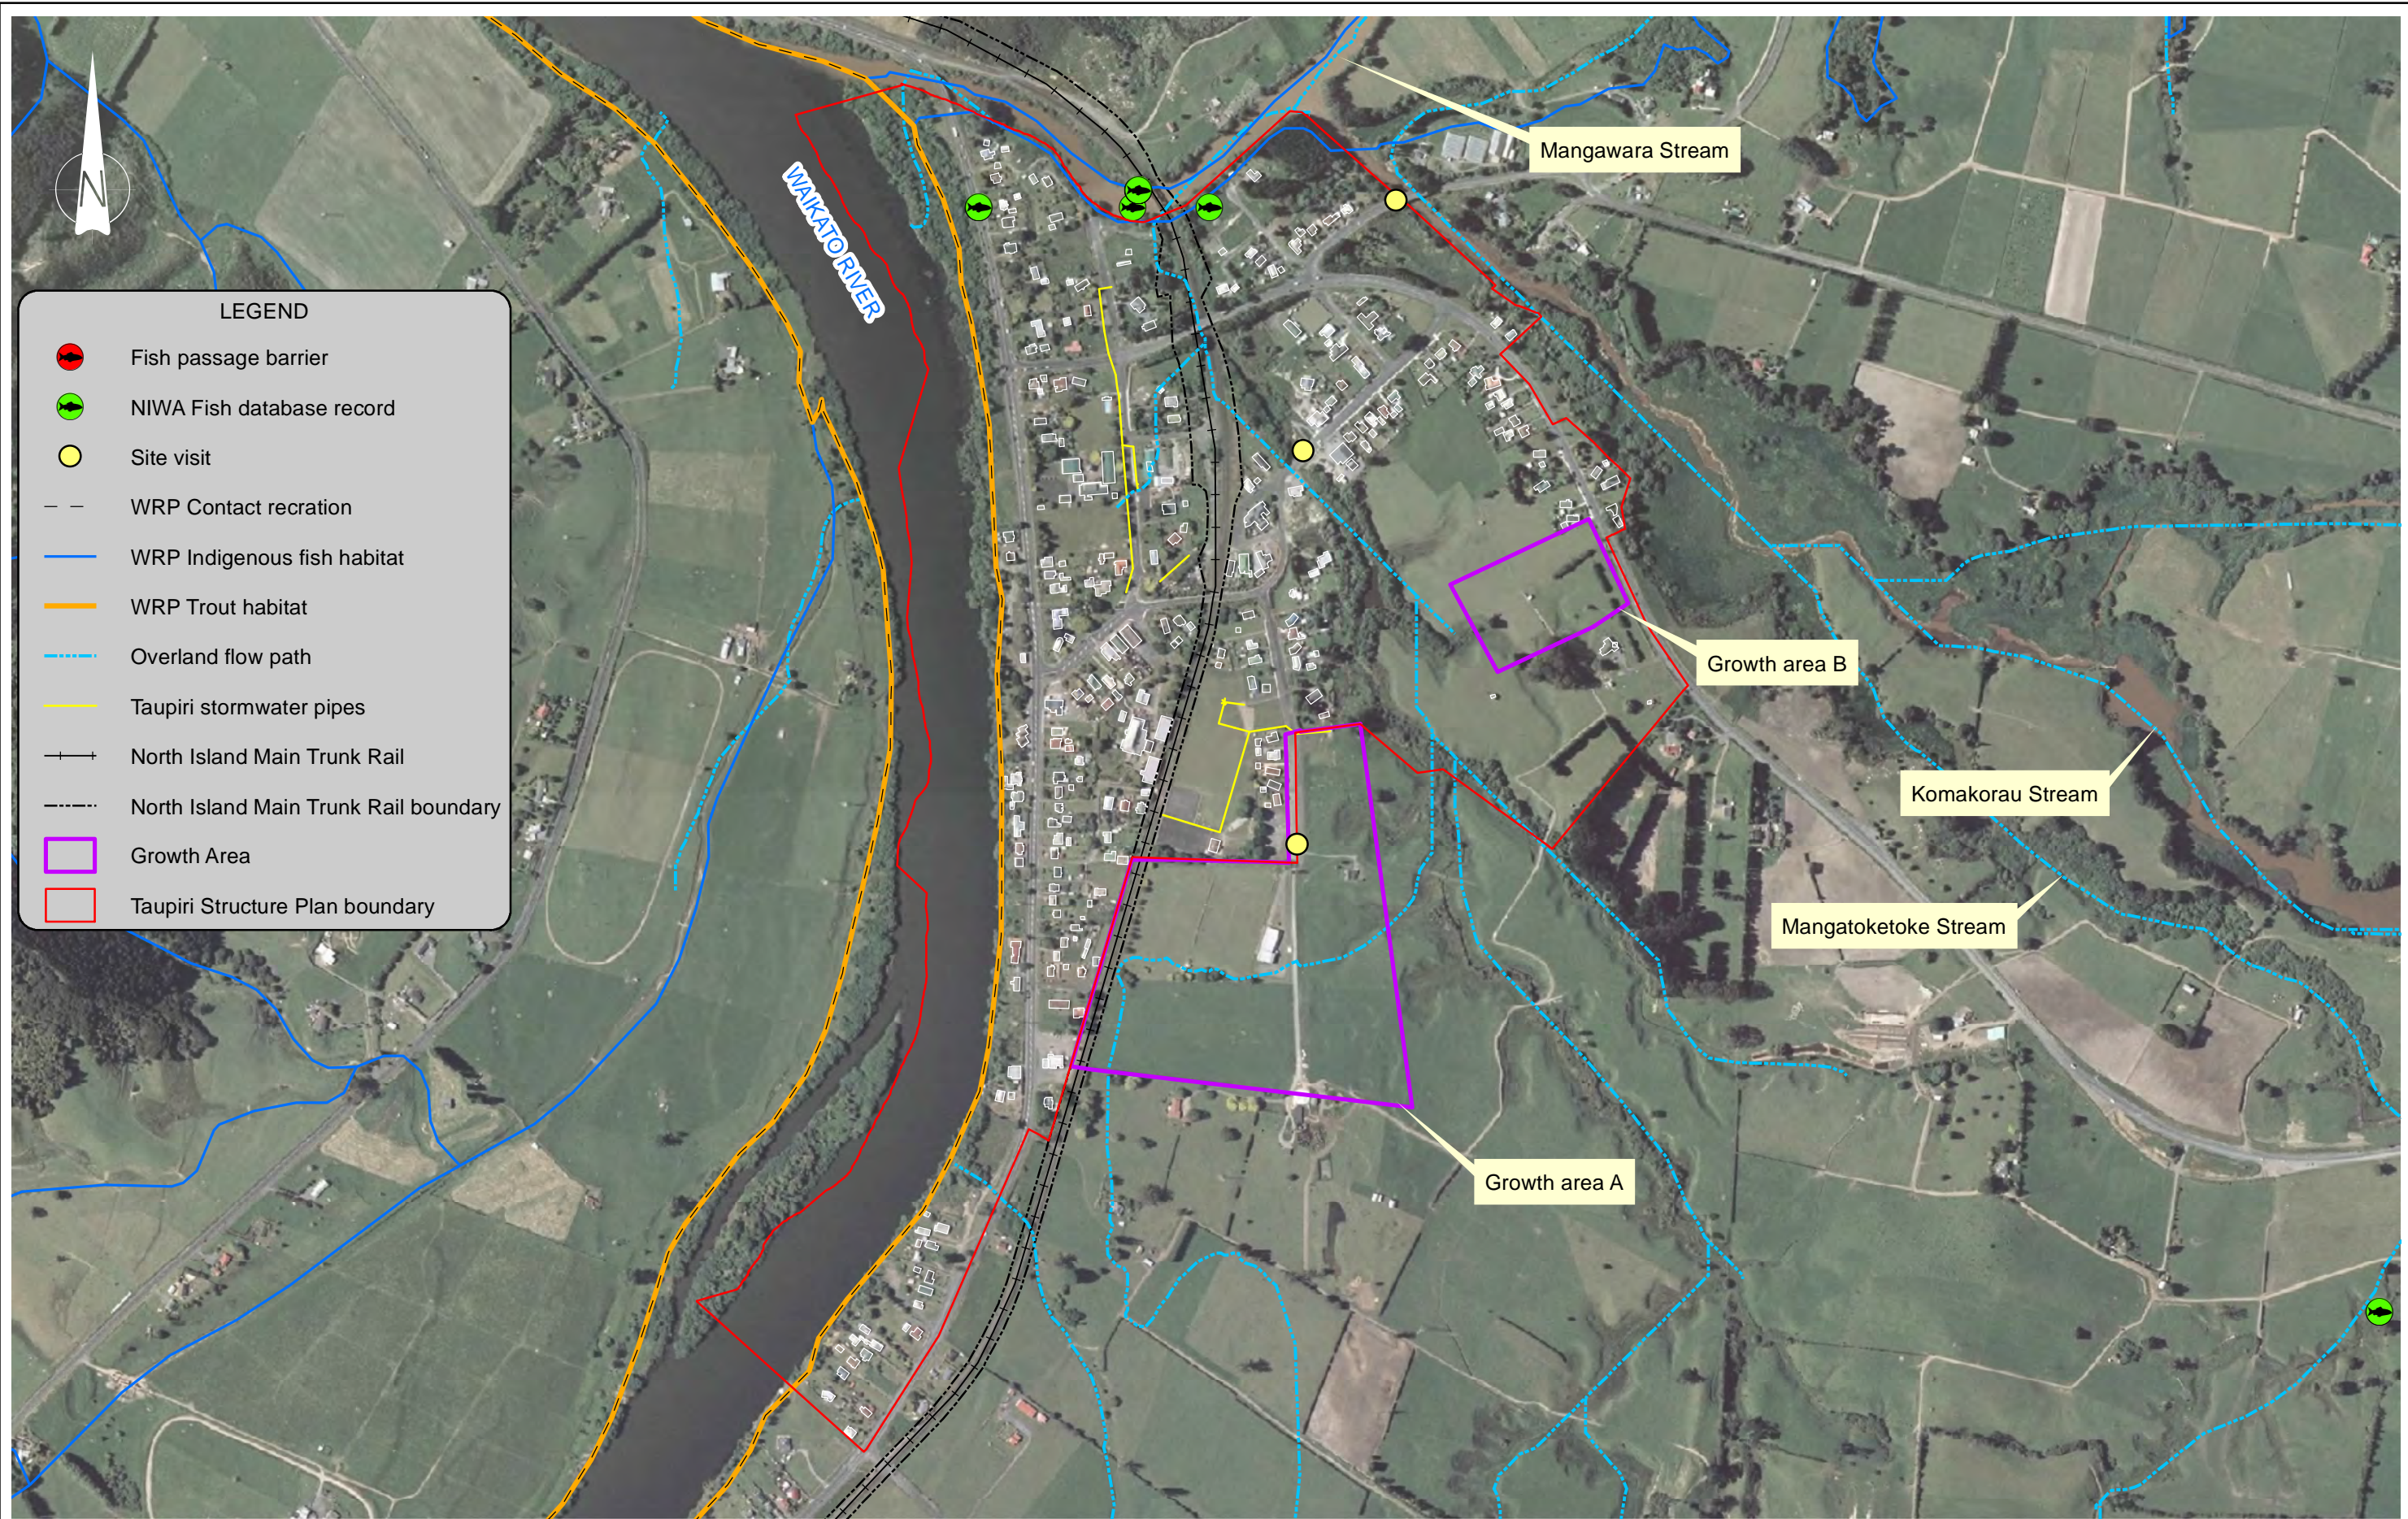
- Fish passage barrier
- NIWA Fish database record
- Site visit
- WRP Contact recreation
- WRP Indigenous fish habitat
- WRP Trout habitat
- Overland flow path
- Taupiri stormwater pipes
- North Island Main Trunk Rail
- North Island Main Trunk Rail boundary
- Growth Area
- Taupiri Structure Plan boundary

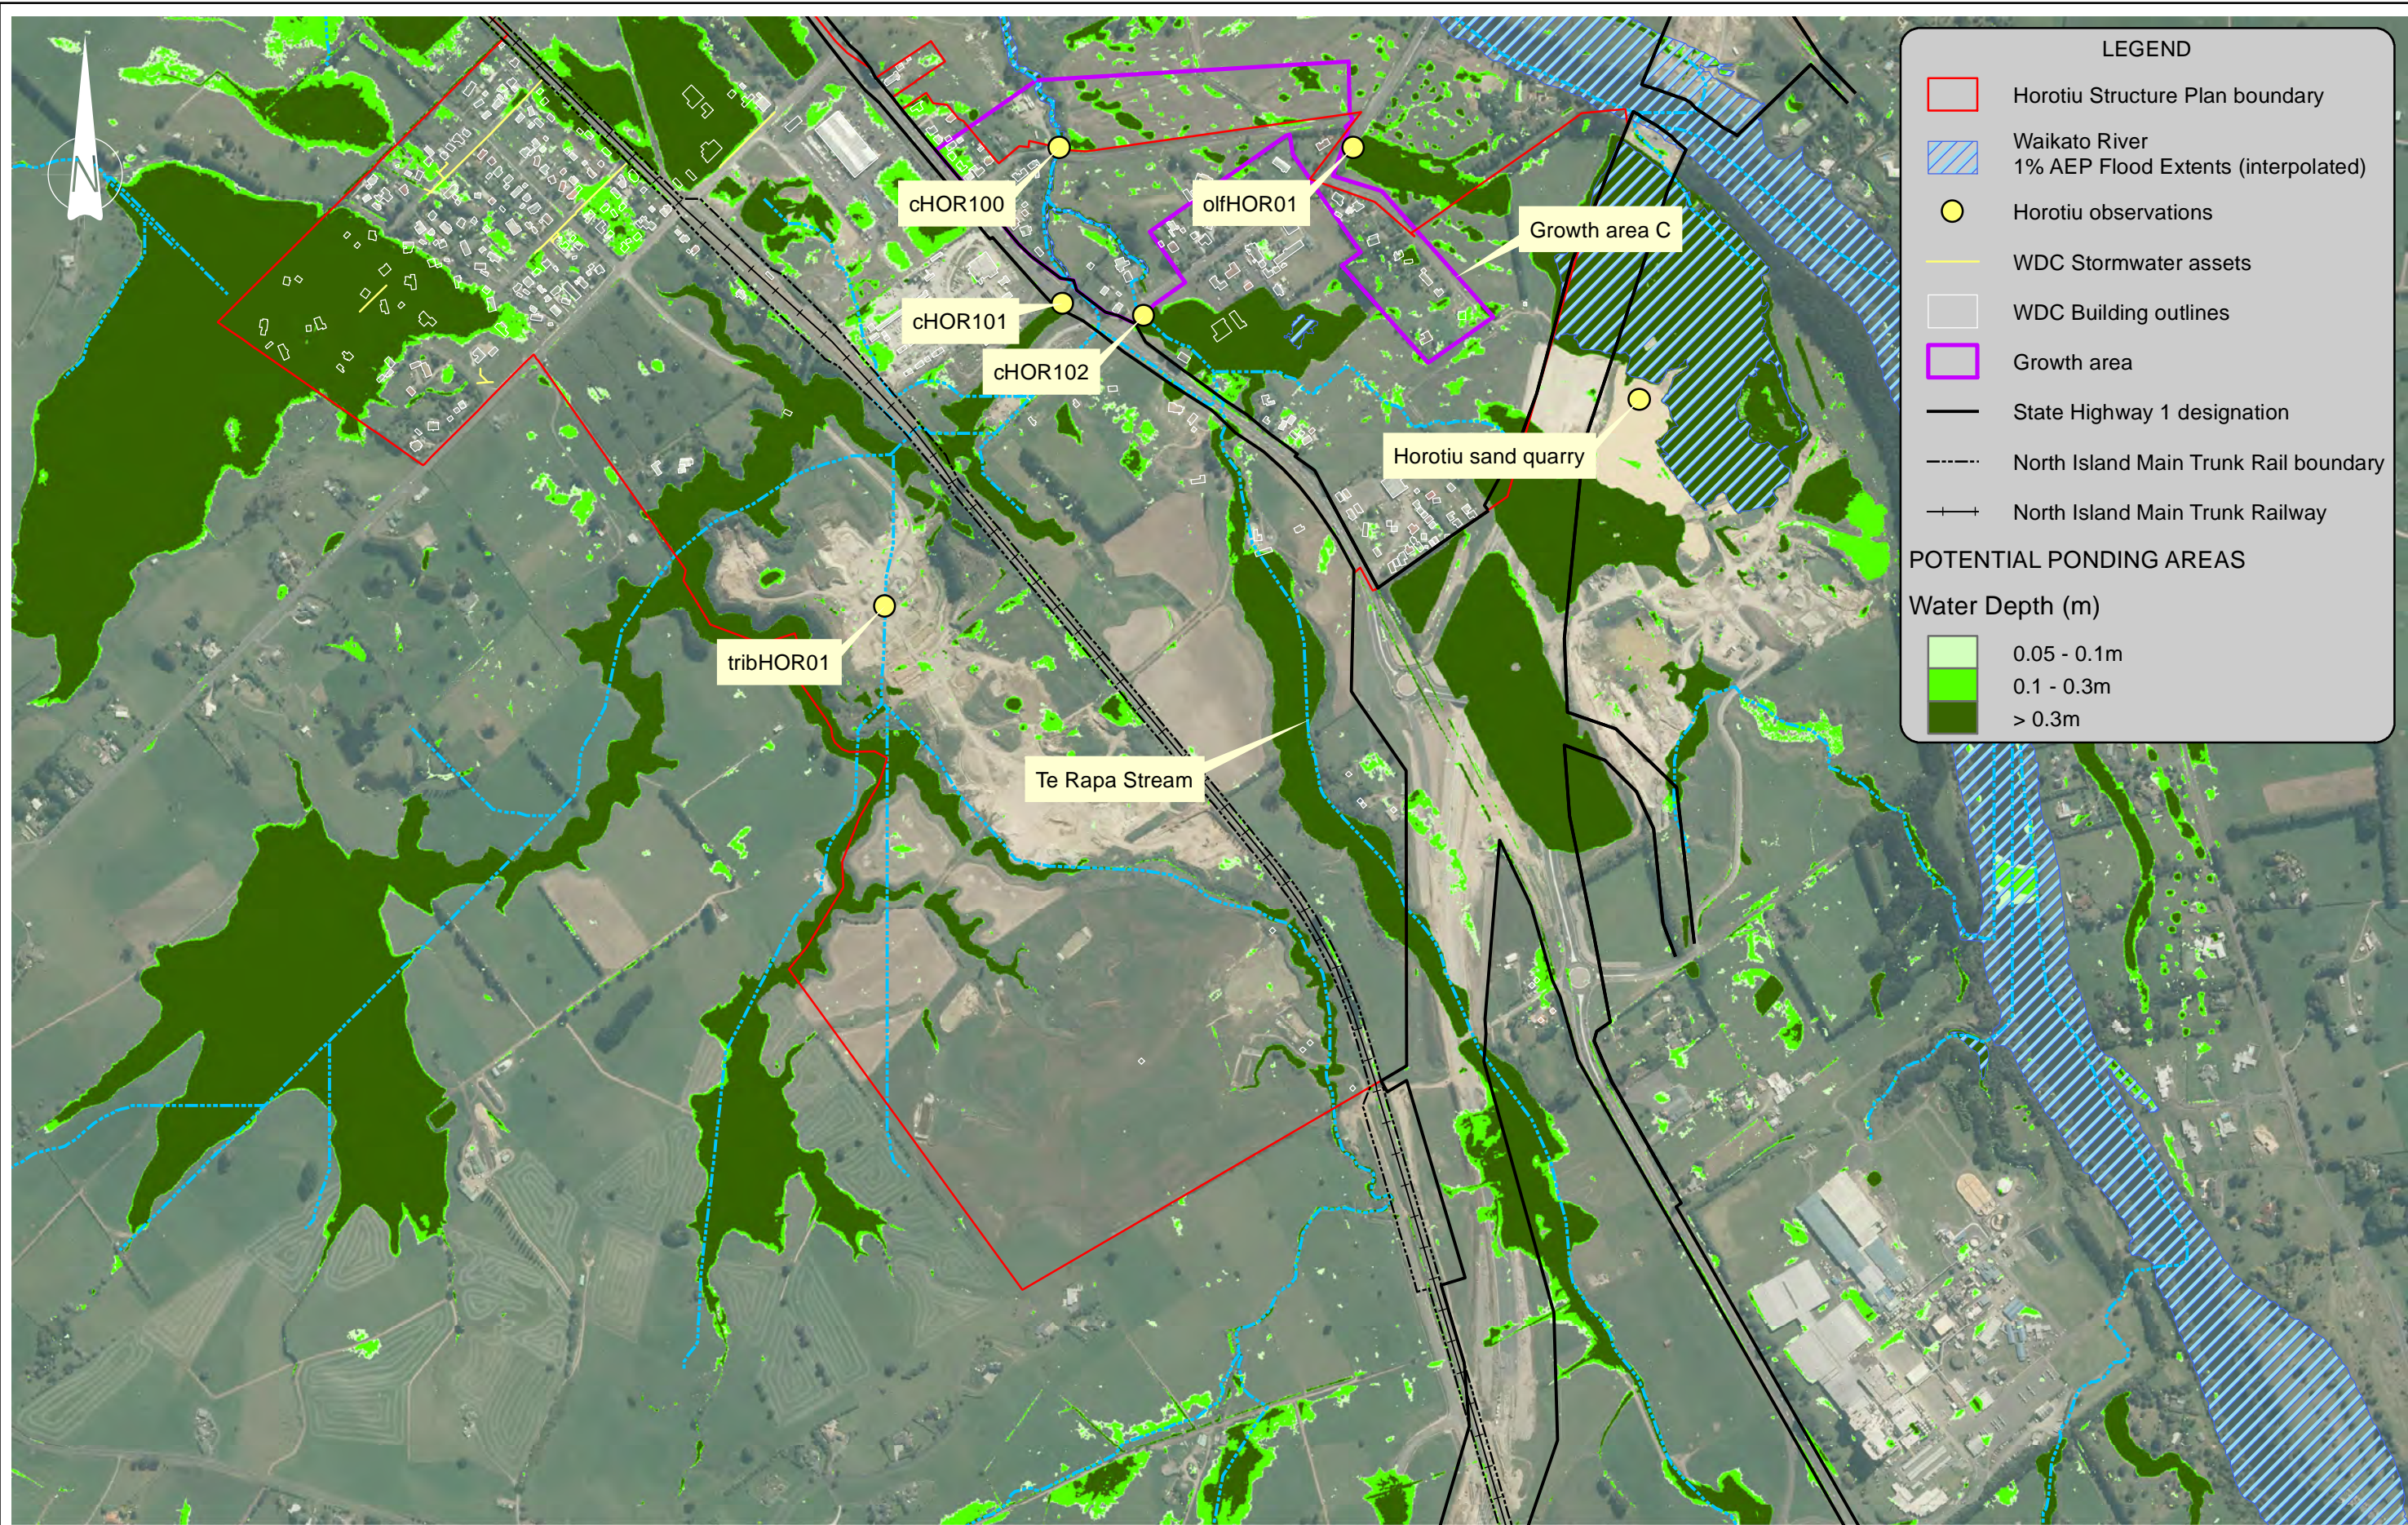
- **Figures 242 & 243 Flooding Maps Sheets 1 & 2**
- **Figure 252 Ecological Map**

- Horotiu Structure Plan boundary
- Waikato River
1% AEP Flood Extents (interpolated)
- Horotiu observations
- WDC Stormwater assets
- WDC Building outlines
- Growth area
- State Highway 1 designation
- North Island Main Trunk Rail boundary
- North Island Main Trunk Railway
