Ngaruawahia Structure Plan

Geotechnical Suitability Assessment

Client: Waikato District Council

AECOM New Zealand Limited

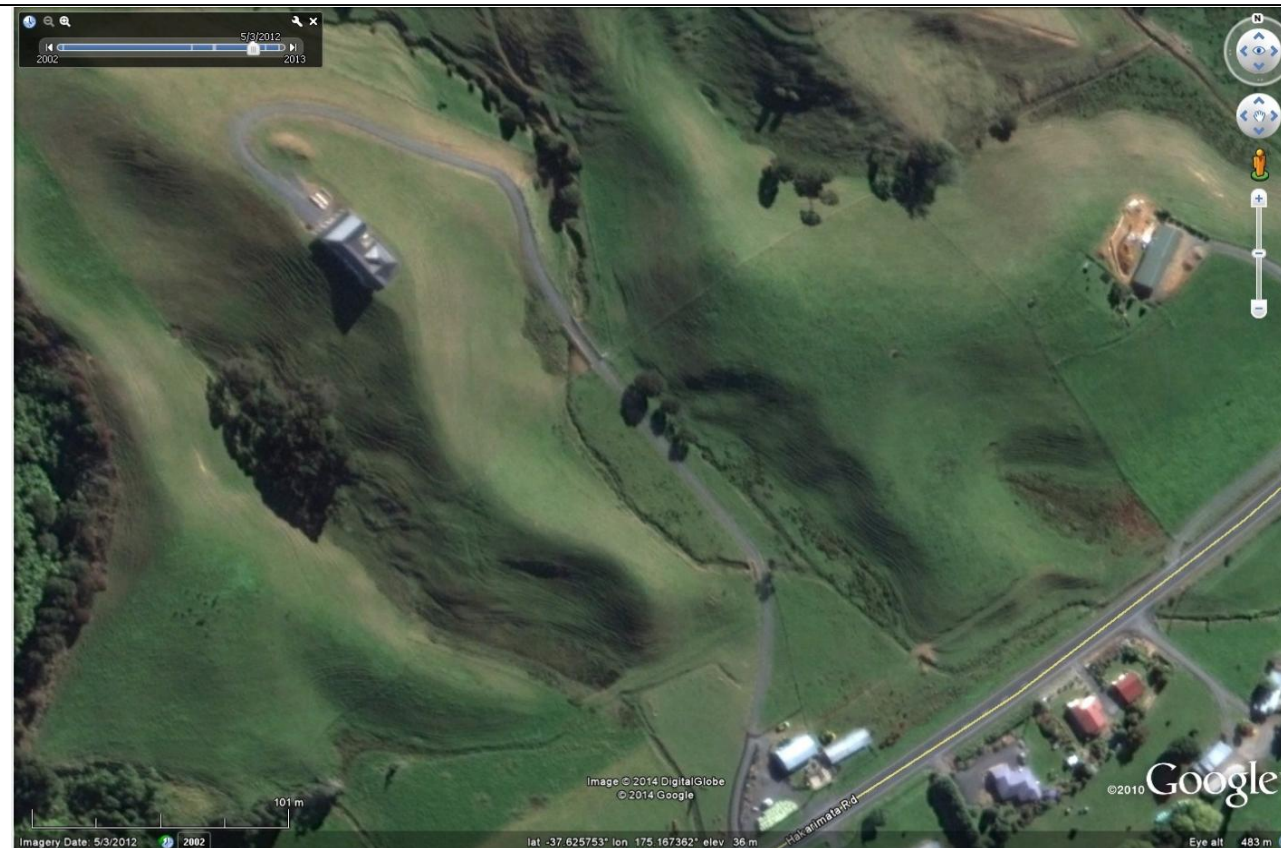
3. By May 2012 a house was relocated to the risge. The image indicates that the driveway did not interfere with the toe of the slope, which subsequently failed in July 2012. The image also indicates that no earthworks were undertaken on the slope.

Had this house been positioned on the slip or in the path of debris flow it would have been destroyed, and any occupants would have been unlikely to survive.

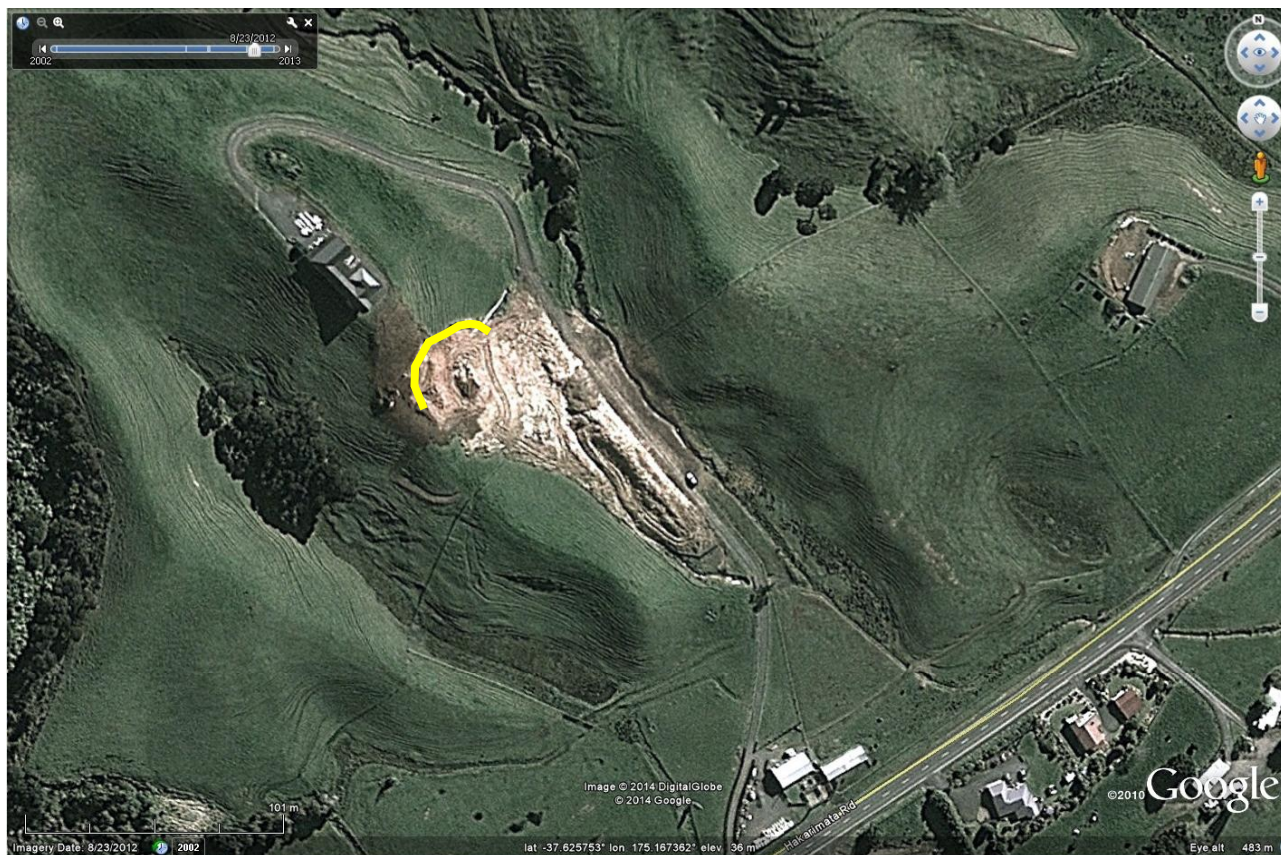
4. This image was taken in August 2012 approximately 6 weeks after the slip occurred. Note the soil has flowed approximately 100 metres from the headscarp. Works have cleared the driveway however surge marks are still visible on the opposite ridge.

Debris from these slips can be fluid and travel a significant distance down slope and across adjacent level ground. Landslide debris from rapid failures poses a significant hazard to property and life. Case Study 2 in Appendix C, discusses a recent slip and debris flow within this area.

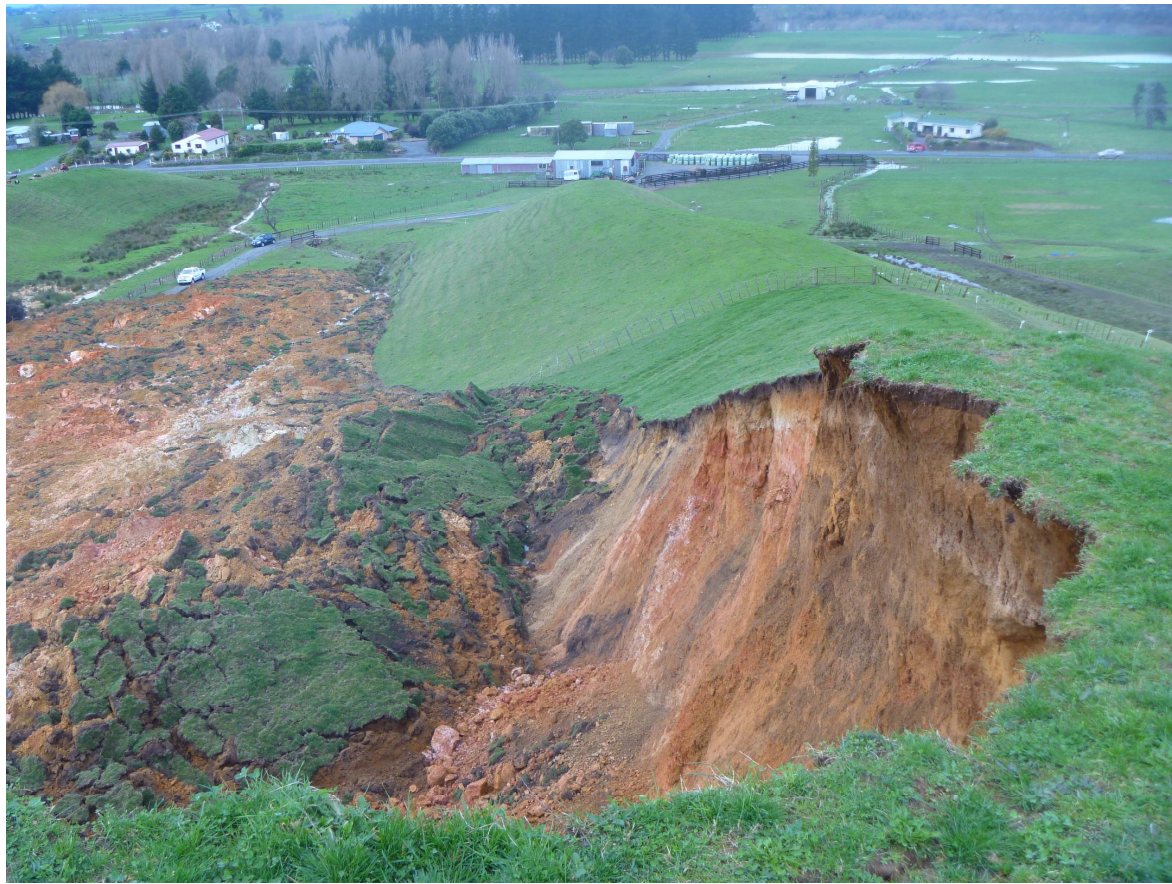
5. Looking across slip backscarp towards Hakarimata Road.

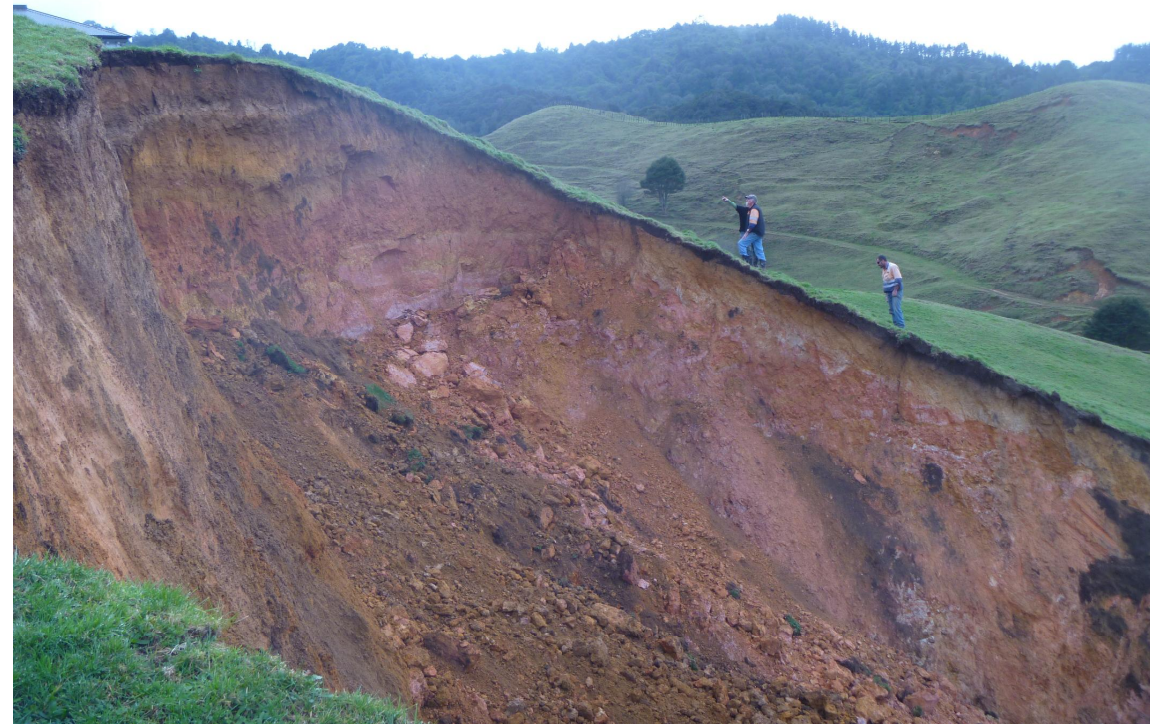
7. The size and depth of back scarp is apparent in this photo

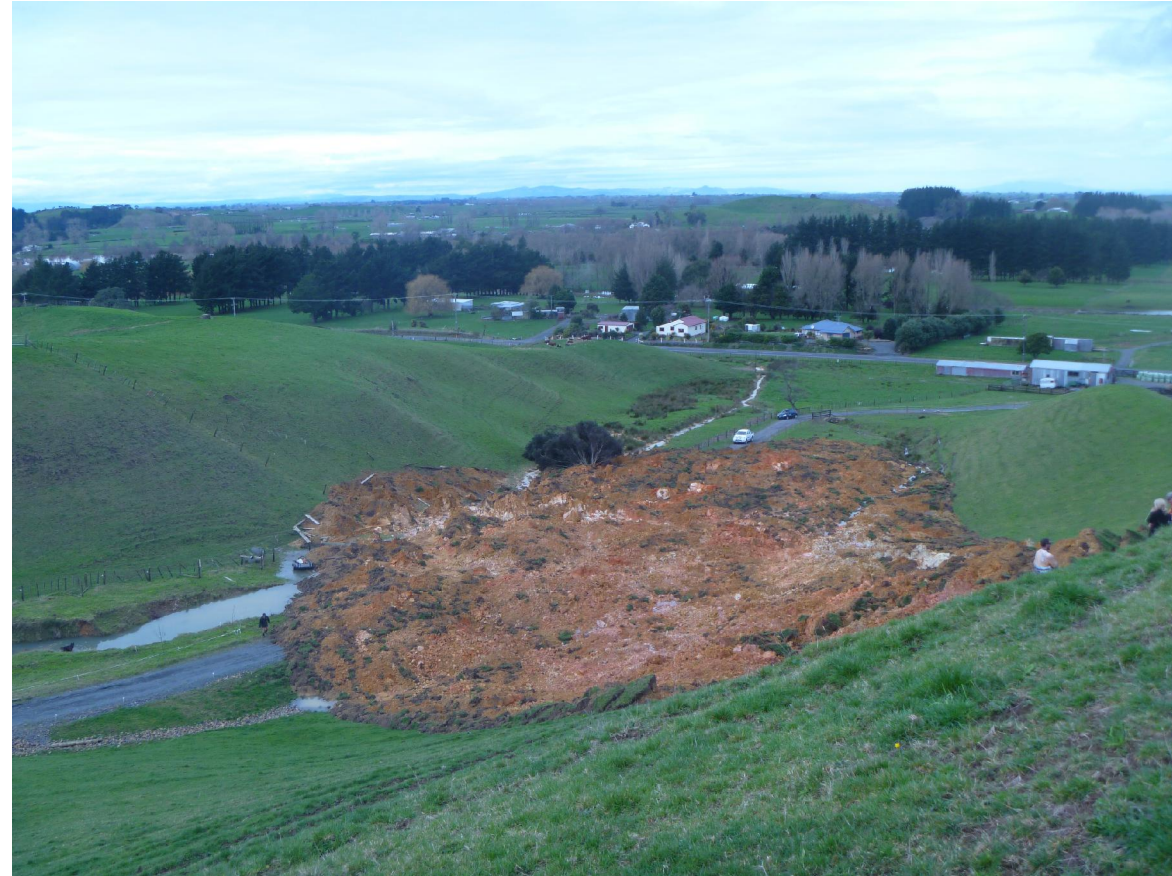
6. Note debris flow had sufficient velocity to travel several metres up adjacent slope and topple mature trees.

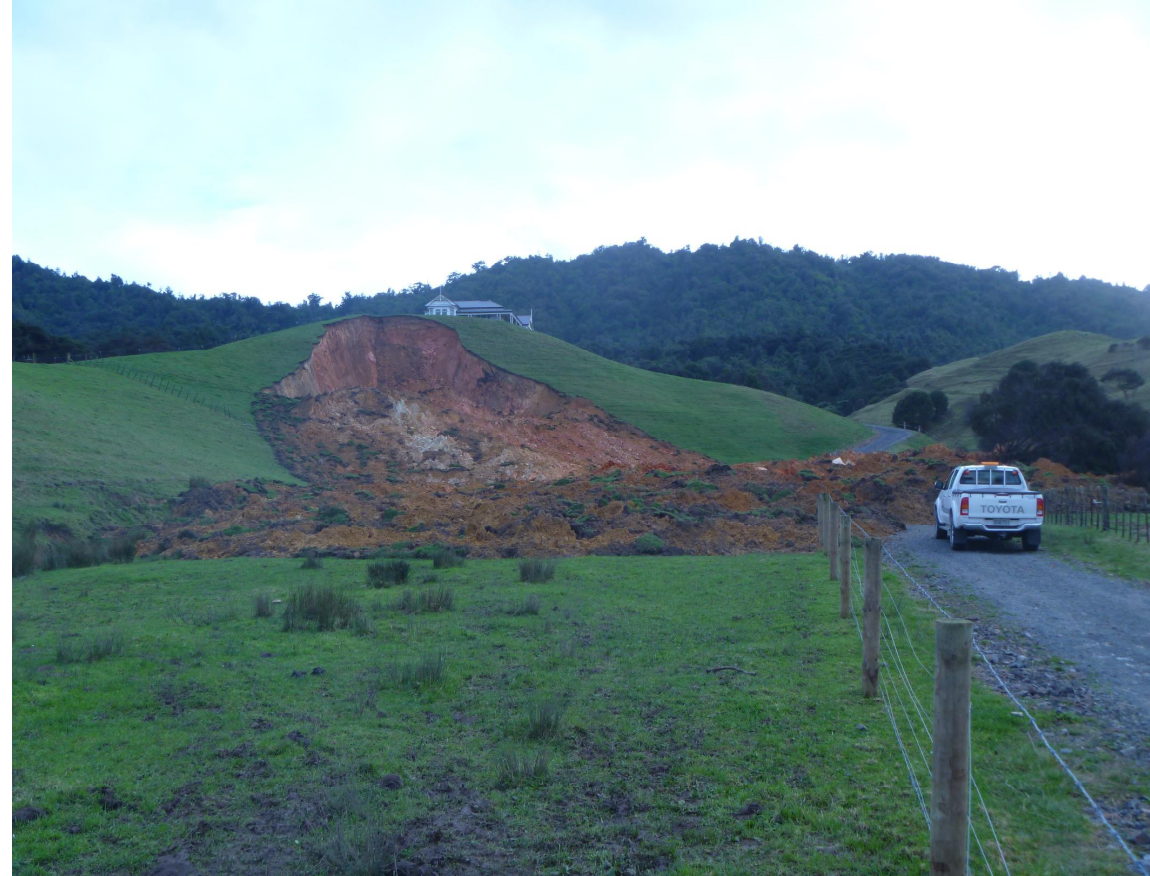
8. View from Hakarimata Road. Note the thickness of the debris 100m from the source.
