NGAARUAWAAHIA AND TAUPIRI CPTED ASSESSMENT

Prepared for Waikato City Council

by Beca Ltd (Beca)

28 April 2023

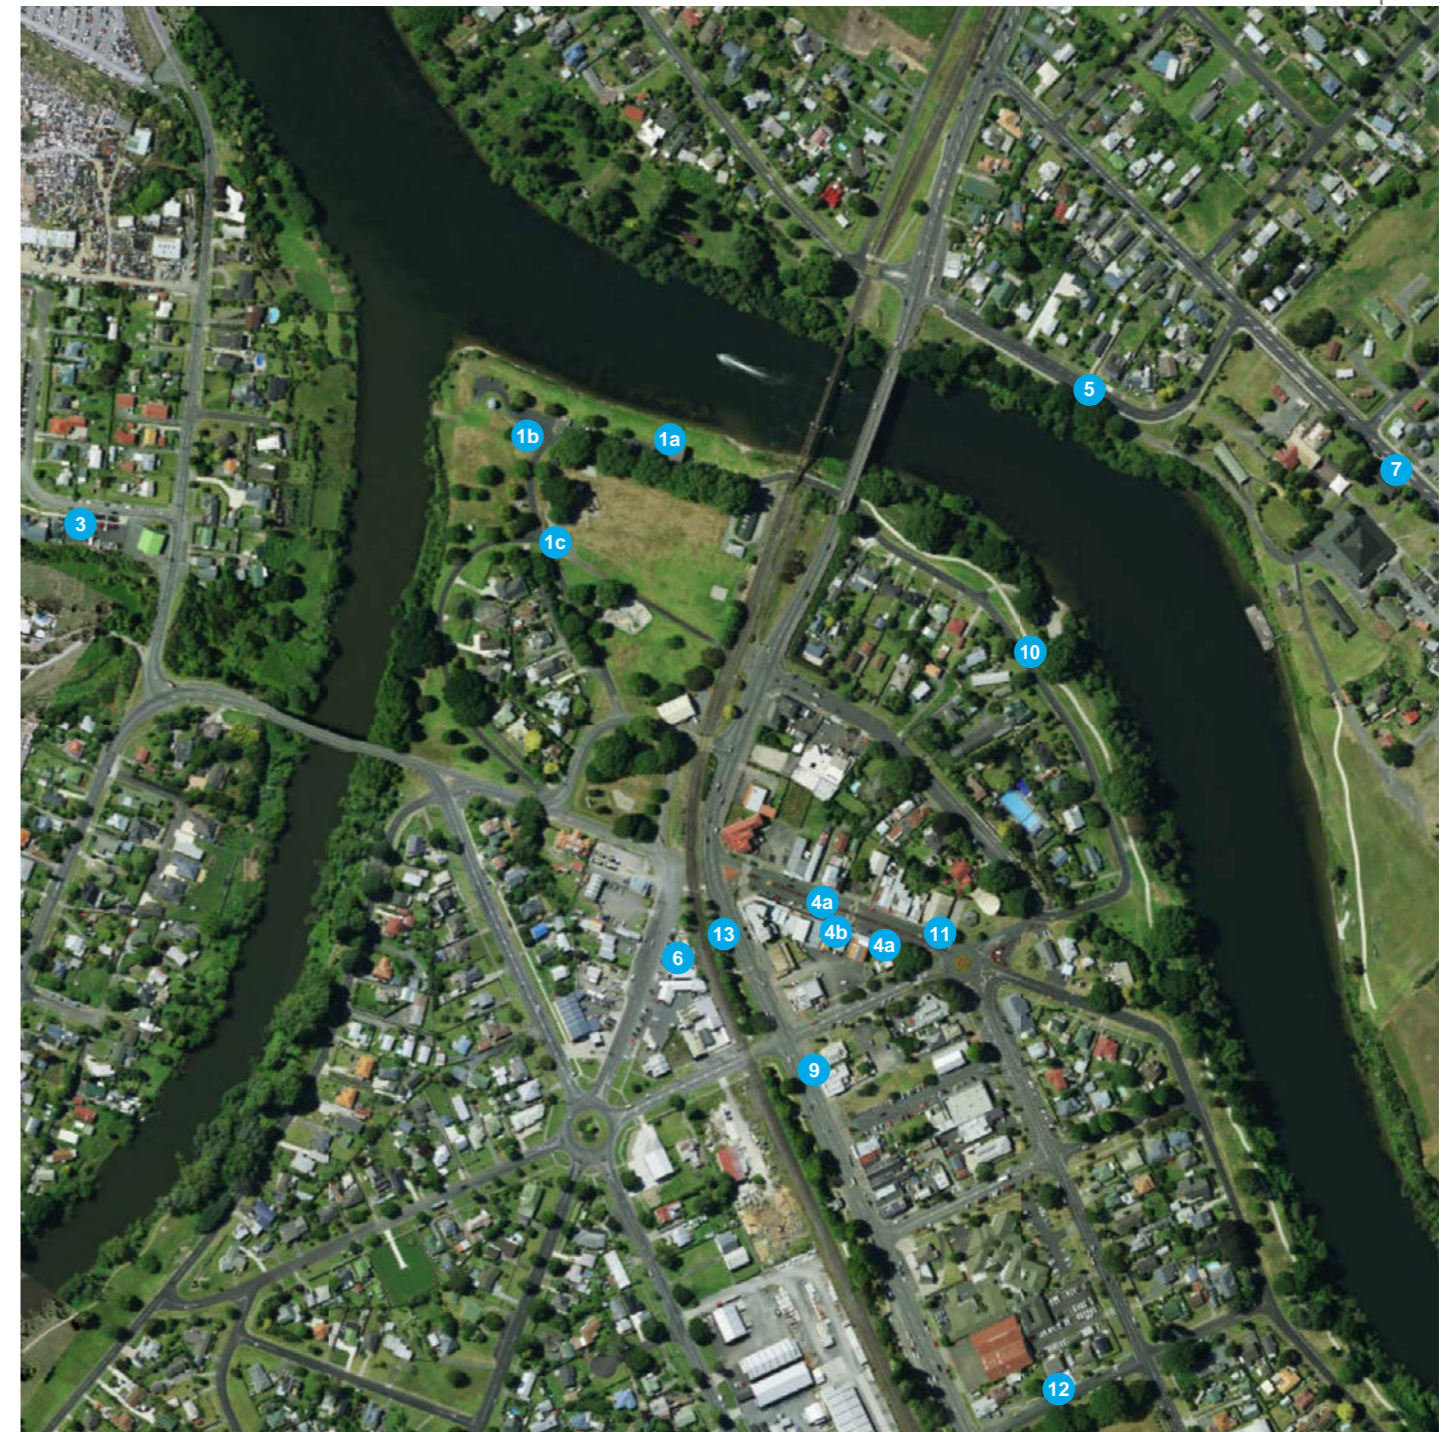
Figure 8. Mapping of positive CPTED features - Ngaaruawaahia

- 1 The Point:
 - a The mural on the hall alongside the Waikato River shows little sign of graffiti and is a good strategy for buildings that provide a blank canvas and have little passive surveillance. It is noted that the wall facing the park has been a target of graffiti and has been painted out to a height of approximately 3m. This indicates that this side could be a graffiti target – the only difference being that the western wall is potentially more recent and painted by Graham Hoete.

- b The interpretation panels providing historical context are well located and maintained considering they are over 10 years old. No graffiti was observed on these installations and other locations in the town centre. While general maintenance is required to the facing panels where there has been water ingress, the durable design and materials could be replicated.

- c Landscaping with feature trees being limbed up providing for clear views. This was complimented with lighting located on main access routes. While the luminaires looked to lack maintenance with missing glass panels the lighting was functional at night.

- 2 Kiingitanga Reserve: Well-lit along Waingaro Road the preferred route. Omission of lighting within the reserve discourages users to take this route at night-time, reducing risks. Some lighting within the Reserve was observed but not working at the time of visit.

- b ATMs along Jesmond Street are located to reduce opportunity for concealment and loitering, maximizing sight lines and visibility. Seating is avoided in close vicinity to ATMs reducing opportunity for users to be observed.

- 7 Turangawaewae Marae: The Marae does not provide views out over the street, however this is consistent with the role within Ngaaruawaahia. It is noted that there is a level of care, maintenance, and detail along this edge.

- 11 Low level planting shows a well maintained environment and contributes to a perception of a cared for town centre environment.
- 12 There are examples such as the ambulance station which have well considered lighting that provides amenity for pedestrians as well as having a security function.

- 13 Bus stop with no hidden walls facilitating clear sightlines and allow pedestrians to move through.

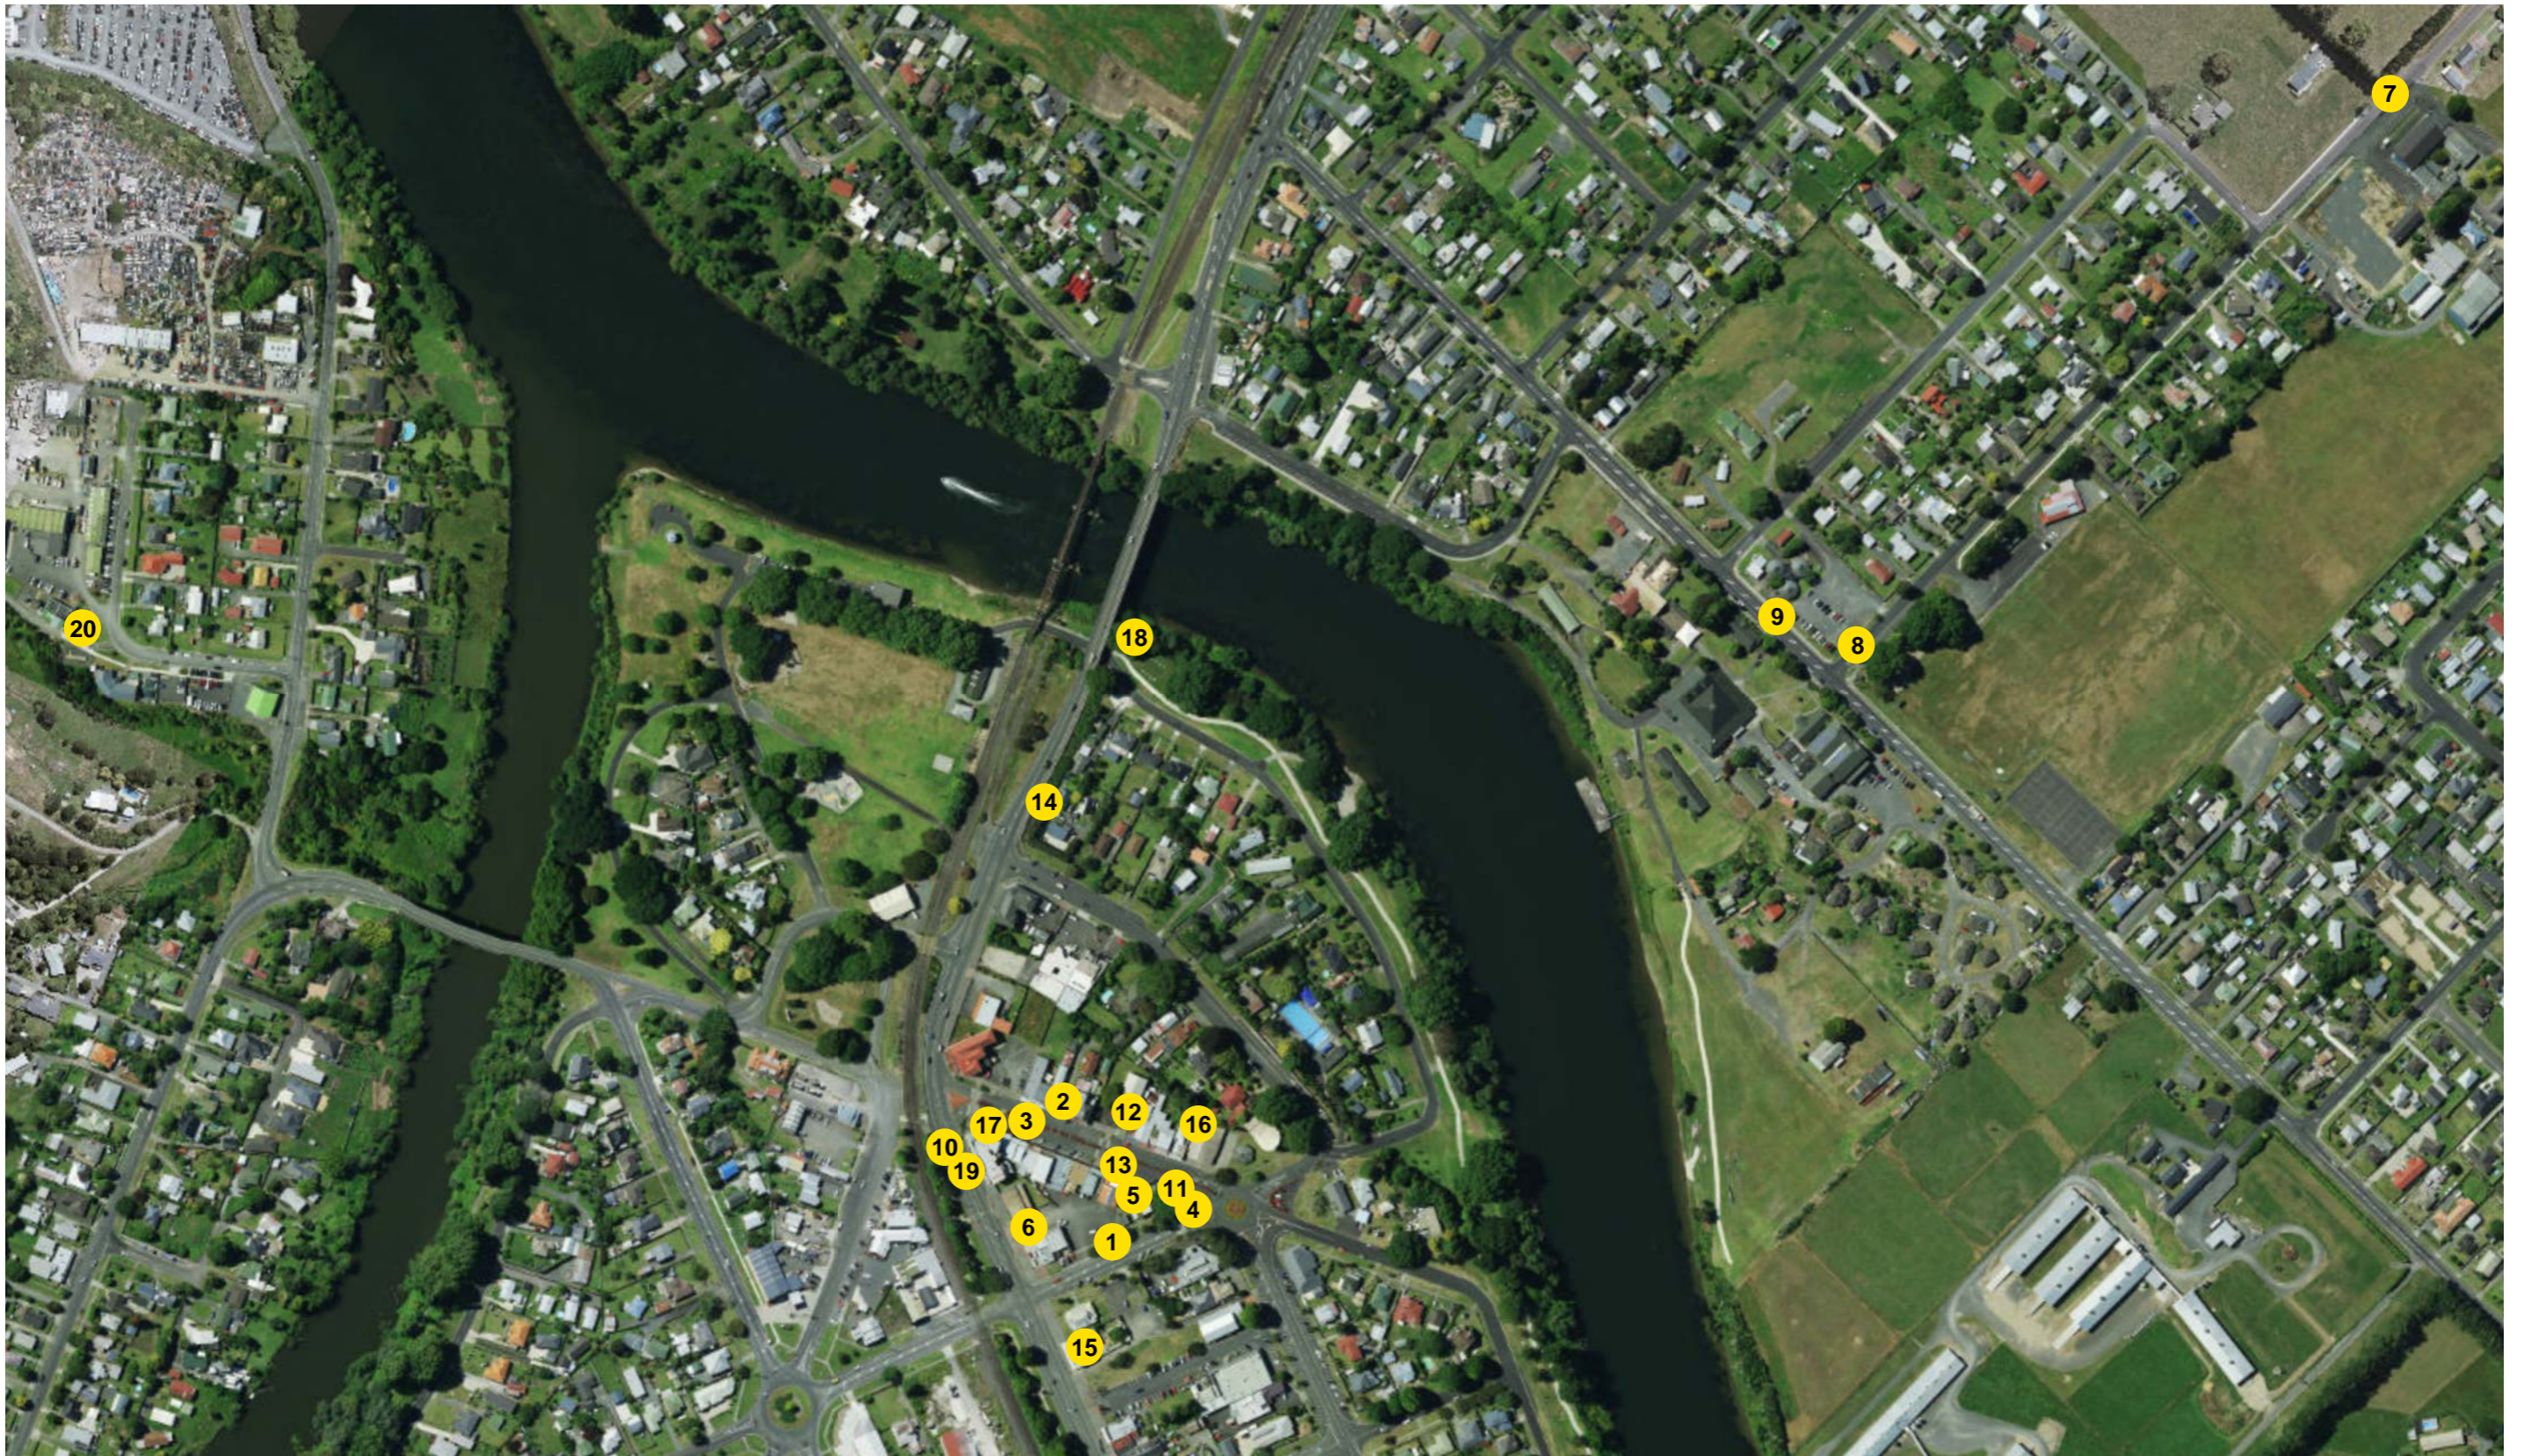
Figure 9. Mapping of CPTED issues - Ngaaruawaahia

A number of graffiti tags were observed around the town i.e. Turangawaewae Marae, bridge, transformer boxes.

Conduct a review of the lighting (on the night of the walkover lights were being replaced) and an arborist review to determine where trees are blocking lighting at ground level.

- Identify who the asset owner is of the elements that are commonly targeted for graffiti. Implement more regular reporting and maintenance. It was noted that several elements are not Waikato District Council assets and lowers the perceived quality environment.
- Plant dense foliage at the base to restrict access to the wall.
- Paint the wall using one of the precinct's theme colours from the agreed palette.
- Consider commissioning a mural artist where locations are identified that are a consistent target.
- Identify through the community if the taggers are from the wider area and reach out through the Police, community for effective ways to lower the incidence.

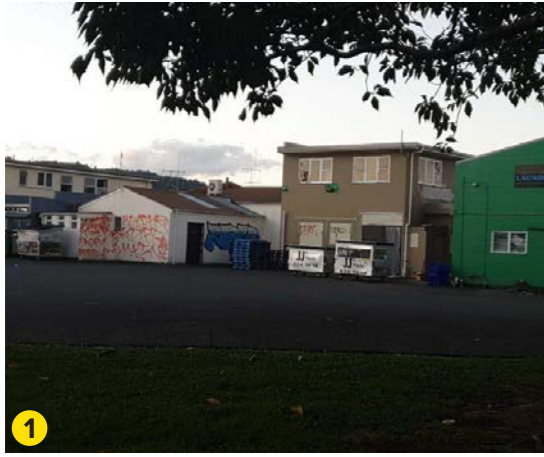
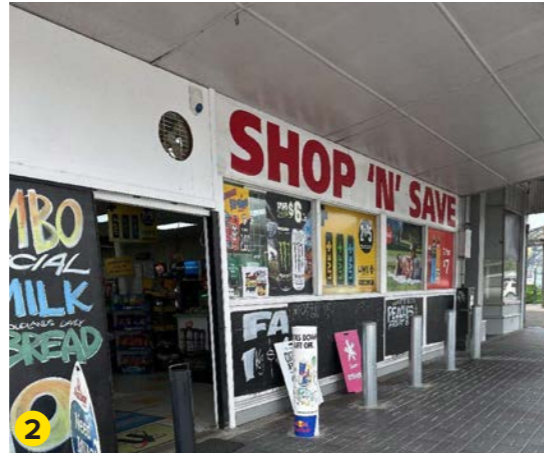
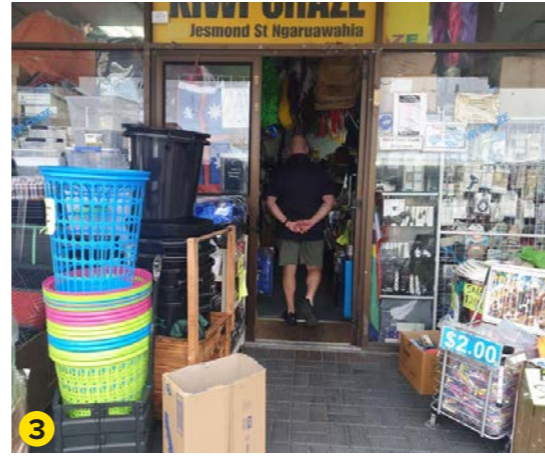
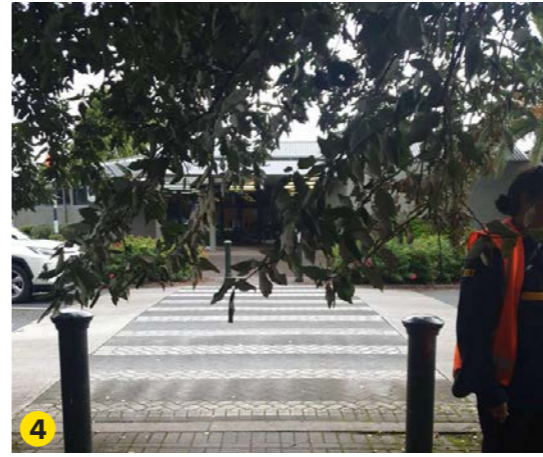
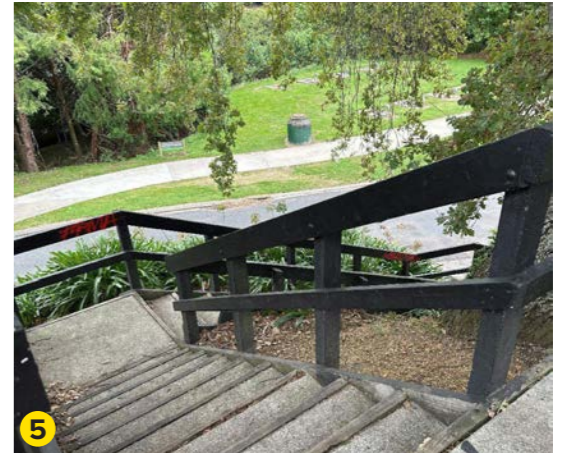
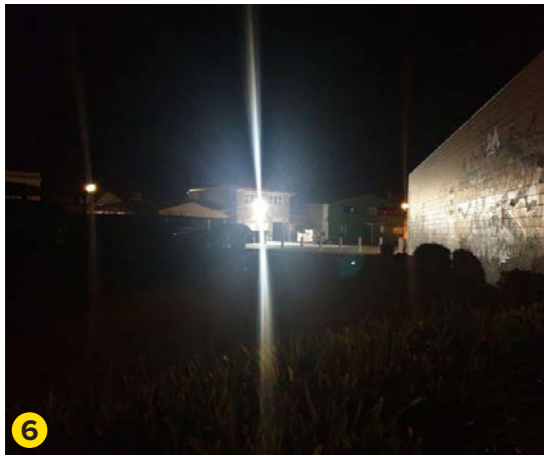
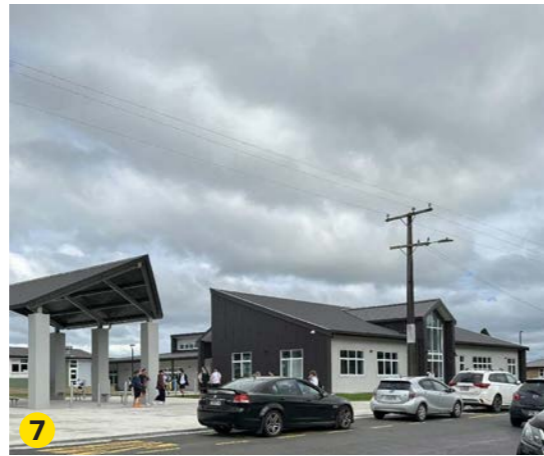
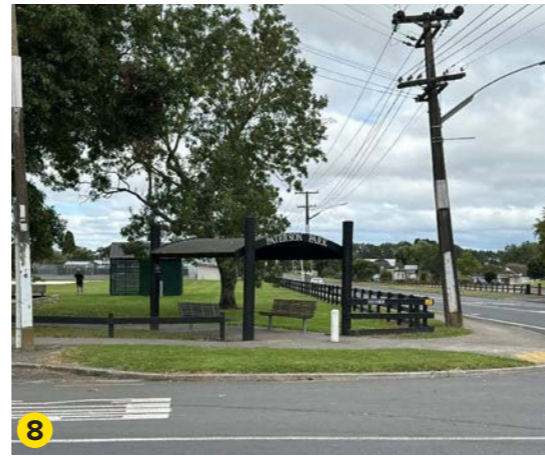
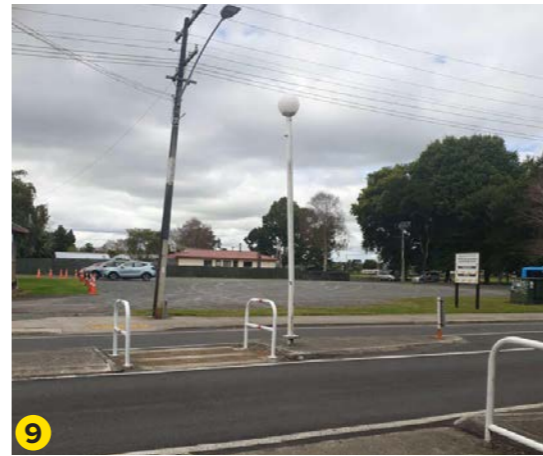
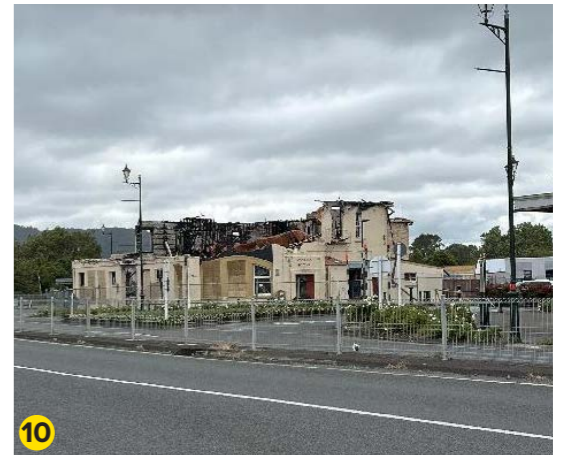
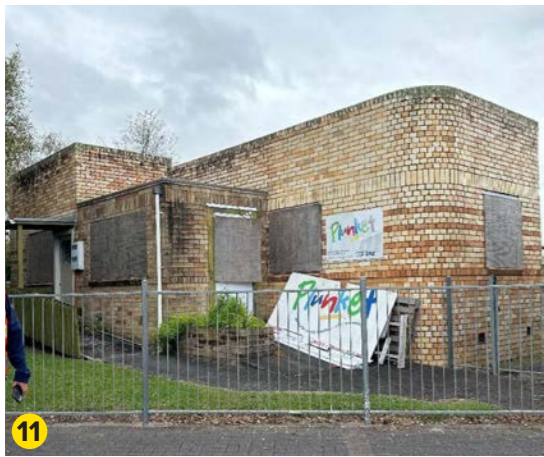
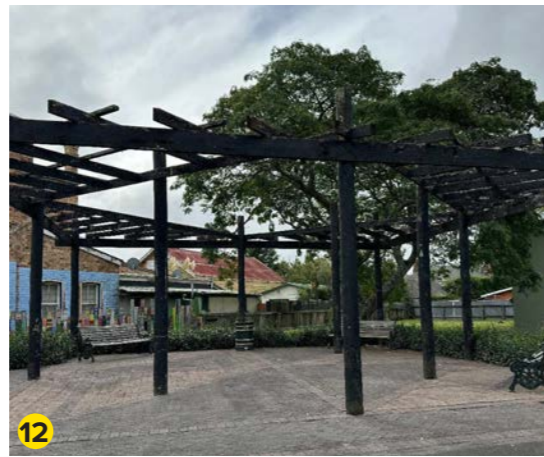
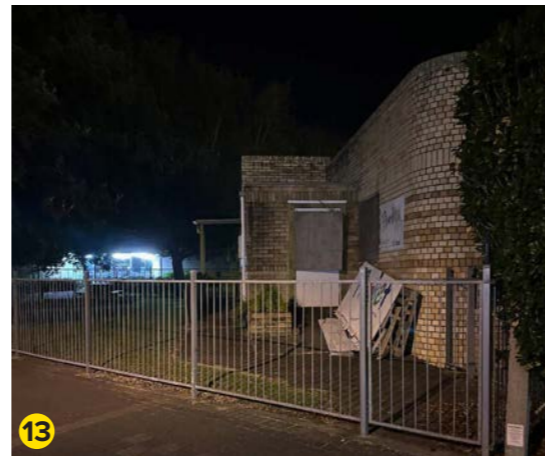
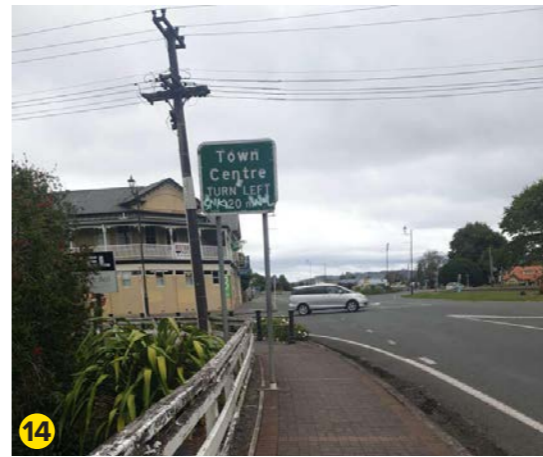
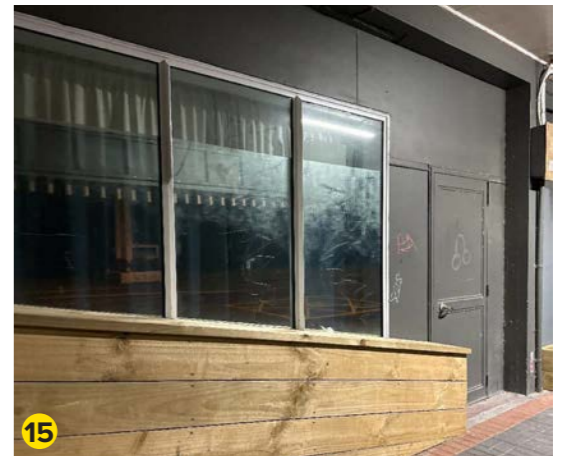
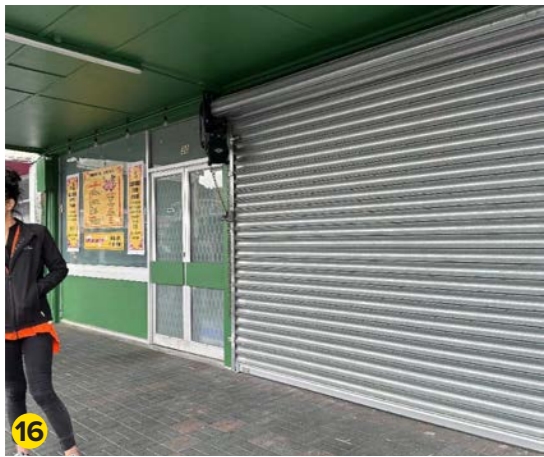
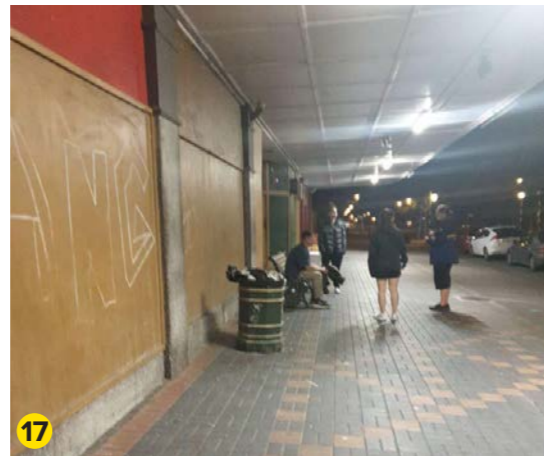
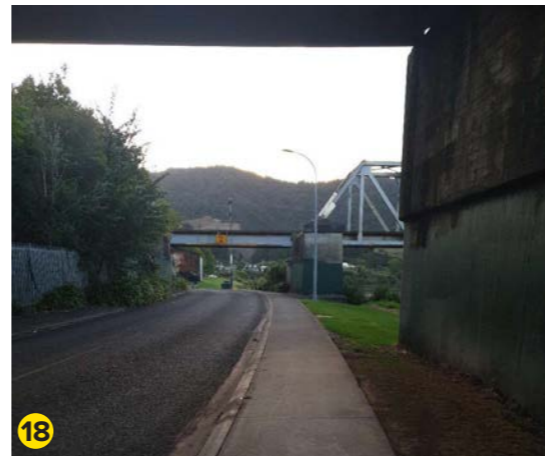
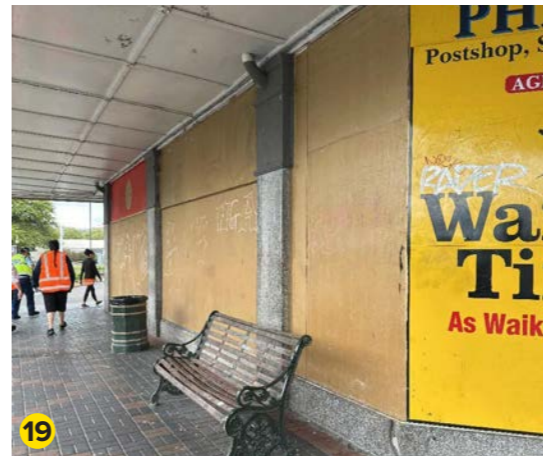
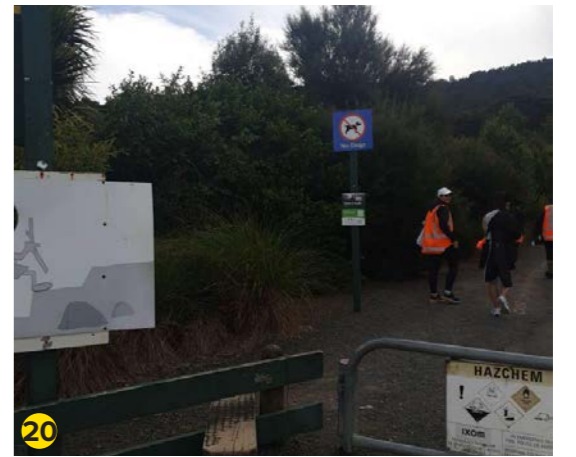
Figure 10. Summary of observed CPTED issues - Ngaaruawaahia

Natural ladders

There are natural ladders behind Great South Road - owners to evaluate if this is an issue for access onto rooves etc. The bins can also be a place for people to hide behind at night.

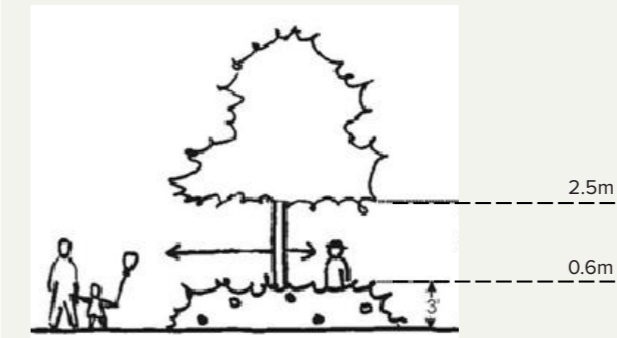
CPTED best practice stipulates a vegetative clearance between 0.6m to 2.5m (refer diagram below).

Trim lower limbs of trees to provide a clear trunk and improve visual connection.

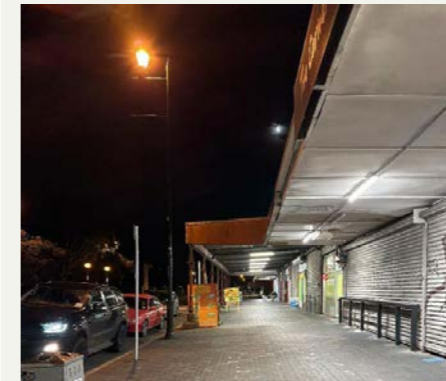
Along the canopies of Great South Road and Jesmond Road shops lighting is effective with no obstruction.

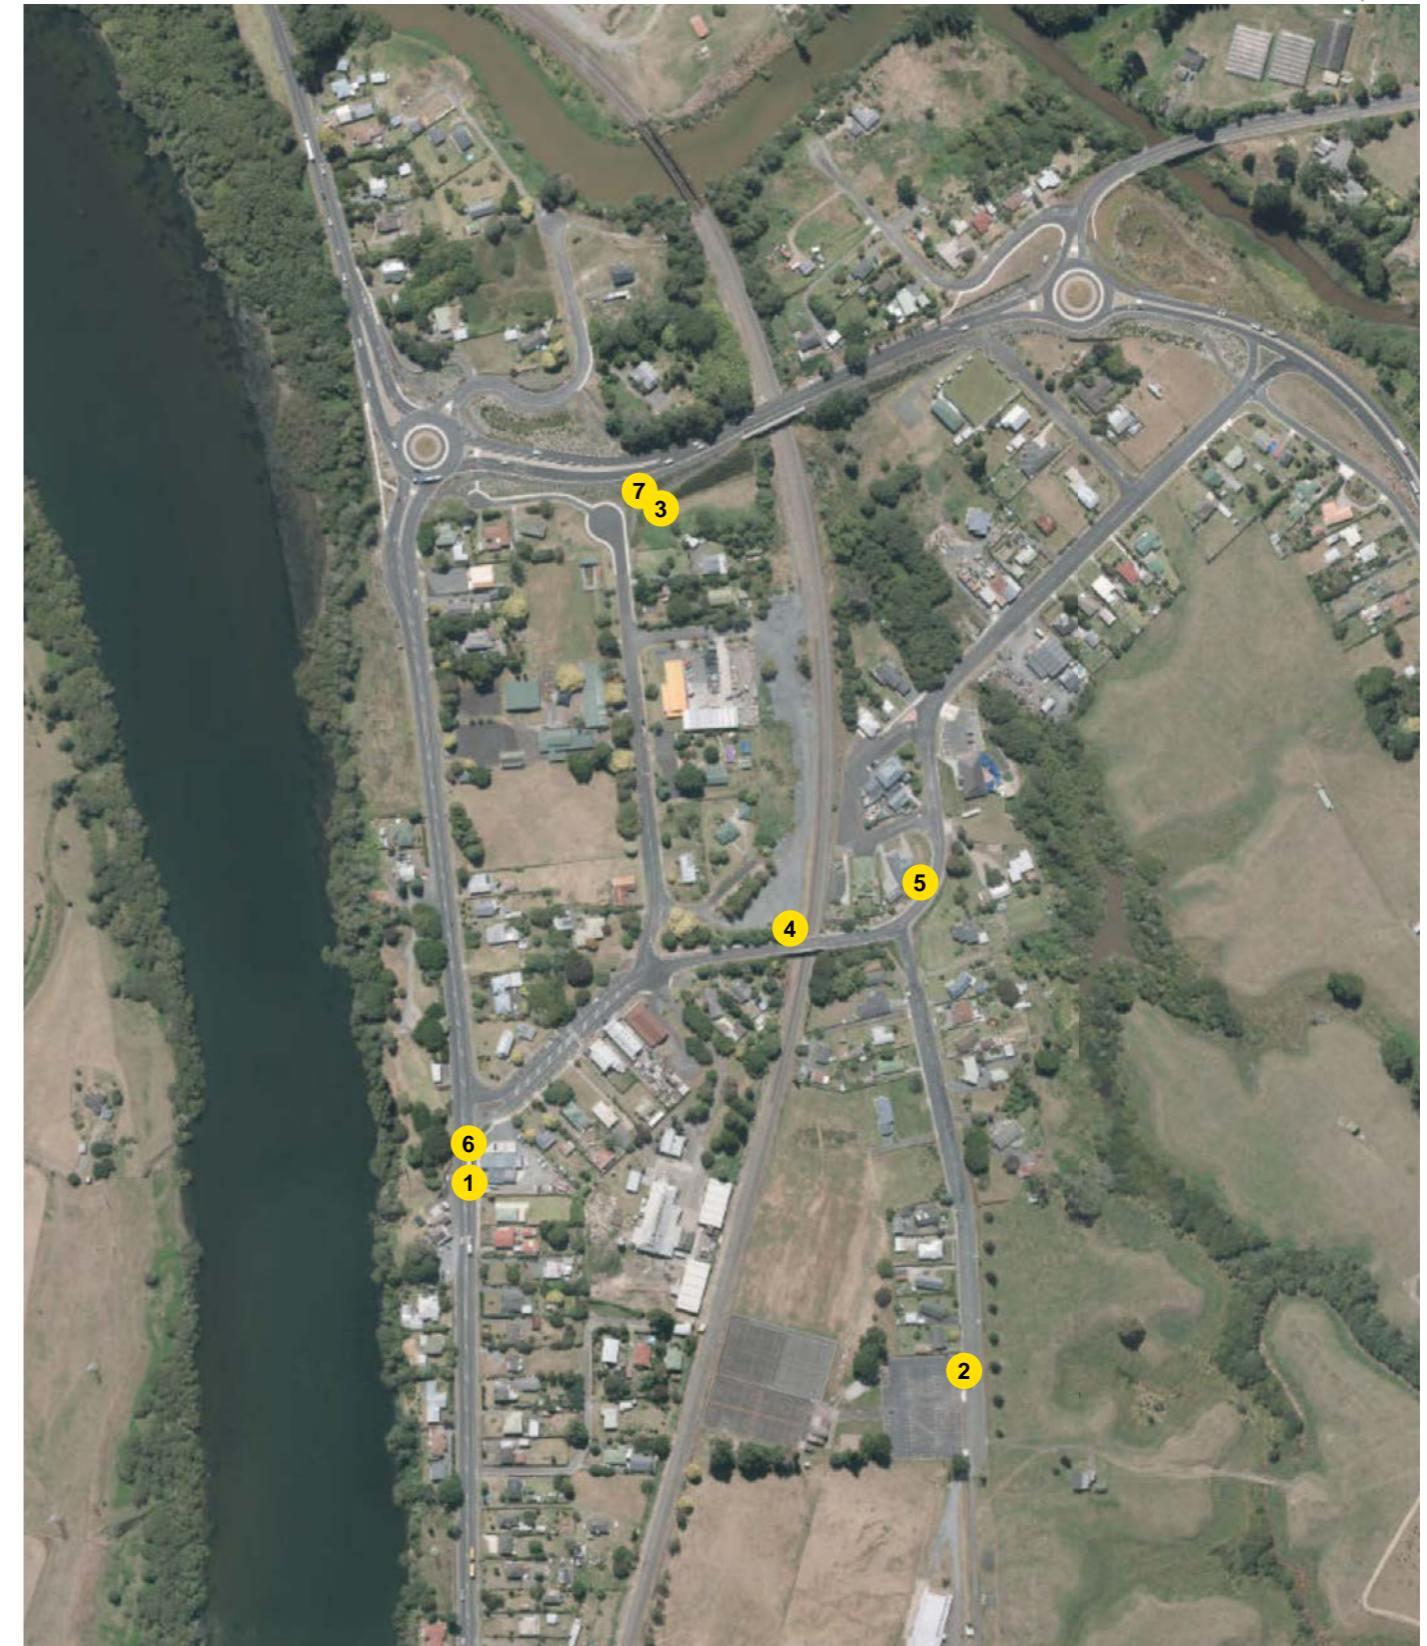
Figure 13. Mapping of CPTED issues - Taupiri

Figure 13 shows the summary of analysis and contains a photo reference map locating the photos and issues as set out in table form on the following pages and broken down into the following categories:

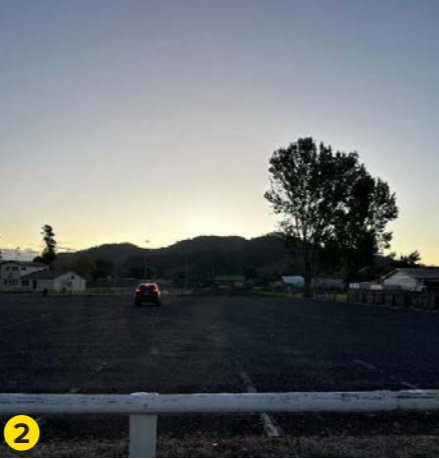
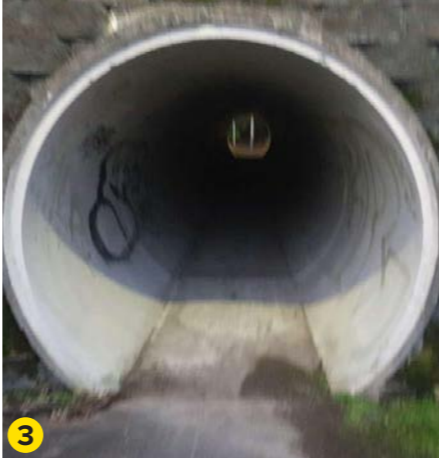
<p>Increase lighting, consider gating areas where there is deep recess if this is an area where there is a level of heightened risk. Receiving wider feedback form users is important to establish whether change is warranted.</p>	<p>HIGH/ BEST PRACTICE</p>
<p>e. Lighting</p> <p>The underpass under Gordonton Road and the Rugby Field carpark are not sufficiently illuminated after dark.</p>

<p>Install more pedestrian scale lighting and provide a wider localised area for the Rugby field parking.</p>	<p>EXTREMELY HIGH</p>
<p>f. Legibility through wayfinding</p> <p>Wayfinding with area severed by roads and no easy pedestrian access to each quarter - there is a need to discuss the lack of access to recreational and community facilities with several people wanting to age in place and use mobility scooters.</p>

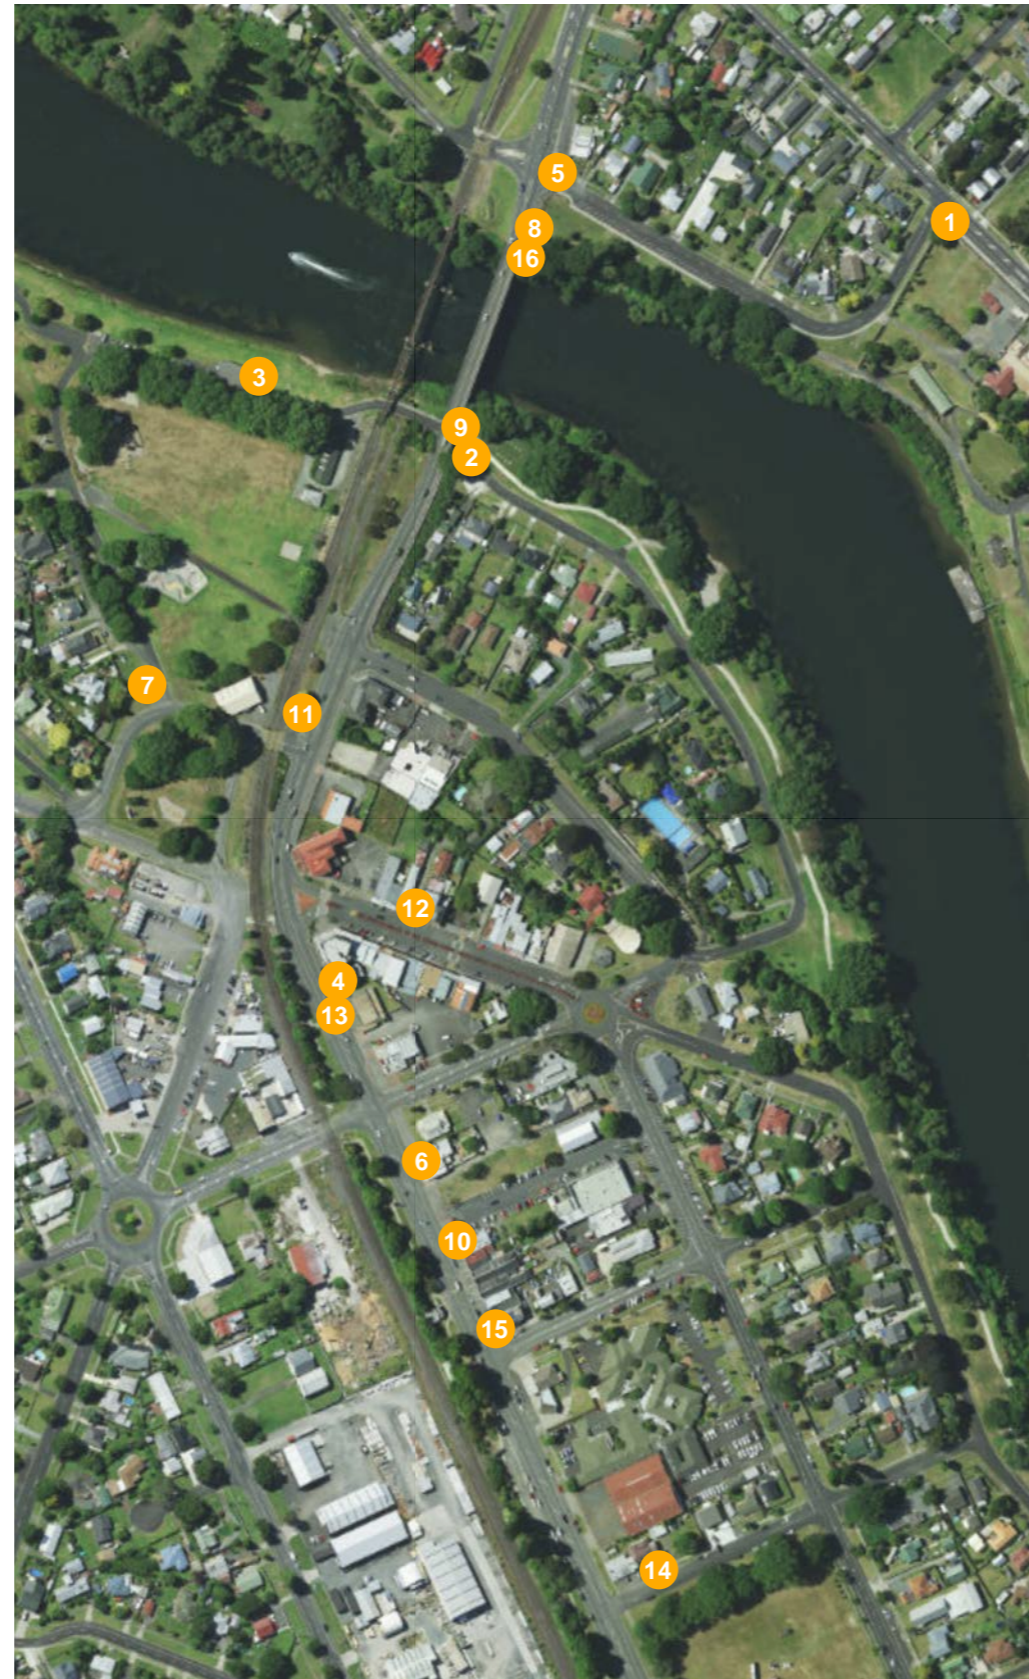
Figure 15. Mapping of graffiti - Ngaaruawaahia

Note the images taken are representative from the site visit and do not include all evidence of graffiti.

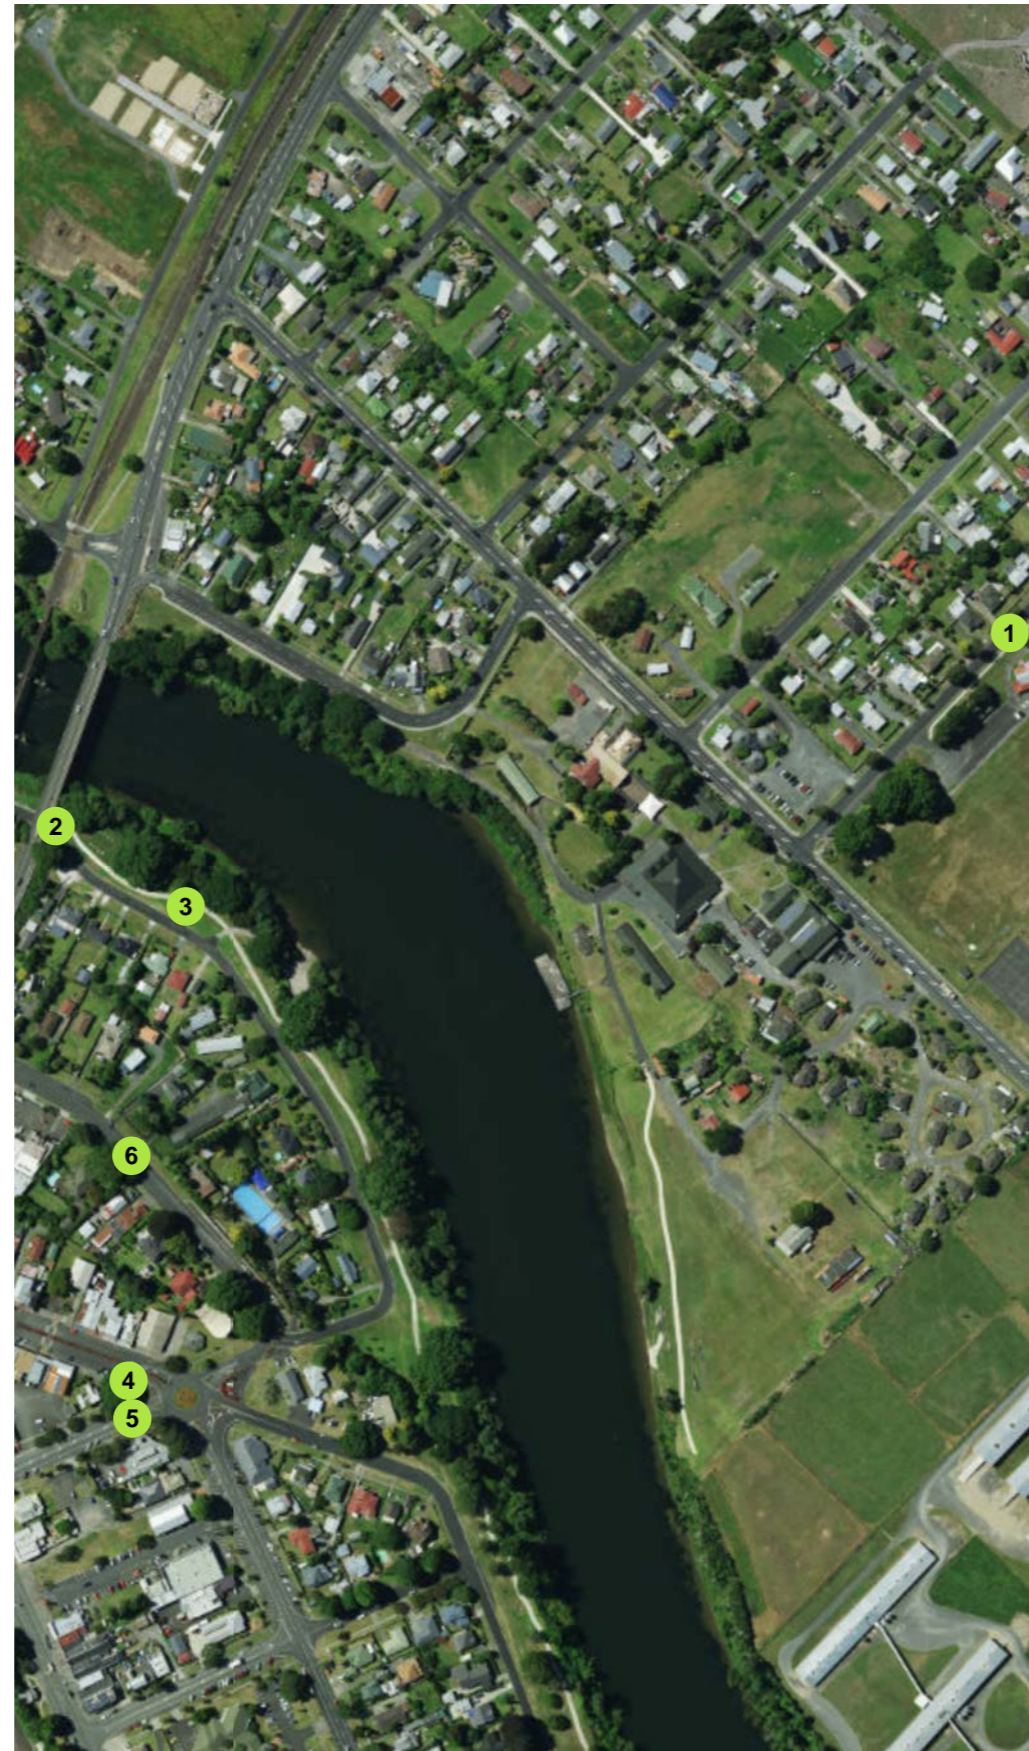
Figure 17. Mapping of overgrown vegetation - Ngaaruawaahia

Other instances include large tree canopies that obscure light poles and limit illumination onto the pedestrian path and roads.

It is recommended to trim vegetation over footpaths and tree canopies as well as that which obscures lighting. This should be included in the maintenance regime to ensure views are not impeded and maximise passive surveillance and safety. Prioritisation should be at higher pedestrian movement areas - The Point, riverside, bridge, Jesmond Street, Great South Road, Market Street, High School, and Turangawaewae Marae.
