ESTABLISHMENT AND OPERATION OF A MANAGED FILL ACTIVITY

RIVERVIEW DRIVE, HUNTLY

TRAFFIC IMPACT ASSESSMENT

Reference 221204

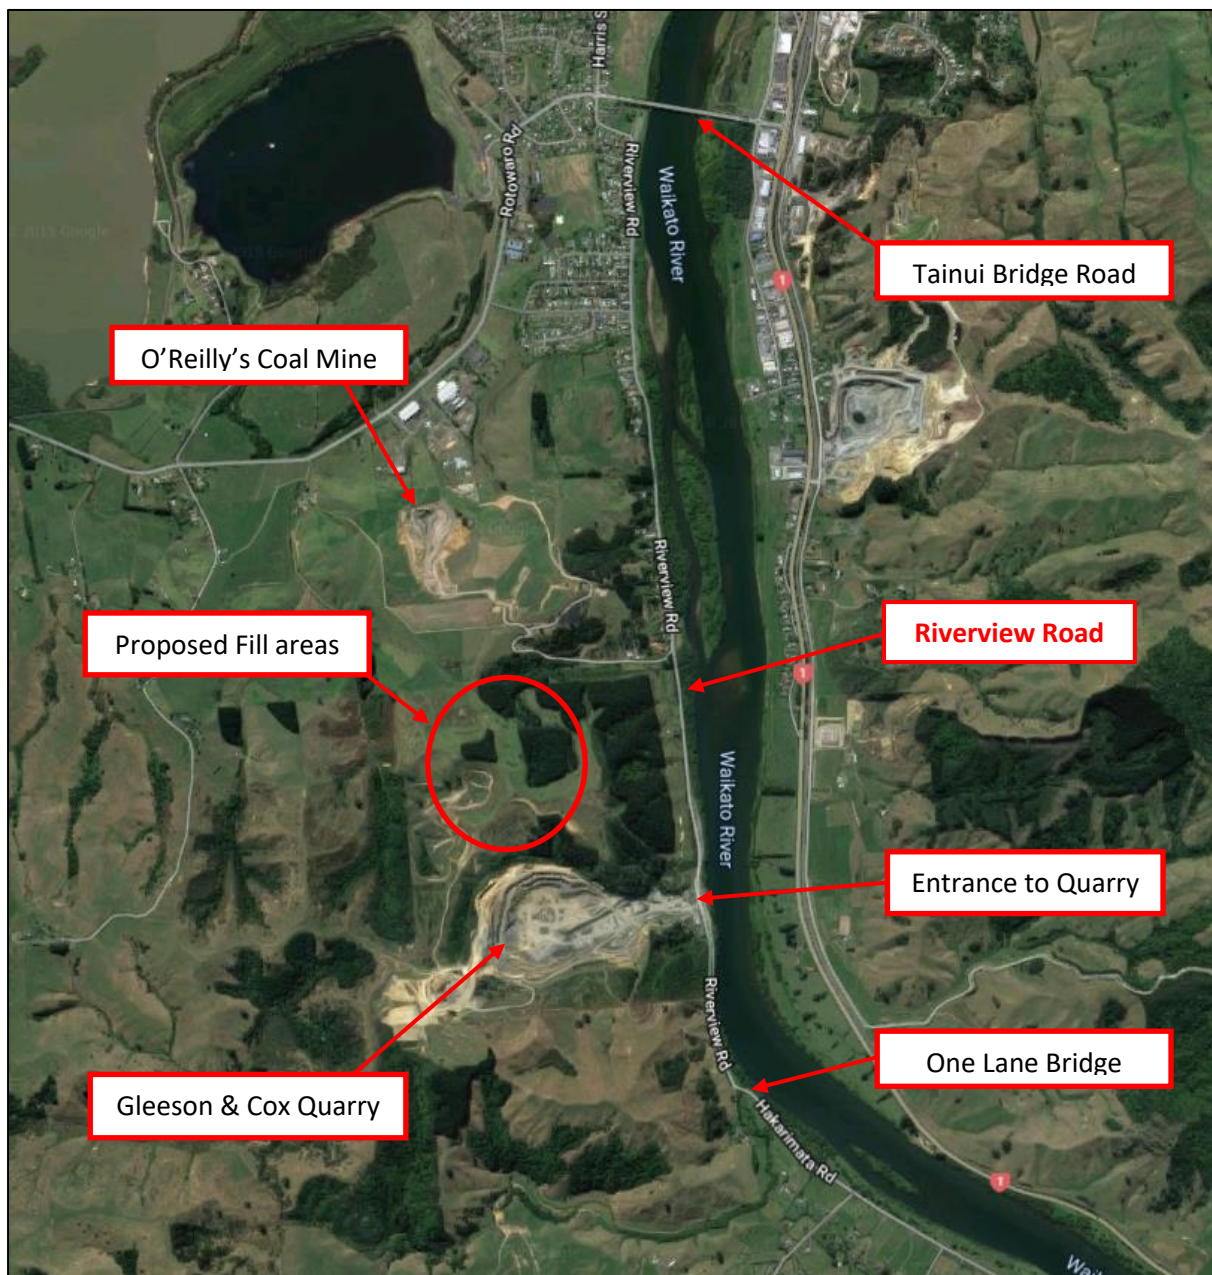
Figure 1: Site in relation to road network and local features.

The location of the site in relation to the road network and surrounding properties is shown in Figure 1 below.

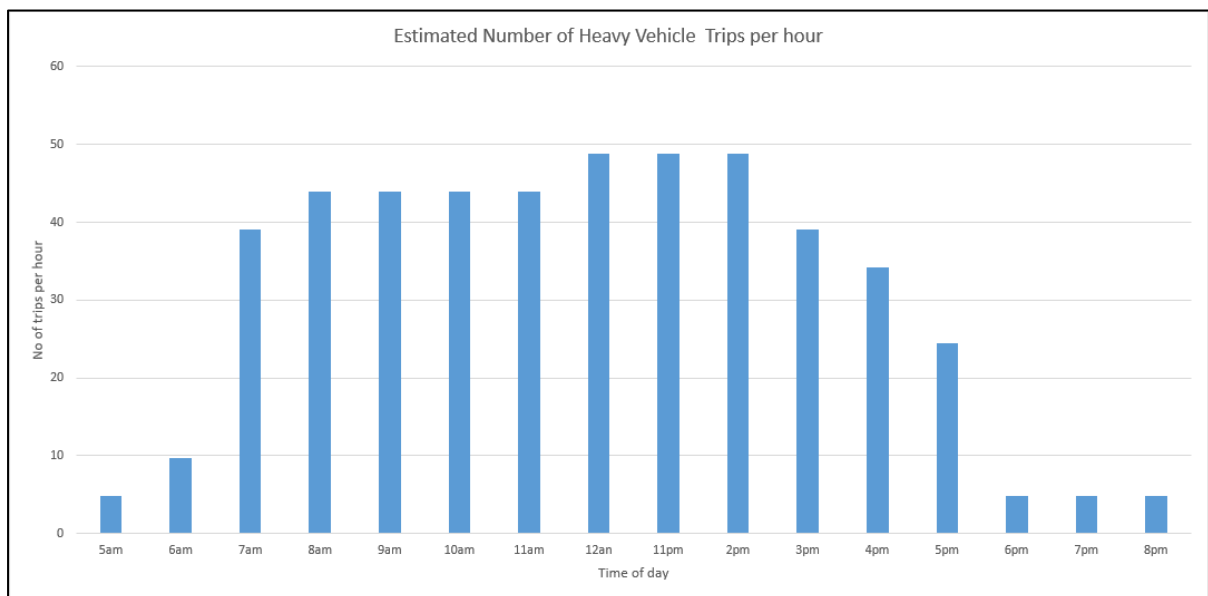
Figure 3: Estimated number of heavy vehicle trips per hour combined

These trips are likely to be spread throughout the day and are likely to follow a similar pattern as currently operates at the quarry. The extension of the operating hours is not expected to generate many movements as and the bulk of the trips will be made between 7.00am and 5.00pm. The table below shows a chart of the anticipated number of HCV trips per hour by both the quarry and the managed fill operations.

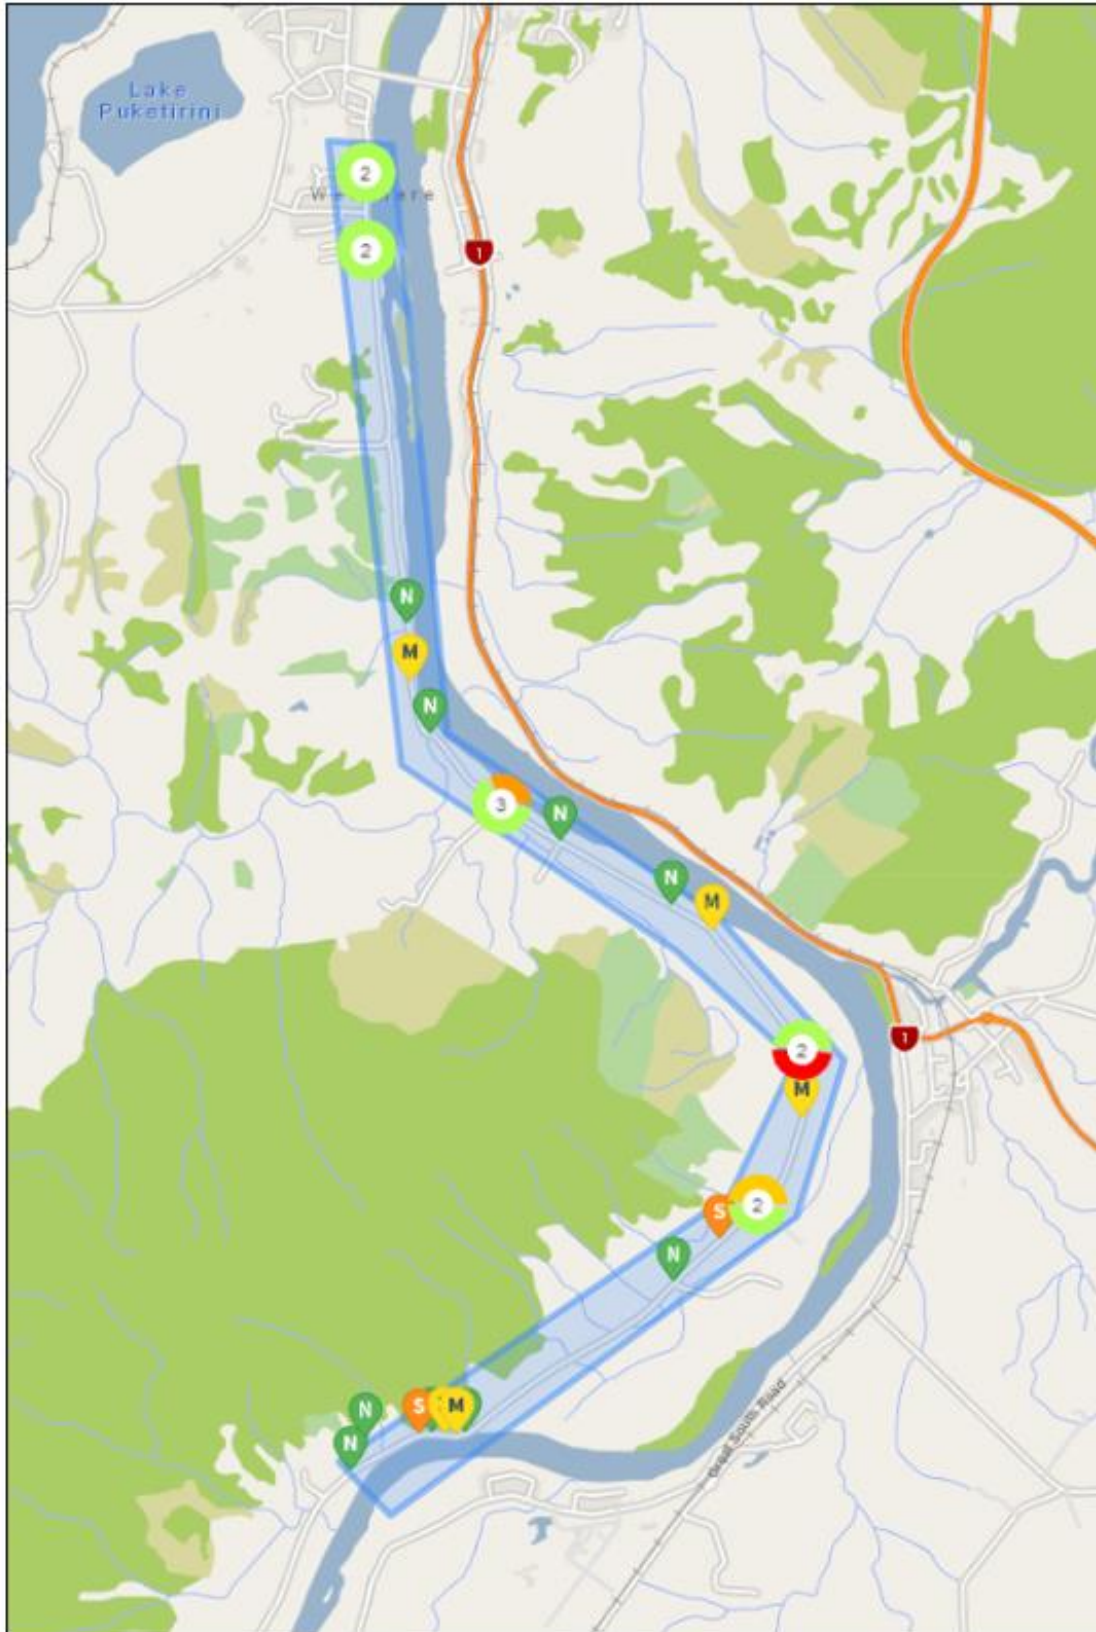
APPENDIX B: COLLISION DIAGRAM

Riverview Rd Collision Diagram 2017-2022
