ESTABLISHMENT AND OPERATION OF A MANAGED FILL ACTIVITY

RIVERVIEW DRIVE, HUNTLY

TRAFFIC IMPACT ASSESSMENT

Reference 221204

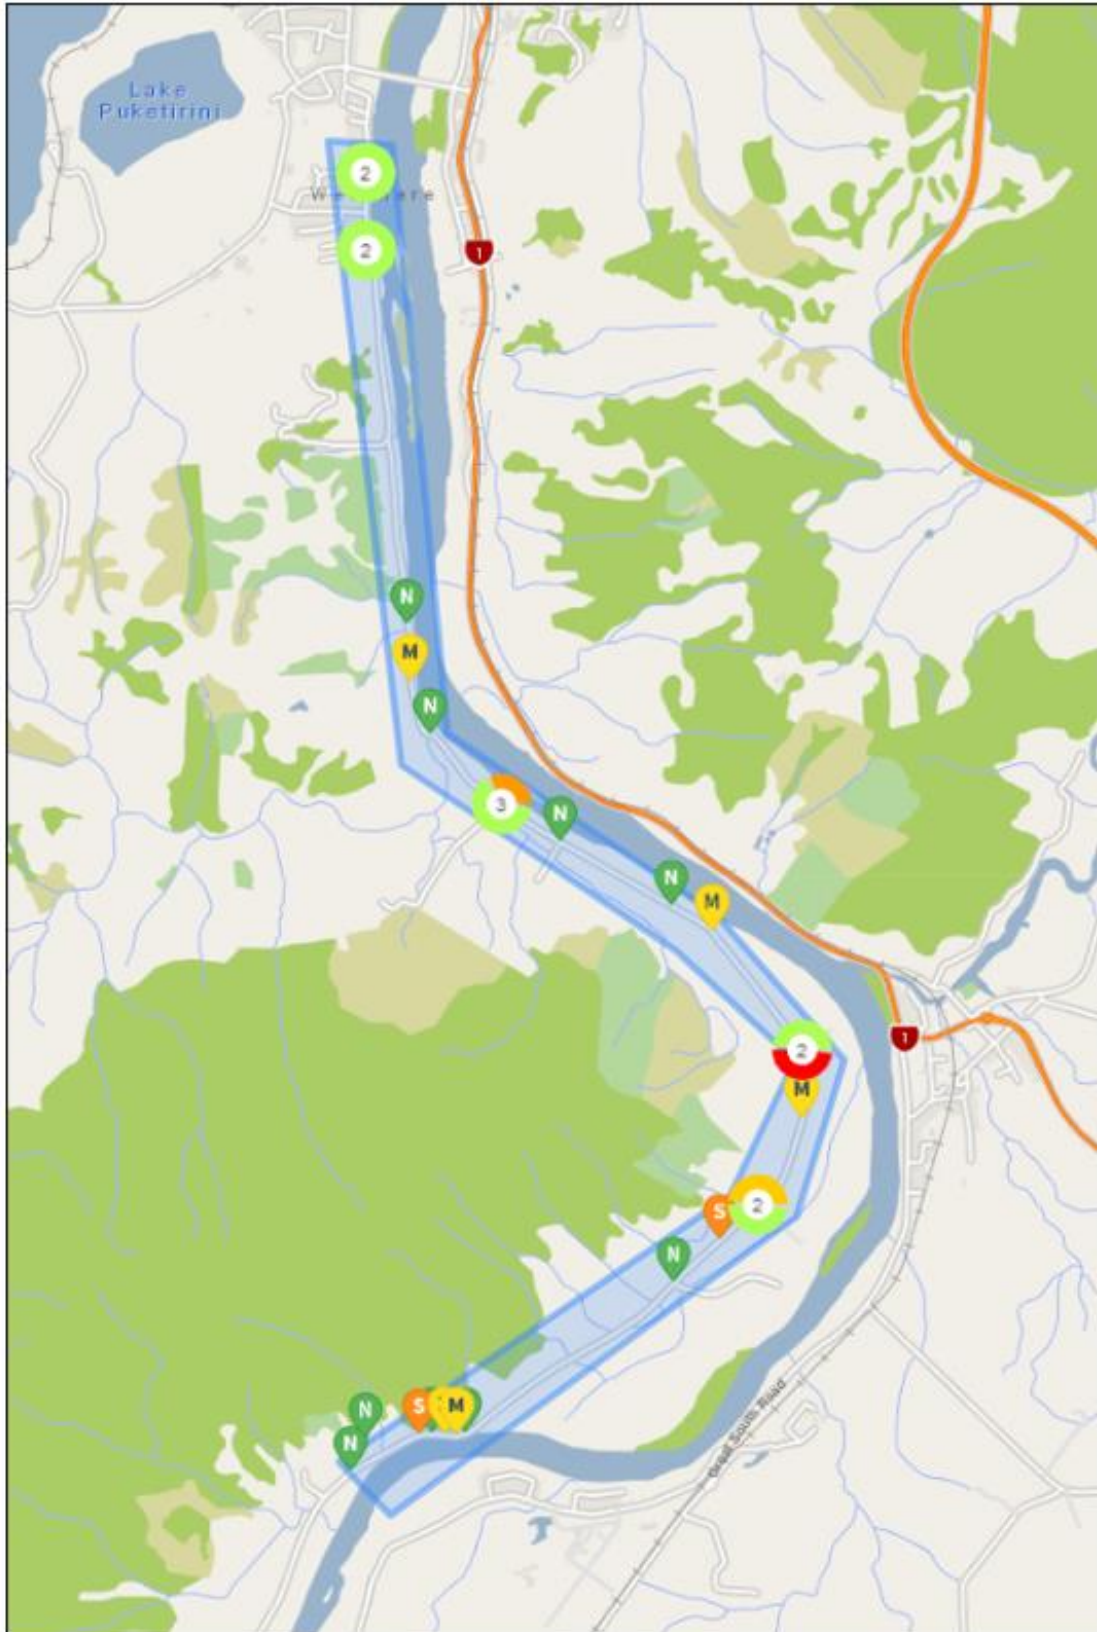
APPENDIX B: COLLISION DIAGRAM

Riverview Rd Collision Diagram 2017-2022
