Te Akau South Water Supply

# The Te Akau South Water Supply

Assessment and Review.

High Level Treatment System Design.

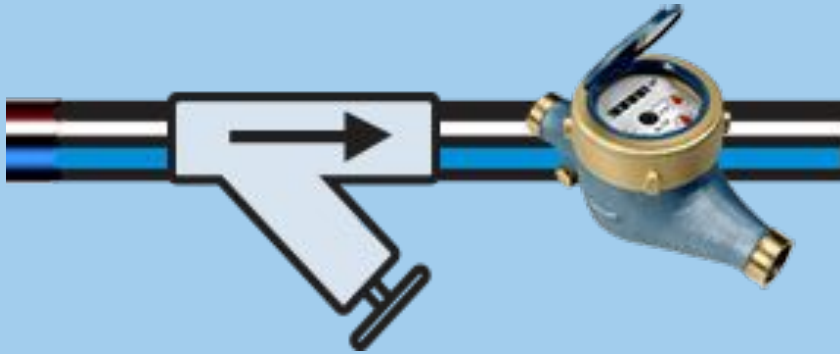
Screen Filter & Volume Meter

# Protecting the water meter

There was previously a Volume Meter used to monitor the water extraction. This is a requirement for WRC Resource Consent (recently removed). Unidentified particles had been found impacting this Meter.

A simple Screen Filter would address this & cleaning the filter would become a light maintenance duty. The Screen Filter would also reduce the replacement times for other filters.

**Note:** There may be other options available e.g. Magnetic Flow Meters. We intend performing a cost/benefit analysis as this technology may also reduce site visit requirements via remote monitoring that provides historicized data.

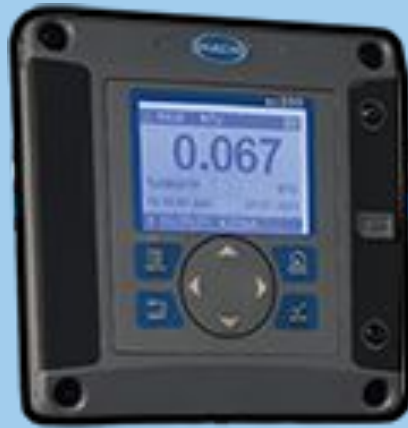
Turbidimeter

# Monitoring the turbidity inflow

Monitoring the inflow Turbidity achieves compliance with the Taumata Arowai Document Section 8 Item SB2

*Source water turbidity must be measured after the point of abstraction and before treatment either continuously or daily <20 NTU at all times*

Use of telemetered turbidity at this point will remove the need for daily visits.

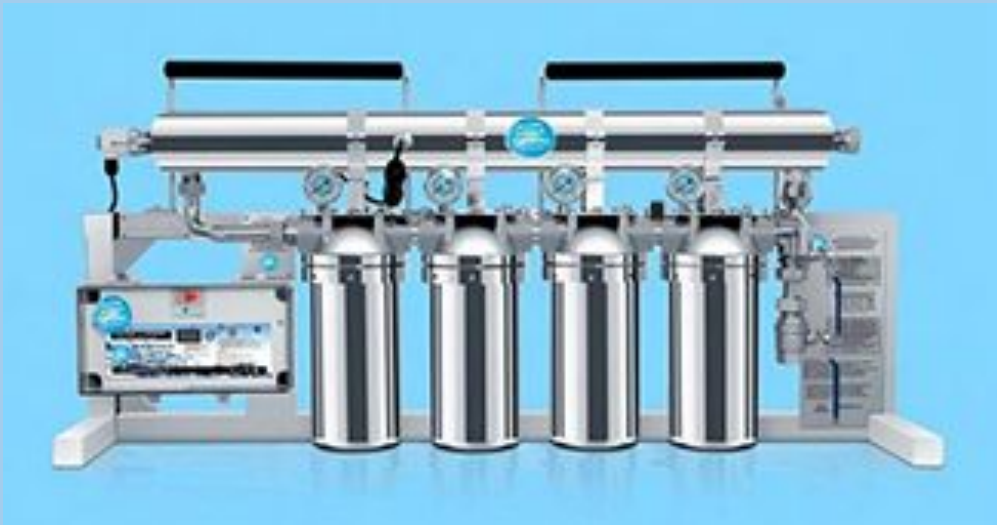
## Filtration & U.V Sterilisation Unit

# Filtering and UV sterilisation

This sterilization unit is compliant with NSF/ANSI 55 for Class A systems. (Taumata Arowai Acceptable Solutions: Section 6.3).

The unit features both physical Filters plus UV sterilisation with a flow up to 100 l/min. This exceeds the flow rate of the previous pump used (80 l/min).

The filters have differential pressure meters as per the EN837.1 European standard and also comply with Taumata Arowai: Section 6.3

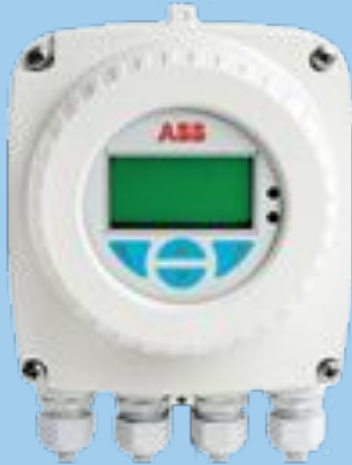
# Measuring treated water flow rate

A Flow Rate Meter is currently installed on site & measures the flow rate in real-time displaying it in units of litres p/second including total volume.

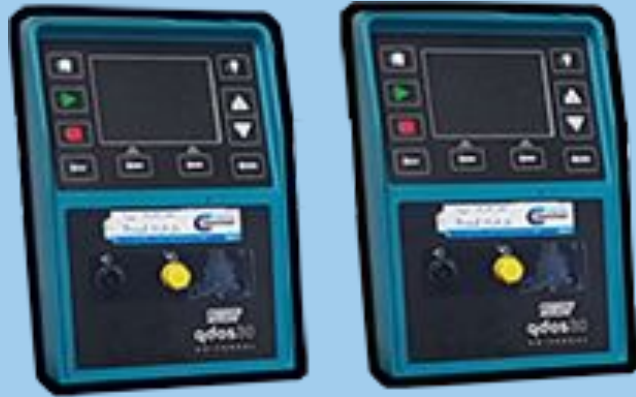
## Cl & pH Dosing Pumps

# Chemical treatment

Previously installed were two qdos Dosing Pumps used to provide chlorine and pH correction recently removed from site. These devices use peristaltic pumps that deliver dosing with the flow rate control input manually set.

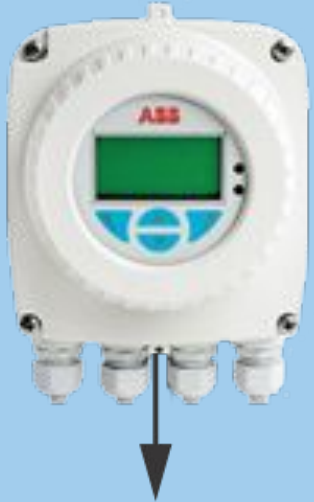
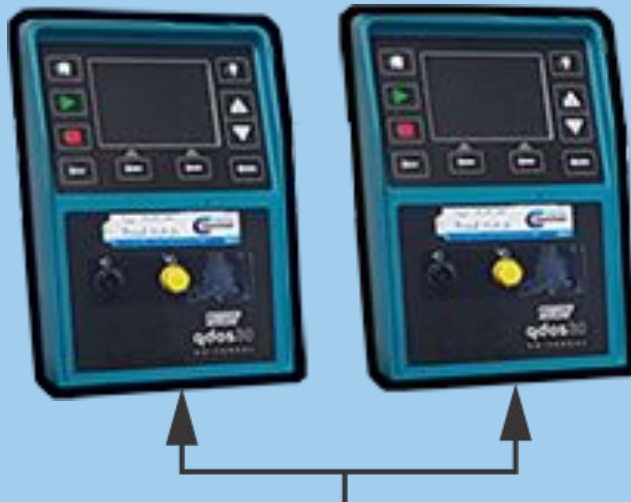
# Dosing Control System

Flow Rate Meter

Cl & pH Dosing Pumps

**Dosing Control**  
Modulated to flow rate

This is a local control function

Dosing control can be achieved by using the Flow Rate Meter to control the previously installed Dosing Pumps. The correct dosing will be achieved, regardless of water flow, ensuring correct chemical balance at all times.

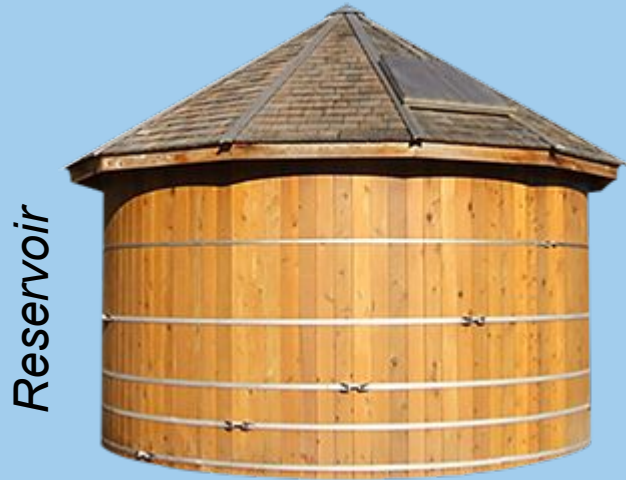
# Reservoir and Volume meter

There is a Volume Meter next to the reservoir to monitor Community consumption.

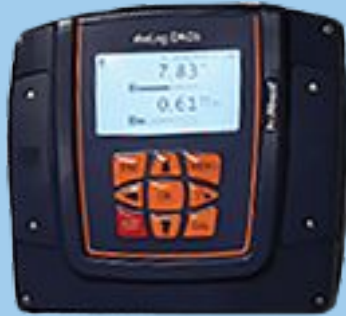
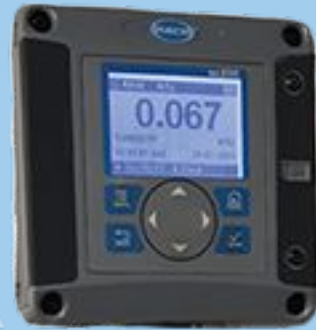
# Water quality metering

*Turbidimeter*

*Cl & PH meter*

A Turbidimeter along with a Cl & PH meter are currently installed onsite and are compliant with Taumata Arowai Acceptable Solutions.

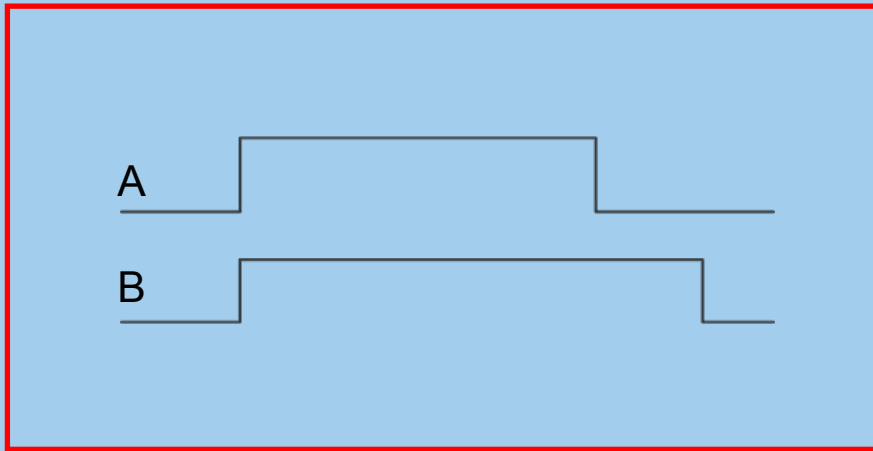
To illustrate this, consider the two plots of water delivery shown below. The top plot (A) shows the normal flow while filling the reservoir. The bottom plot (B) shows lower flows at a longer period signaling a partial failure.

This data would enable the operators to anticipate partial failures and provide more accurate fault diagnosis

In addition to water quality, the flow rate should also be telemetered providing a valuable diagnostic tool
